A Case Study of Residential Buildings Subjected to Cracking Failures

Abstract: The purpose of this paper is to present some preliminary findings of residential buildings which subjected to cracks. The study case covered in this paper is to determine the cause of cracking of semi-detached residential houses which initially expected due to a construction project nearby. Several types of buildings and infrastructures were evaluated through the preliminary qualitative forensic assessment for the hypothesis on the cause of the problems on residential buildings. The initial assumption that caused the cracking was due to the nearby construction works. From the inspection it was suggested that the piling work from the construction project does not have an impact that could damage or jeopardize the main structures. It was expected that the failures occurred on the walls and floors of the houses are more reflected due to the soil settlement on the housing area.

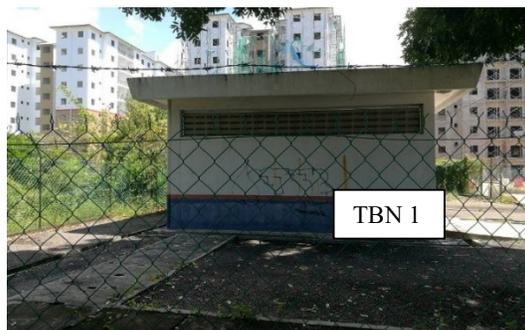
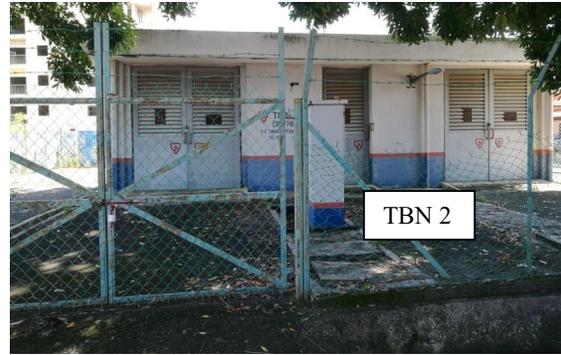
Fig. 2 Electrical Substation TNB 1 and TNB 2

There are two existing TNB (1 and 2) electrical substations located to the left and right adjacent to the construction project. Visual observation can be only conducted from the outside fence for both buildings. Both of the TNB substations are the closest building to apartment construction projects in this investigation work. From the rear view of the fence, there is no significant cracking can be observed on the outside of the building structure, outer wall, apron floor (outer perimeter) and concrete trench around the building for both TNB substations as shown in Fig. 2.

2. The two existing TNB substations are the closest building to the construction projects not showing significant cracking of walls, floor / drain around the buildings. This suggests that piling work of the construction projects has no effect that could damage the structural and non-structural parts of the two TNB substations.

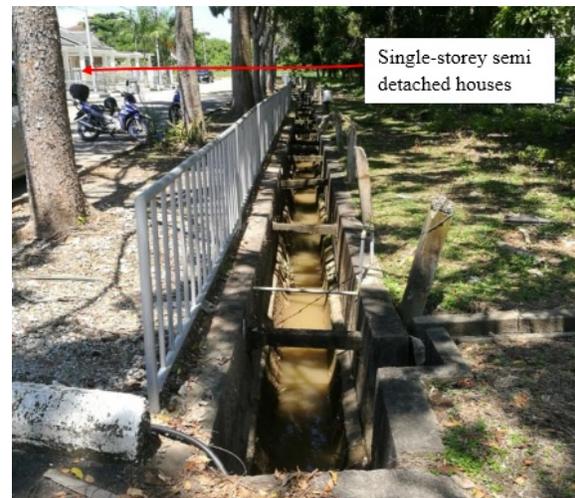
Fig. 3 Concrete drain in front of the semi-detached single storey houses

For the concrete drain located in front of the construction project and adjacent to the semi-detached single storey- houses (Fig. 3), the existing drainage concrete was in satisfactory condition. There was no significant cracking occurred on the concrete channel, its walls and the iron barrier was also not deflected.

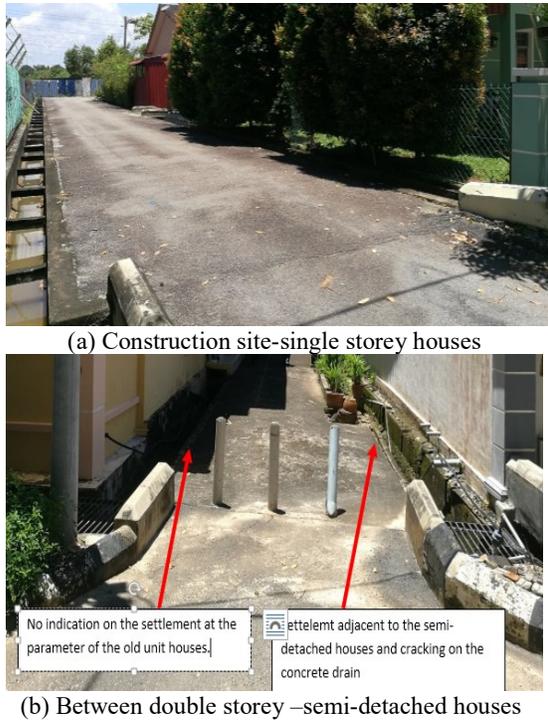
Fig. 4 Condition of infrastructures

Observation on a small lane between the single storey houses and the construction site shows there was no settlement or cracking effects on the roads and the drains (Figure 4(a)). However, observation on the small lane between the end of semi-detached houses and the double-storey houses shows there was a settlement and significant crack on the side of the semi-detached single storey houses, but there was no settlement and significant crack observed on the old two-story terrace house (Figure 4(b)).

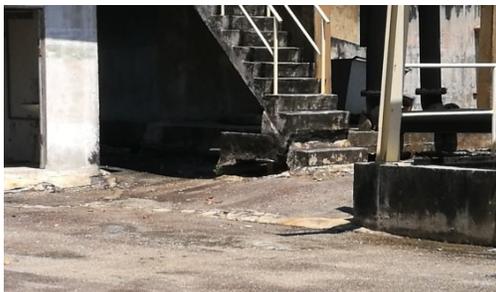
Fig. 5 Oxidation Pump House

There was a significant settlement about 150mm observed on the apron and stairs of the oxidation pump house (Figure 5). The pump house and the oxidation pond were both using the old system and were built before the project started. Based on the observation on the settlement, the coloration of the structure it could be expected that the settlement occurred long before the project started. As the Melaka River, which located less than 100 m from the pump house, it could be an indication that the significant settlement may be caused by high water and groundwater levels. From the inspection, it is also expected that the location be more susceptible to the settlement due to the soft ground and water sources. For such location, soil investigation and suitable foundation are necessary to avoid this phenomena.

4. The same settlement phenomenon can be observed has occurred in the oxidation pump

house. Based on the conditions and its large settlement indicate that the phenomenon has occurred long before the project started.

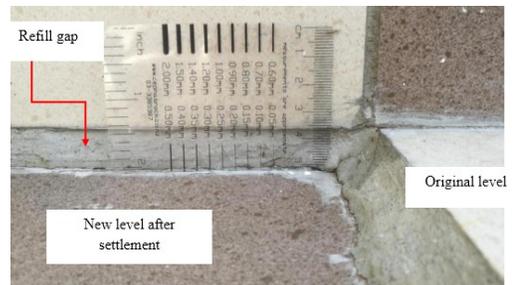
Fig. 6 Car-porch area

- (i) Car porch floor
The settlement and cracking on the car porch can be seen on the houses (Figure 6). According the resident, the settlement occurred once they occupied the house.

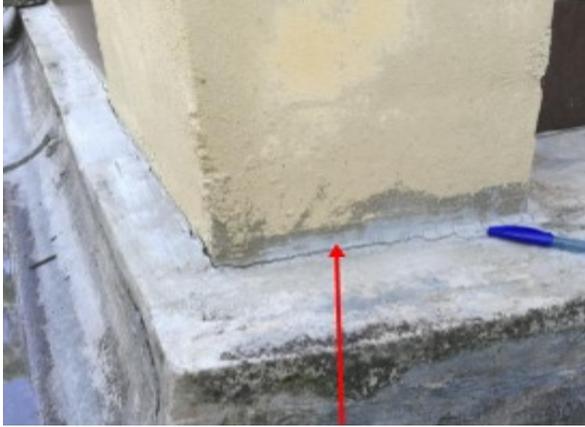
Fig 7 Surrounding the house area

- (ii) Settlement on the apron and surrounding column outside of the houses (Figure 7)
- (iii) Living room floor (Figure 8)
- (iv) Concrete flat roof at the car porch (Figure 9)
The cracking can be seen as the results of rainwater penetration.

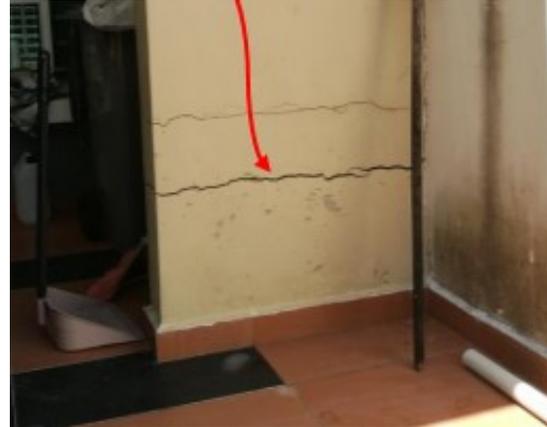
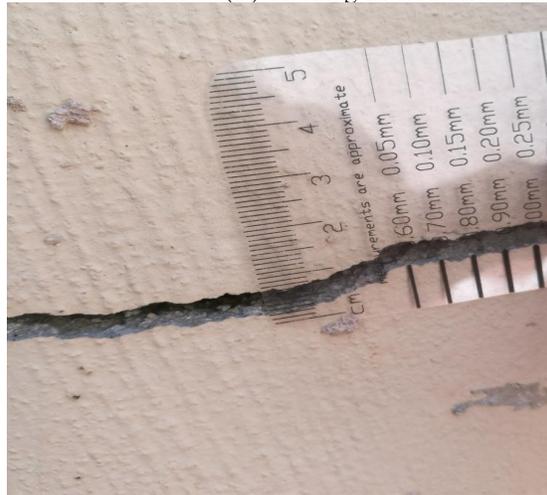
Fig. 10 Cracking on brick wall frame at the car-porch floor

- (v) Wall at car porch
The brick wall cracked horizontally near the floor level (Figure 10) and the crack width is 7mm which can be classified as moderate [3]. The brick wall is likely to be built without a ground beam and located directly above the floor below it. Therefore, it is not impossible that as the floor experience settlement it will resulted in the brick walls undergoing movement and subsequently cracking.

(a) Cracking on the wall

(b) 7mm crack on the wall

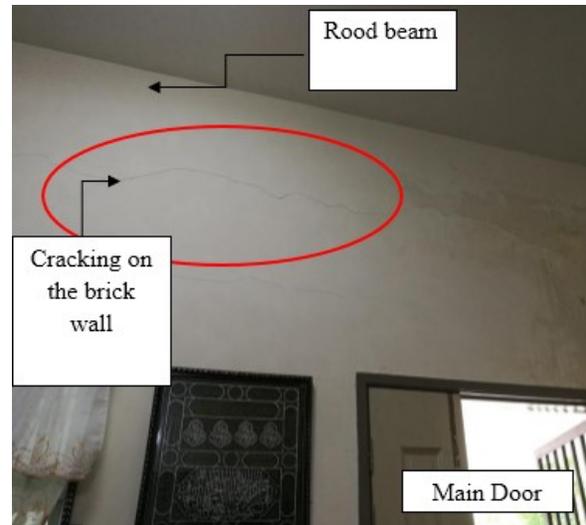
Fig 11 Cracking on brick wall

- (vi) Cracking of interior walls
Transverse cracking could be seen mainly on a few sections of the houses (Figure 11). The cracking significantly observed along on the brick wall and the beam intersection, which was expected due to the movement of the building structures, excessive vibration shrinkage / expansion ratio between the different materials (brick, concrete and mortar plaster). However, there is no failure observed in the main building structures.

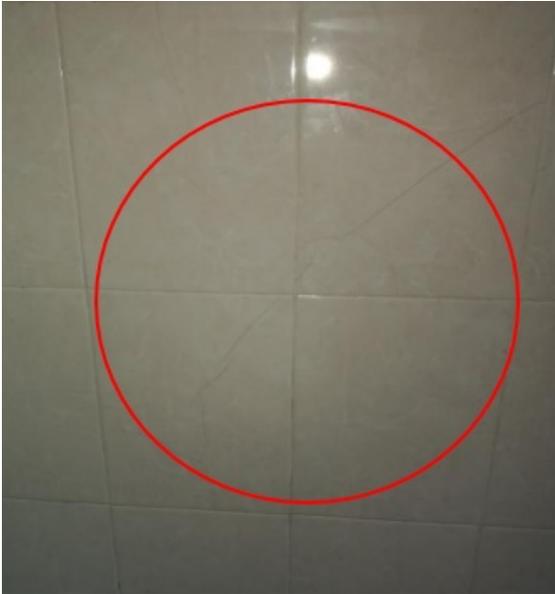
Fig 12 Cracking on the wall finishing

- (vii) Single-storey terrace house
A single-storey terrace house has been investigated and according to the resident the cracking on the brick walls occurred during the piling work on the construction project. However, most of the cracking is no longer noticeable as the walls have been repainted and during the investigation the cracking can be only observed on the kitchen wall (Figure 12)
