Building Defects Investigation - Two Case Studies on Steel and Reinforced Concrete Structures

The purpose of this paper is to present two case studies involving the initial assessment of potential causes of building structures that are in doubt. The investigation involving a fertilizer-manufacturing building and residential buildings. The corrosion problems that occurred in the industrial building were severe, and necessitating an assessment to gauge the building's safety condition. For the residential building, a visual inspection was conducted not only on the residential structures themselves but also on the surrounding infrastructures, in order to justify whether the nearby construction works were responsible for the problems. From the investigation on the industrial building, corrosion seems to be the primary problem and a potential cause of structural instability. The severity can be seen as most of the steel structural elements exhibited signs of material loss from their surfaces. From the evaluation through visual inspection and tests, the aggressive environment and insufficient maintenance are the main contributors to the corrosion related damage. Concerning the residentia

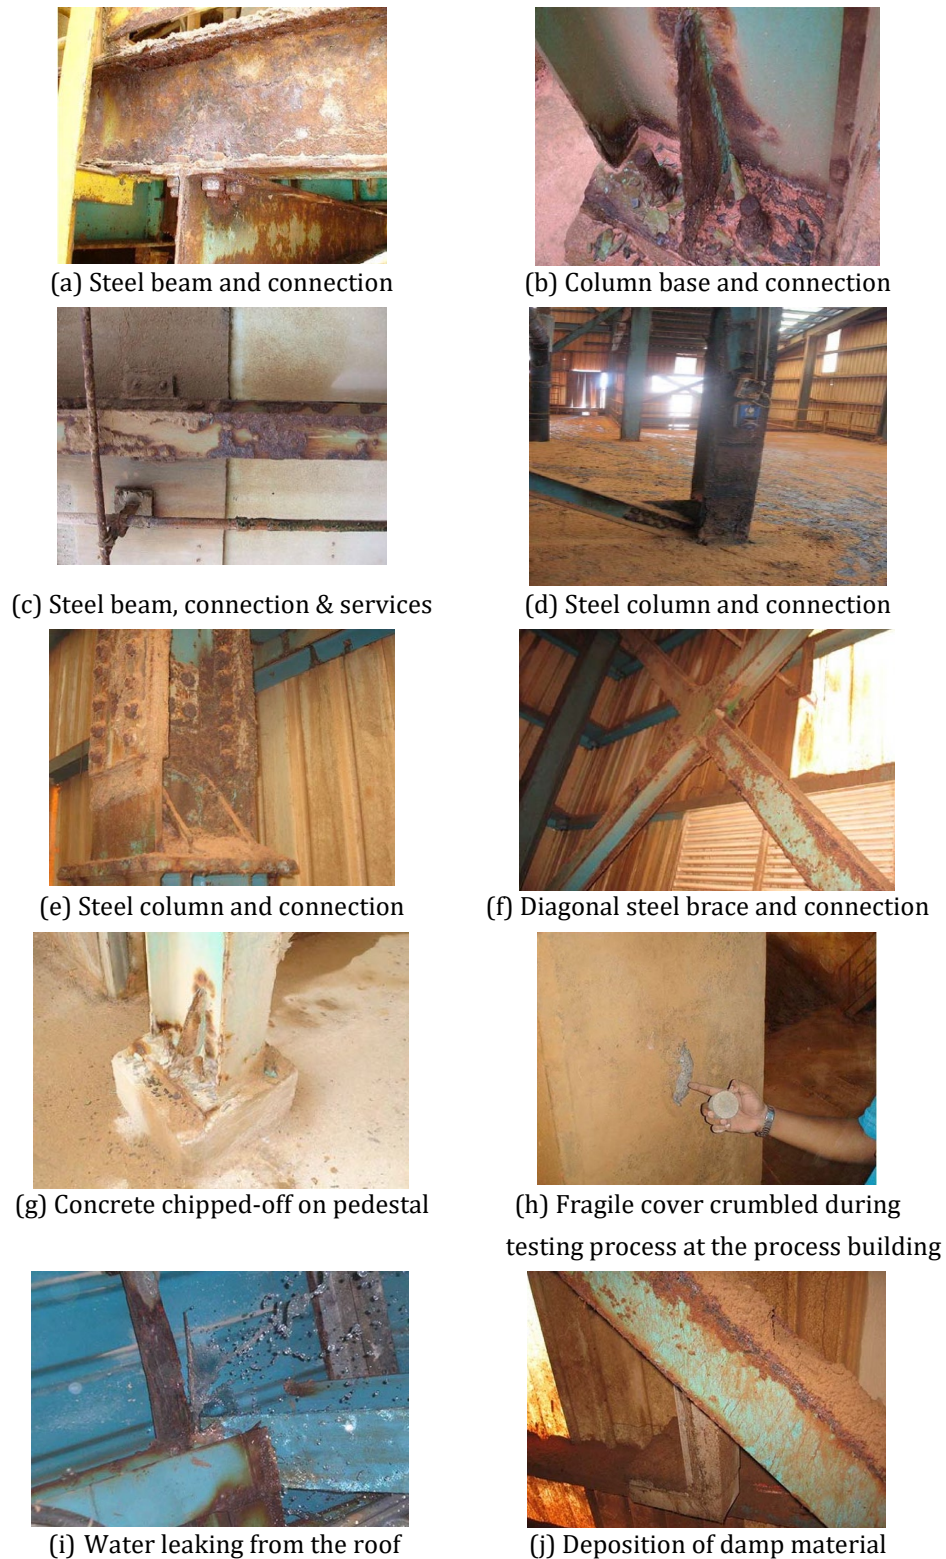
Fig. 2 Observation on structure defects

The visual inspection identified corrosion across various structural steel elements, manifesting at varying degrees, site locations, and elemental positions—especially at connections and flanges. This corrosion is attributed to environmental exposure and the deposition of aggressive damp material or chemicals, causing material disintegration and distortion. Material disintegration refers to the deterioration and breakdown of the steel due to the corrosive processes while the distortion can be observed from the deformation or alteration in the shape of the steel elements caused by the corrosion. Several figures are referenced to illustrate specific instances of corrosion and related concerns. As depicted in Fig. 2, the visual inspection further substantiated the widespread corrosion affecting the structural elements of the building.

Fig. 2 (a) presents the corrosion evident on a steel beam and its connection situated between the bagging and intermediate storage buildings. The severity of corrosion on the column base plate is depicted in Fig. 2(b), which was captured from the same location.

At the upper storey of the process building, corrosion has manifested on various steel elements: beams and steel for services, steel columns as depicted in Fig. 2(c) and Fig. 2 (d). Further signs of corrosion can be seen on

the column splice (Fig. 2(e)) and the steel brace (Fig. 2(f))—both located on the upper storey of the process building.

Fig. 2(g) illustrates how corrosion on the column base plate can affect the concrete pedestal. As steel corrodes, it generates iron oxide (rust) as a byproduct. Iron oxide occupies a greater volume than the original steel, resulting in the expansion of corrosion products. This expansion eventually generates internal pressure within the concrete, leading to chipping off the concrete pedestals. Consequently, tests were conducted on the pedestals to assess their current strength and their ability to support the steel elements.

The corrosion's severity is evident as it affects other structural members. Fig. 2(h) illustrates the fragility of the concrete cover during testing, indicating potential integrity concerns. The persistent compromised site conditions further contribute to the deterioration, as illustrated in Fig. 2(i) and Fig. 2(h). The former demonstrates steel elements exposed to rainfall, while the latter highlights the deposition of damp material, exacerbating the corrosive environment.

To address these issues, it is necessary to implement measures for safeguarding and maintaining structural integrity. This might involve corrosion protection strategies, maintenance efforts, potential redesigns, and repair work. Addressing corrosion and concrete spalling, along with mitigating compromised site conditions, ensures the facility's sustained safety and functionality of its structural elements.

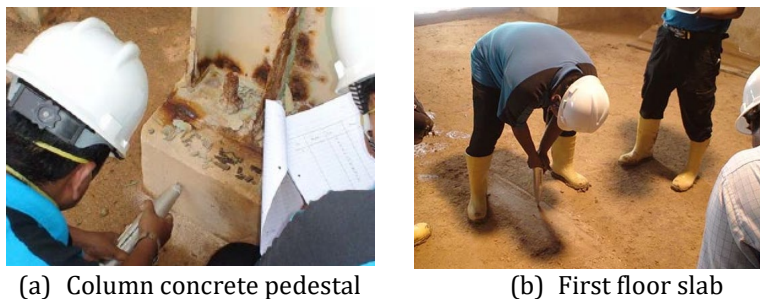
Fig. 3 Rebound hammer test

The rebound hammer test was performed on several structure elements and the correlation of the rebound hammer test to the concrete strength are as listed in Table 2

The results of the rebound hammer test generally indicated that most structural elements had values exceeding 30 kN/m². However, a few cases showed compressive strength below 20 kN/m², suggesting that the concrete strength in those locations might be low.

A pedestal is a crucial component of a compression structure, situated between the footing and column. Its purpose is to evenly distribute the load over the footing. Typically, a concrete pedestal serves as a compression element designed to bear the column or statue's compression load. Therefore, it is concerning that some pedestals have experienced concrete loss, compromising their structural integrity.

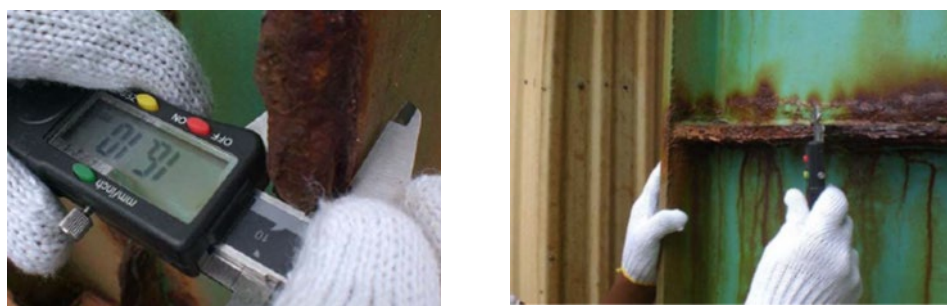
Fig. 4 Vernier calliper measurements

In addition to the Rebound Hammer test, Vernier caliper measurements were also conducted as part of this study (Fig. 4). Given that corrosion can occur at varying rates based on the environmental conditions the metal is exposed to, Vernier caliper measurements are essential. These measurements allow us to determine the current thickness of the structural elements and evaluate the extent of deterioration caused by corrosion.

The results of the vernier caliper measurements on selected elements are indicated in the Table 3. In general, the steel structures could be seen distorted and its material thinning out occurred due to the expansive corrosive stresses. The results of the vernier caliper measurements on selected elements are as indicated in the Table 2. In general, the steel structures could be seen distorted and its material thinning out occurred due to the expansive corrosive stresses. As the factory building is still in operation facing the problem of directing the structure of the building and repairs need to be done as one of the maintenance routines

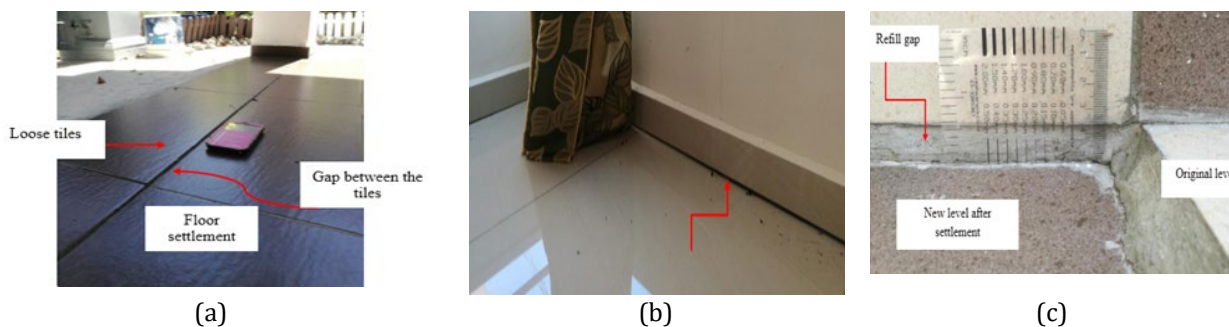
Fig. 6 Settlement in residential

Fig. 6 shows the settlement observed in semidetached single-storey houses located directly in front of the construction project. Settlement can be observed at several locations within these houses including the car porch, living room and apron (Fig. 6). According to the homeowners, settlement in the car porch area began once they occupied the house.

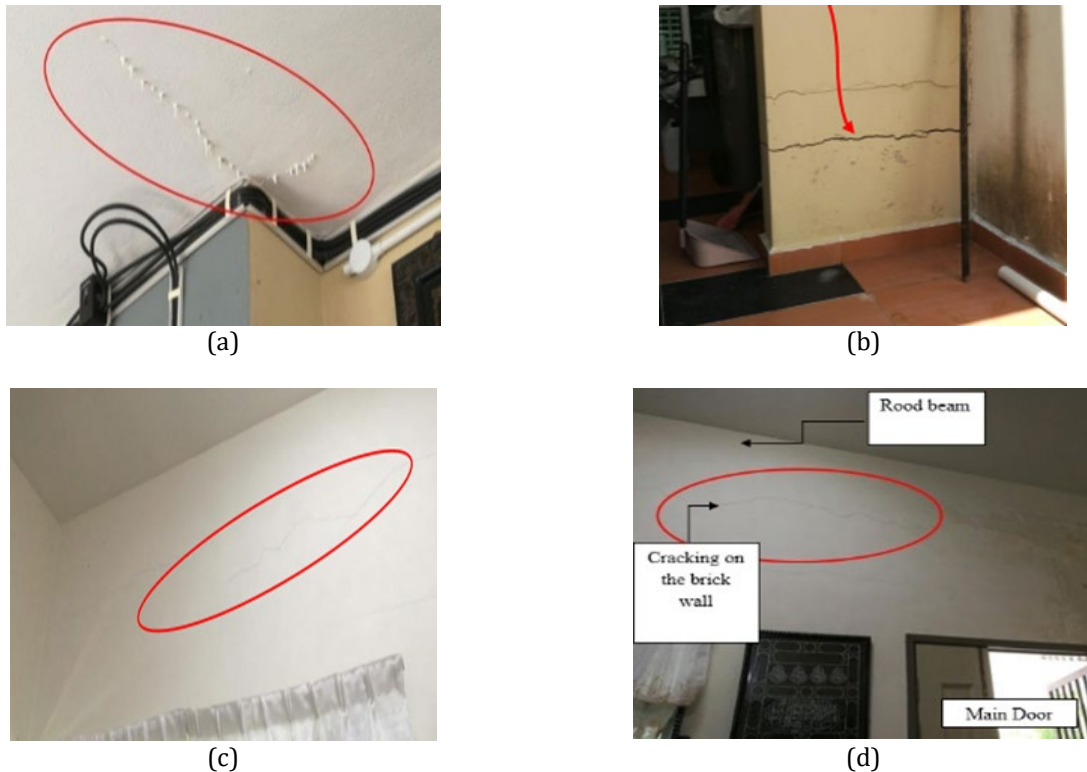
Fig. 7 Few observed defects in residential

Another defect can be seen on the concrete flat roof of the car porch, evident in the form of calthemite stalactites, as shown in Fig. 7(a). Calthemites are concrete, mortar, or lime-derived secondary deposits consisting primarily of calcium carbonate that grow on or under man-made alkaline structures such as concrete. In this case, the condition cannot be related to ground settlement as no cracks were visible. This problem is actually common in concrete flat roofs and is solely caused by waterproofing issues and water ponding.

The brick wall at the car porch has horizontal crack near the floor level as depicted in Fig. 7(b). It is likely the wall was constructed without a ground beam directly above the floor below it. Therefore, as the floor settled, it caused the brick walls to shift and subsequently cracking. Longitudinal cracking along the adjoining beam-brick perimeter is also visible in several sections of the houses, as can be seen in Fig. 7(c) and Fig. 7(d). This cracking is most prominent at the intersection of brick walls and beams, which is expected due to structural movement, excessive vibration, and differences in shrinkage/expansion ratios between various materials such as brick, concrete, and mortar plaster. It's important to note that there were no failures observed in the main building structures.

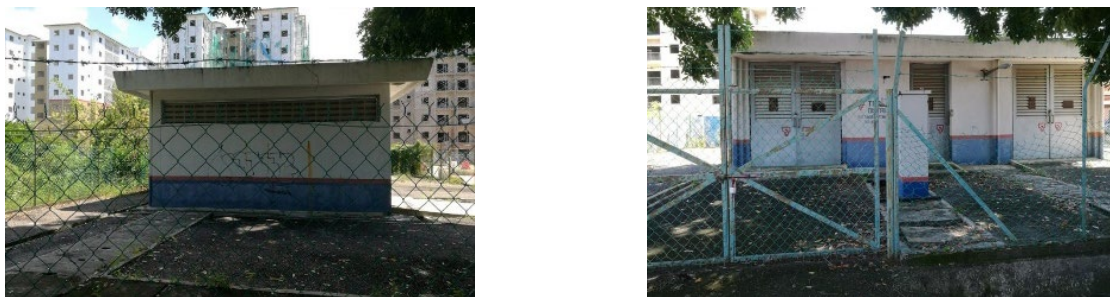
Fig. 8 Electrical substation TNB 1 and TNB 2

To investigate whether the defects in semidetached single-storey houses were caused by the construction site, inspections were carried out on the infrastructures surrounding the project. These included TNB substations, existing concrete drains, road, the oxidation pump house, and the oxidation pond. Both TNB substations are the closest buildings to the construction projects and the visual observation on the sub-station could only be made from outside the fence. No significant cracking was observed on the outer structure, outer wall, apron floor (outer perimeter) or concrete trench around the building of both TNB substations, as shown in Fig. 8.

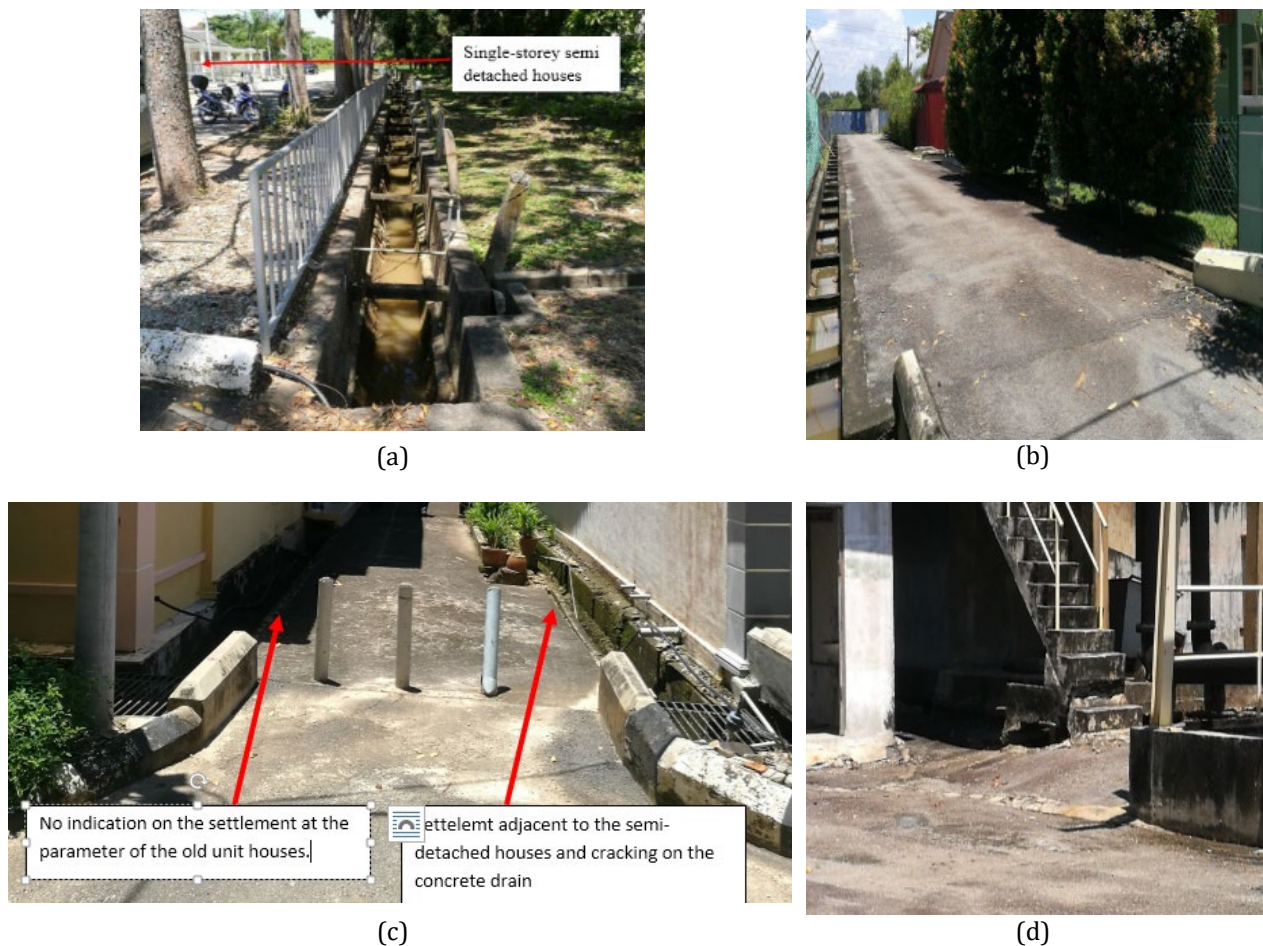
Fig. 9 Defects surrounding the residential area

Inspection of the concrete drain located in front of the construction project and adjacent to the single storey-detached houses was found in satisfactory condition (Fig. 9(a)) with no significant cracking observed on the concrete channel, its walls and the iron barrier. There was also no settlement or cracking observed on the roads and the drains in the small lane between the single-storey houses and the construction site (Fig. 9(b)). However, observation in the other small lane, located between the end of semi-detached houses and double-storey houses,

showed settlement and significant crack on the side of the houses. Surprisingly, there was no settlement or significant cracking observed on the old two-story terrace house as shown in Fig. 9(c).

Regarding the pump house and the oxidation pond, a significant settlement, approximately 150mm, was observed on the apron and stairs of the oxidation pump house (Fig. 9(d)). Based on these observations, including the settlement and the discoloration of the structure, it can be inferred that the settlement occurred long before the construction project started. Additionally, these infrastructures were built using an older system and were in place before the project commenced. Since the Melaka River is located less than 100m from the pump house, it could be an indication that the significant settlement may be caused by high water and groundwater levels. The inspection also suggests that this location may be more susceptible to settlement due to soft ground and the presence of water sources. Therefore, soil investigations and suitable foundations are necessary to prevent such phenomena in such locations."
