# The Investigation of Cracks and Repairing Methods on Residential Building: Case Study at Kompleks Penghulu Ayer Hitam, Muar

Mas Ezaty Mohamad<sup>1</sup>, Tuan Norhayati Tuan Chik<sup>2\*</sup>, Nor Aiza Erme Mohamad<sup>1</sup>, Nor Athirah Farhah Mat Jali<sup>1</sup>, Muhammad Azizi Yusri Rusidi<sup>1</sup>

DOI: <https://doi.org/10.30880/jsmbe.2024.04.01.005>

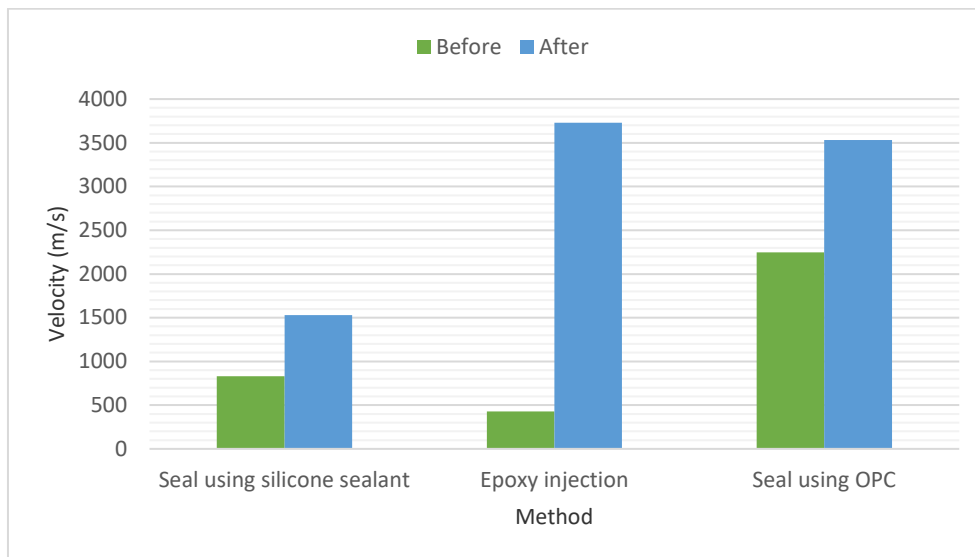
**Fig. 4** Comparison between UPV test result before and after repairing process

The comparison between UPV test result before and after repairing process is shown in Figure 4. The sealing using silicone sealant, epoxy injection method and seal using OPC are categories of method that being perform during the repairing process. There two sub-categories which is velocity value of UPV test before and after the repairing process. This allows the researcher to compare how the crack curing is performing after repairing process and identify the most effective repairing method by addressed performance at the crack location.

By having a glance at the chart, it can be seen that the value of velocity for epoxy injection sharply increased from 427m/s which classify as very weak concrete to 3730m/s which is classified as good concrete at location 2. From the result, the value of velocity at location 2 and 3 also slightly increased after sealing using silicone sealant and OPC by 829m/s (very weak) to 1530m/s (very weak) and 2247m/s (doubtful) to 3530 (good) respectively.

As shown in Figure 4, there is a clear upward trend in the value of velocity at the three locations after the repairing process has proven that these three methods can cure the crack; however, while the value of velocity is increasing after using these three methods, repairing using epoxy injection shows the most effective repairing method.
