Application of Unmanned Aerial Vehicle (UAV) in Visual Inspection for Civil Infrastructure at Sekolah Menengah Bandar Maharani, Muar

Nor Shuhada Natasha Rosli, Nur Adlin Sabrina Mohd Akbar, Nurul Qamarina Kamarolzaman, Ahmad Hakimi Mat Nor *, Masiri Kaamin

Department of Civil Engineering, Centre for Diploma Studies, Universiti Tun Hussien Onn Malaysia, Pagoh Education Hub, 84600 Pagoh, Johor, MALAYSIA

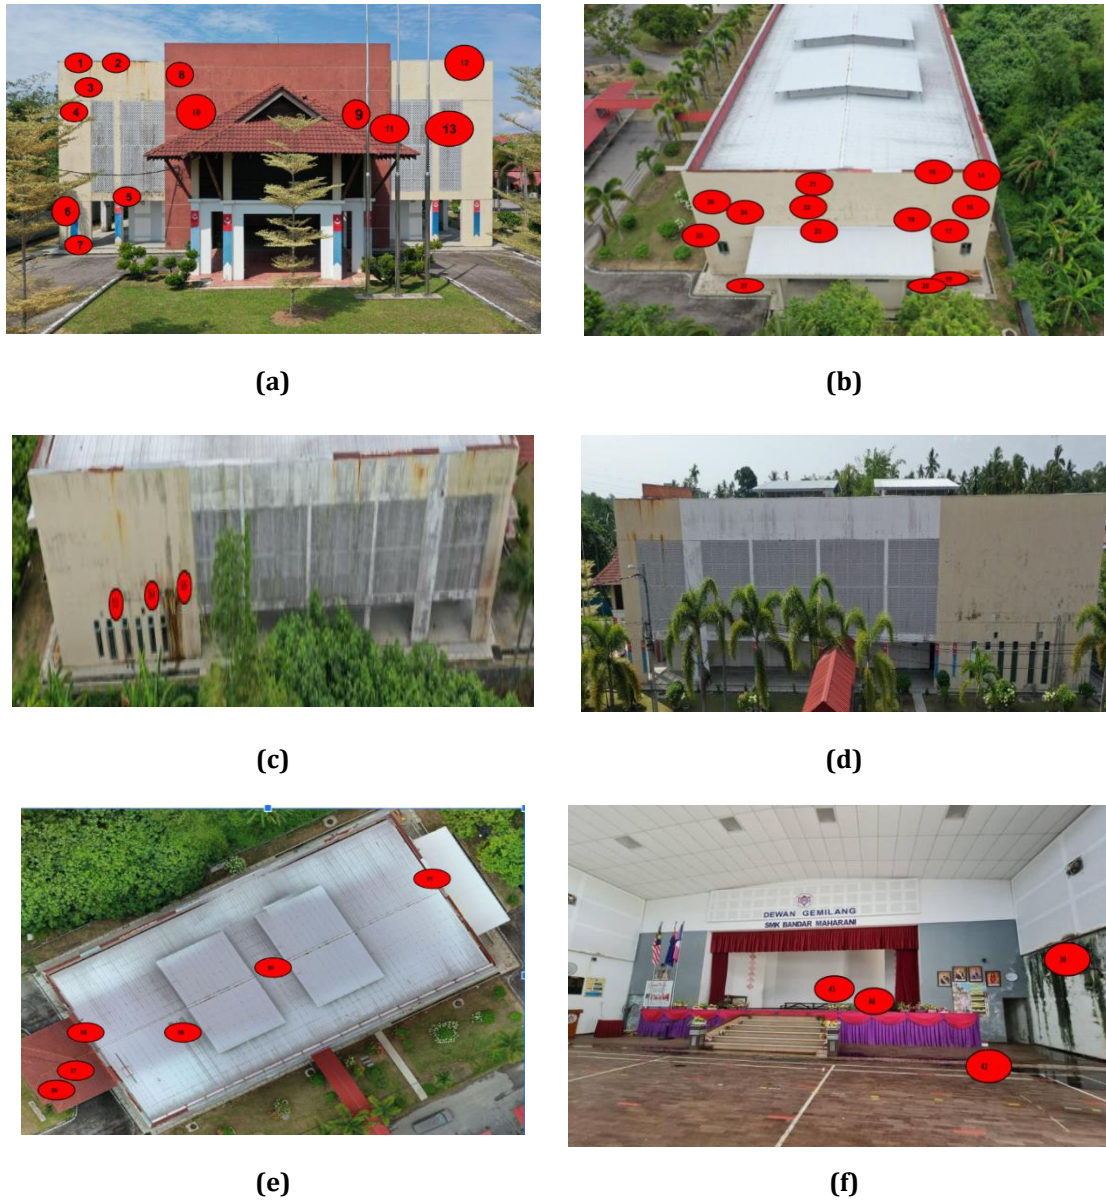
Fig. 2 depicts the location of SMK Bandar Maharani Hall from the front, back, left, right, inside, and roof, as captured by an unmanned aerial vehicle (UAV). The location of the damage identified in each of the hall building's structures is indicated on each diagram with a red mark. Plan diagrams were also captured with a drone and edited with Pix4D Mapper. Prior to being granted an assessment level in accordance with the requirements of the Malaysian Public Works Department, as stated in Table 4, all damage is first assessed in terms of position, type, and cause.

Fig. 2 Damaged positions are indicated by red circles with numbers (a) Front view of the hall; (b) Rear view of the hall; (c) Left side view of the hall; (d) Right side view of the hall; (e) Plan view of the hall; (f) Interior view of the hall.

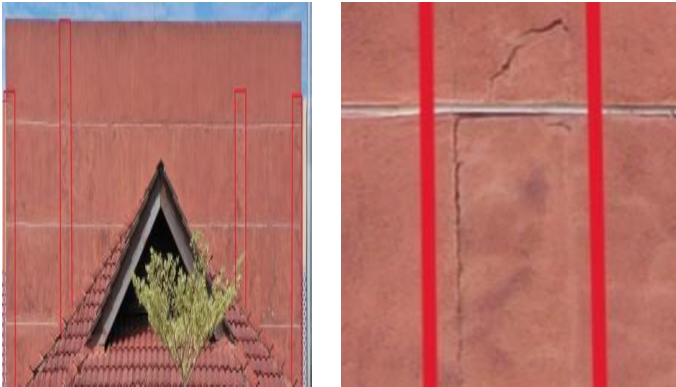
3	3				
Location: The front centre of the hall Level: Top Element / component: Outer column wall Defect description: Medium size of column crack Possible cause: Penetration of moisture Remarks: Weakening of building structure Area: 2.779 m ²					
No of defect : 22					
Condition	Priority	Matrix	Colour

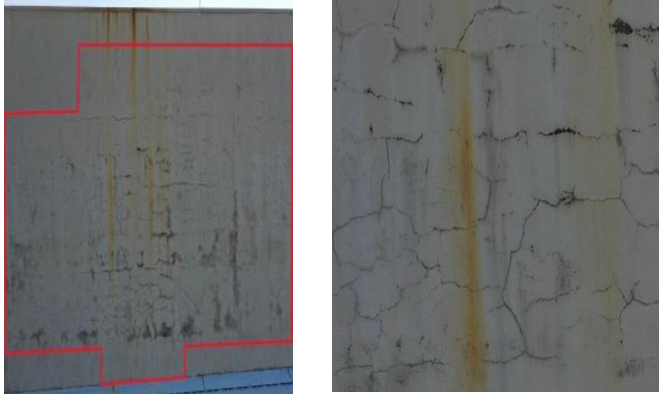
4	2	8			
Location: Behind the central hall Level: Middle Element / component: Outer wall Defect description: Large size of crack Possible cause: The penetration of moisture through the opening Remarks: Weakening of concrete structure Area: 77.976m ²					
No of defect : 53					
Condition	Priority	Matrix	Colour

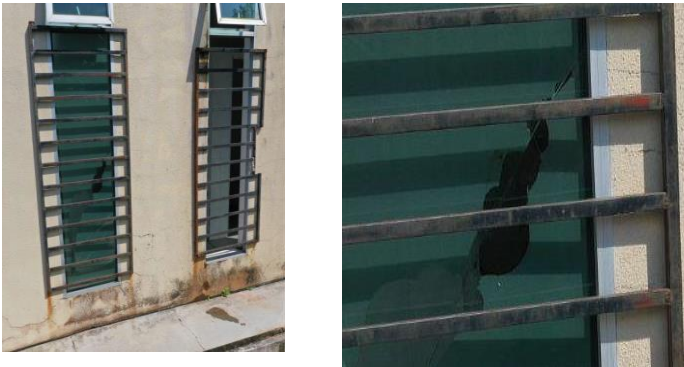
5	5	25			
Location: Bottom left of the left side Level: Bottom Element / component: Outer wall Defect description: Broken windows Possible cause: Thermal stress Remarks: Poor installation Area: 1.509m ² (each window)

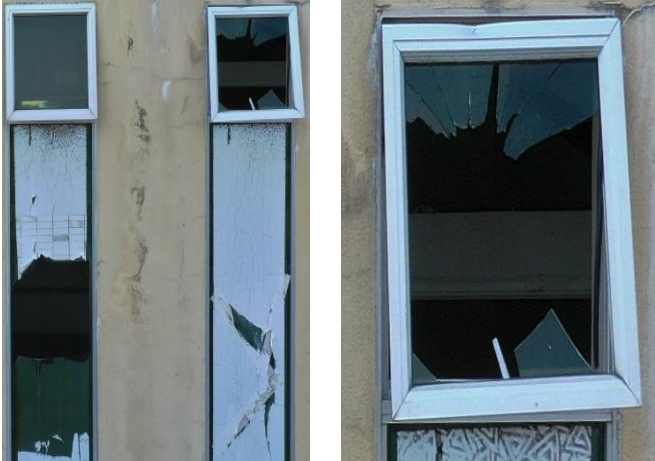
Location: Bottom right of the right side Level: Medium Element / component: Window Defect description: Broken windows Possible cause: Thermal stress Remarks: Poor installation Area: 1.172 (each window)					
No of defect : 58					
Condition	Priority	Matrix	Colour		
4	3	12

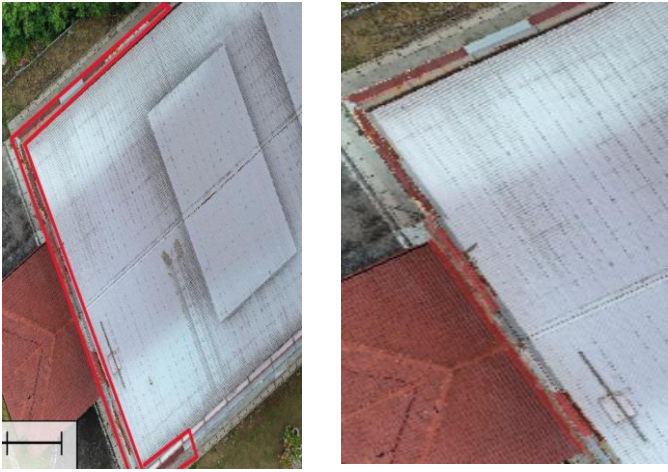
Location: Hall roof Level: Top Element / component: Roof Defect description: Large area of rust Possible cause: Water exposure over an extended amount of time, dirt and debris build up. Remarks: Clogs of debris and leaves can cause rust Area: 37.411 m ²					
No of defect: 39					
Condition	Priority	Matrix	Colour		
3	4	12

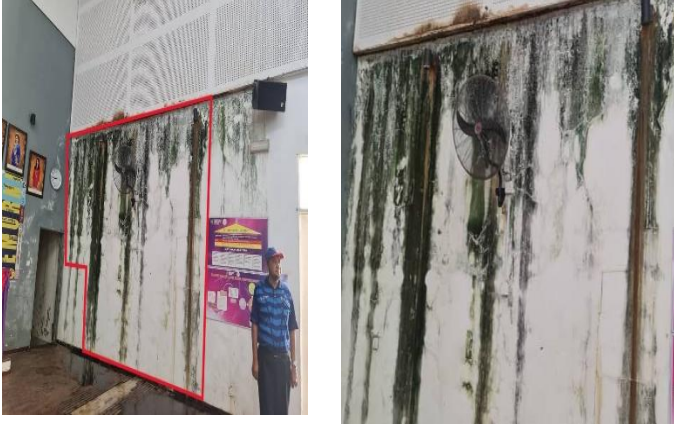
In order to demonstrate how to determine the level of damage as well as the colour class in more detail, position 39 is used as an example. Table 1 is also used to determine the value of the priority level of the study building maintenance action. Table 1 is used to provide the value of the building condition score. To obtain the matrix referred to in Table 2, the results of the values acquired must be multiplied. The colour of the damage should be chosen based on the amount once the complete matrix has been obtained. The final step is to determine the status of the structure investigated as shown in Table 3 after gathering all sorts of damage and their levels.

Location: Inside hall Level: Middle Element / component: Inside wall Defect description: Large size of moss and mould Possible cause: Dampness because of leaking roof and pipe Remarks: Cause cracking and trigger health Area: 10.796 m ²
