Visual Inspection using Unmanned Aerial Vehicle (UAV): Case Study of Building Defects at Canteen and Surau Between SK Kampong Raja and SK Pekan Pagoh

Nur Aqilah Iryani Abdull Rahim, Nur Hafizah Shamsudin, Norellysha Fariha Mohd Norhisham, Hazirah Bujang*, Mardiha Mokhtar

Department of Civil Engineering, Centre for Diploma Studies,
Universiti Tun Hussein Onn Malaysia, Pagoh Higher Education Hub,
84600 Pagoh, Johor, MALAYSIA

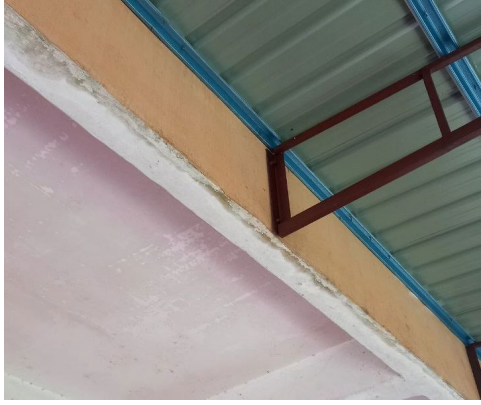
Condition	Priority	Matrix	Colour	
3	3	9		
Level: Exterior Element/component: EL/CS 01: Beam Defect Description: DS/CS 17: Leakage, DS/CS 20: Mould Growth Recommendation: Fix the leakage, clean the mould and repaint the affected area

Figure 1: (a) Defect (leakage and mould growth), & (b) Defect from Surau Sekolah Kebangsaan Pekan Pagoh

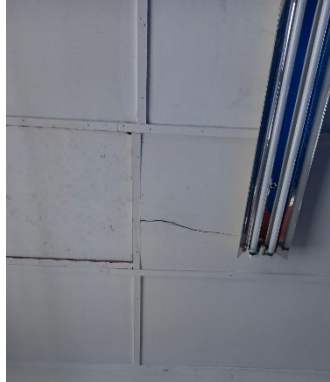
(b)

Condition	Priority	Matrix	Colour	
3	2	6		
Level: Interior Element/component: EL/A 02: Ceiling Defect Description: DS/A 25: Crack Recommendation: Replace the ceiling with the new one.

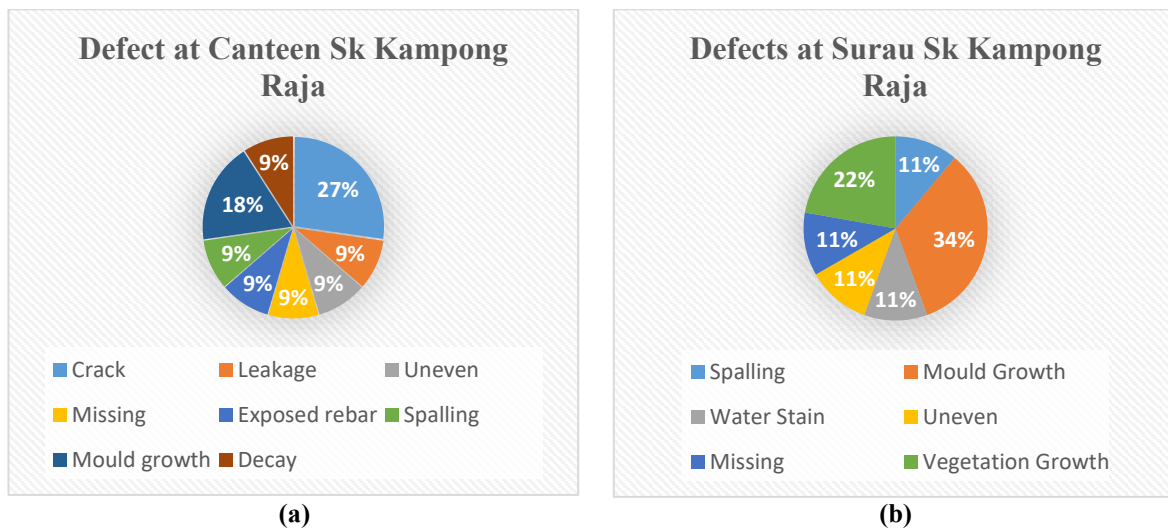
Figure 2: (a) Defect at Canteen Sk Kampong Raja (b) Defect at Surau Sk Kampong Raja

Based on **Figure 2 (a)**, shows how much of each defect is found at the canteen Sk Kampong Raja. The defects are composed of crack, leakage, uneven, missing, exposed rebar, spalling, mould growth and also decay. From the analysis, cracking was the most severe defect in the canteen at SK Kampong Raja which is 27% but it can be fixed. The flood in 2014 was one of the main factors for the most of defects at this school, especially at the canteen. Other than that, the other defect can be caused by poor maintenance and also by the environment. For cracking at plaster ceiling, it may be fixed by replacing it with a new one. While the tiles can remedy by applying glaze on the crack surface.

The whole list of defects from pie chart **Figure 2 (b)** is presented above, along with their percentages, which indicate how common each defect is in the surau. During the investigation, water stain, mould growth, spalling, uneven, vegetation growth, and other defects were detected with damage and mould growth representing 34 percent of all defects which is the most common defect. Long-term

deterioration is the most likely cause, which may be fixed by cleaning and repainting the damaged area with a new coat of paint. Other defects that represent 11% of defects may be caused by poor maintenance but still can be fixed.

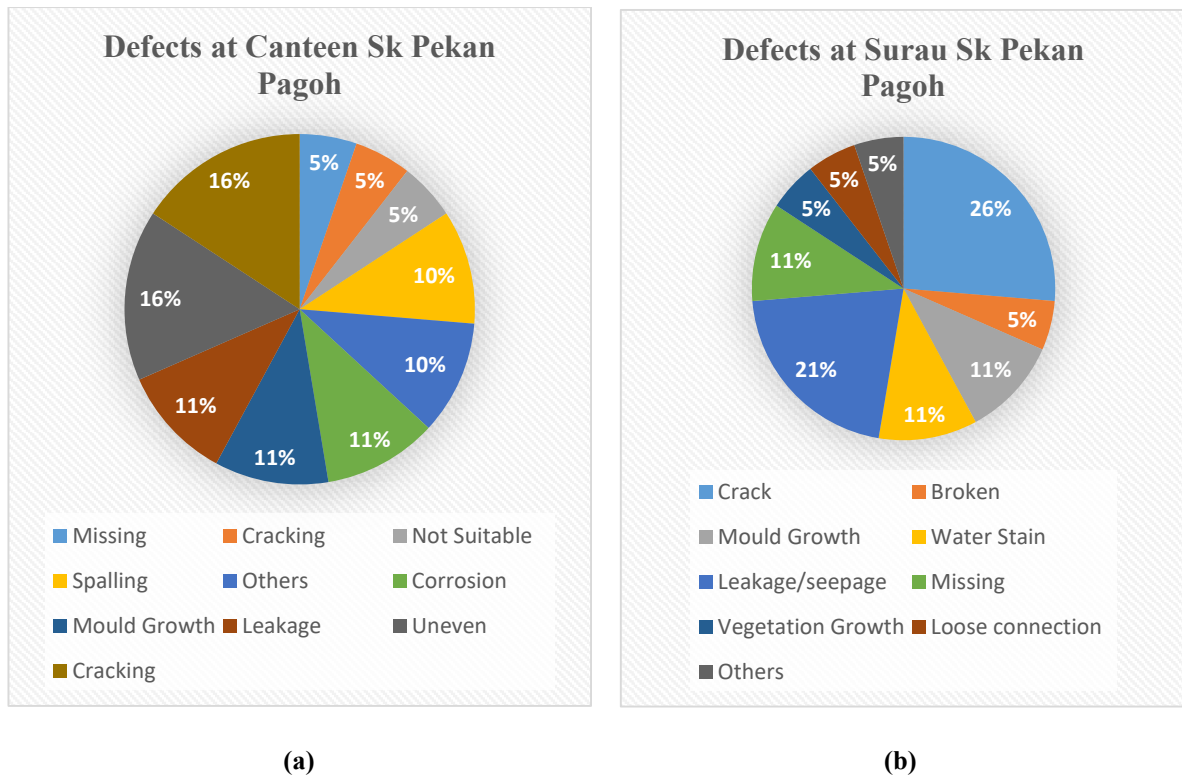
Figure 3: (a) Defect in Canteen Sk Pekan Pagoh (b) Defect in Surau Sk Pekan Pagoh

The complete list of defects in pie chart **Figure 3 (a)** is shown above, along with their percentages, which show how much of each defect is found in the canteen. Cracks, mould growth, spalling, damage, uneven, not suitable, corrosion, and other defects were discovered throughout the analysis, with damage and uneven being the most common defects which are 16% each. In addition, the defects found after the analysis are missing, cracking and not suitable which is 5%. The most likely cause is long-term deterioration, which may be remedied by rendering cement mortar and repainting a new coat on the affected area.

From the list of defects from **Figure 3 (b)**, along with their percentages, indicates how much of each defect is present at the surau Sk Pekan Pagoh. Crack was the most severe defect which is 26% and the cause of this is most likely long-term deterioration but surely can be fixed by patching new cement mortar and came along with a new coat of paint on the area that has been affected. The least percentage for this defect are vegetation growth, leakage, broken and others which is 5%. This can be caused by poor monitoring and also environmental changes.

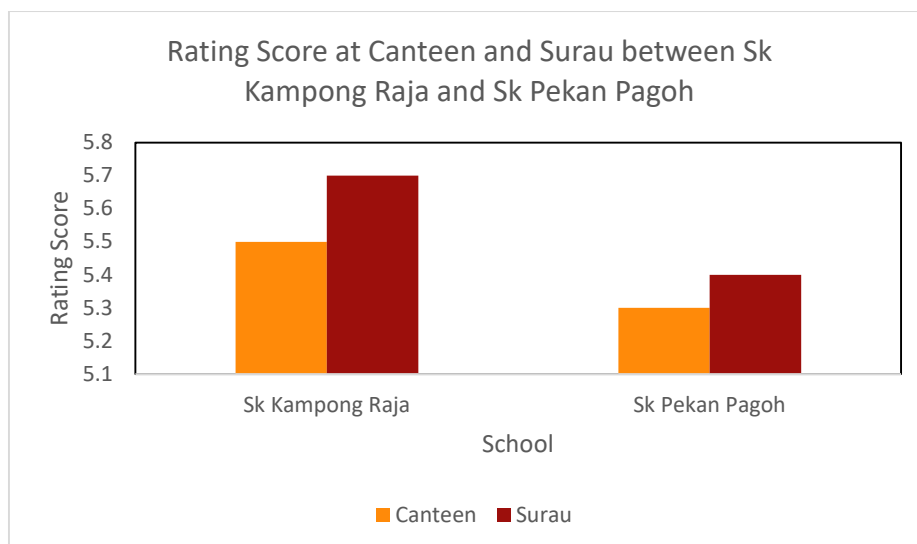
Figure 4: Rating Score at Canteen and Surau between Sk Kampong Raja and Sk Pekan Pagoh

Figure 4 shows that surau and canteen between two schools had been built in 2009. By referring to the CSP1 matrix, both buildings have been discovered that it is still in a fair condition. After analyzing the results, it shows that Sk Pekan Pagoh’s rating score is better than Sk Kampong Raja in both buildings which are 5.3 for the canteen and 5.4 for surau. Meanwhile, the rating condition for both buildings at Sk Kampong Raja is 5.5 for the canteen and 5.7 for surau which means worse than Sk Kampong Raja. This is because Sk Pekan Pagoh had been renovated in the past few years for the surau and canteen building as it was in the same building. Other than that, the defect that had been found were also can be caused by the environment as it has been closed for a long time because of the pandemic Covid-19. So it is hard to monitor the building as well as it should be but the condition for the building is still in a good condition.
