## Vibration Investigation on Rotational Pumps at UTHM Biodiesel Pilot Plants

**Abstract:** Vibration is an unavoidable reality in machinery and equipment. Therefore, it was essential in investigated the vibration phenomena occurring in the rotating equipment to maintain its performance. The research aimed to study the different specifications of the rotating pump's vibration in determining the fault occurrence prediction and correlation of temperature fluid to the pump's vibration. Based on the ISO-10816 standard, the pump safe limit was identified, and the pump operation was decided to continue to run, stop immediately, or undergo maintenance. In determining the type of maintenance, the pump's fault was investigated individually based on the characteristics shown in the Fast Fourier Transform (FFT) waveform. If the safe limit condition is exceeded, the maintenance is done according to the fault diagnostic test. The experiment shows that pump A must stop immediately, undergo alignment maintenance, and change the rubber bush since it generated a vibration velocity of more than 2.80 mm/s (safe limit standard for motor less than 5kW power). In contrast, pumps B, C, and D are accepta

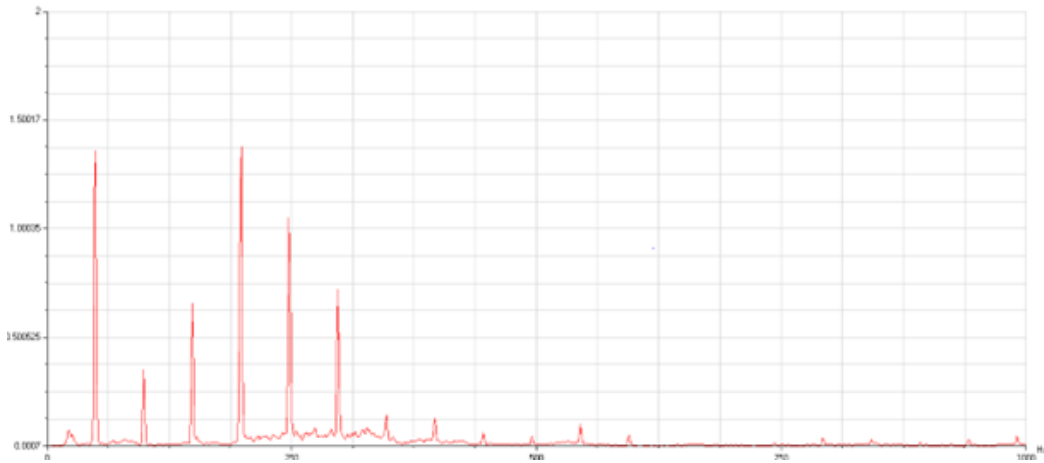
**Figure 4 Horizontal vibration spectrum for pump A at Point 2**

Based on Figure 4, pump A showed several peaks that can be analysed to misalignment, angular misalignment, parallel misalignment and coupling fault. First, the misalignment is a combination of angular and parallel misalignment. Misalignment of the pump recognized from the six (6) firm peaks. The angular misalignment showed by the reasonably strong peaks at the vertical and horizontal at almost the point collected. For parallel misalignment, the high peak at 2X and relatively strong peaks at 1X and 3X produced shear force and bending moment on the coupled end of the shaft. Since this type of pump had parallel flange faces, the coupling fault needs to be considered since the vibration measurement of the pump exceeded the safe limit. The criteria of the coupling faults were the same as misalignment and required to be inspected before the pump could be run in a safe condition and not create hazards. After the inspection, the coupling fault may occur from the rubber bush on the bolt that couples the flange of the shaft at the motor and pump. The rubber bush's condition was not poor and needed to be changed. This problem was suspected to be a source of fault that occurred on the coupling.

The recommendation for the pump is to cope with these problems by aligning pump A, adjusting the height of the motor by adding shims and adjusting the angle of the motor. The rubber bush on the coupling also must be changed for the better performance of the pump.

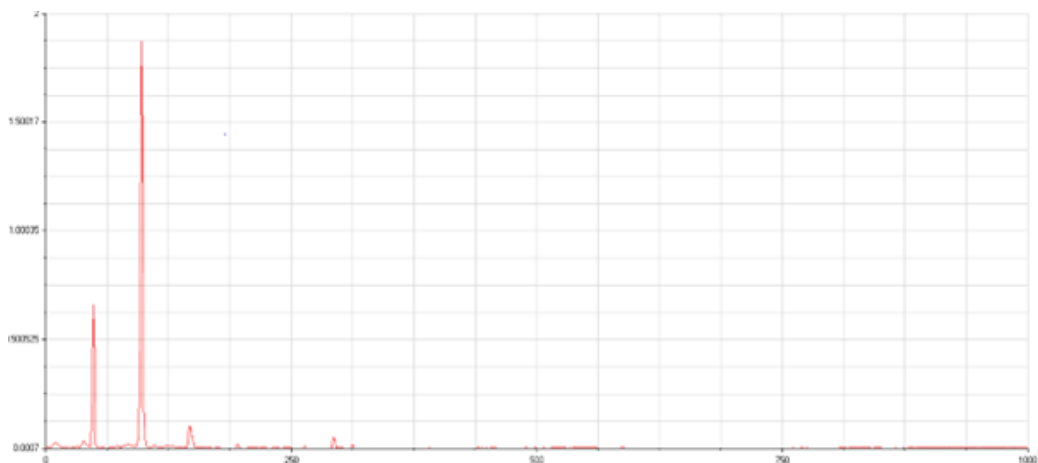
**Figure 5 Vertical vibration spectrum for pump B at Point 4**

Based on Figure 5, pump B showed three (3) peaks that were at 180°, which can be analysed as purely parallel misalignment. It is because the 1X and 2X were low in height at the peaks. The criteria of parallel misalignment in which the vertical and horizontal recordings showed the same conditions of peaks could be concluded as parallel misalignment. This problem may be caused by the shim plate being used soft and getting thinner after some time. Since the pump was in satisfactory condition

according to ISO-10816, the pump may be used and need to be changed if necessary, and the state of the pump will worsen.

The recommendation for the pump to cope with this problem by adding shims on the motor of pump B to decrease the parallel misalignment

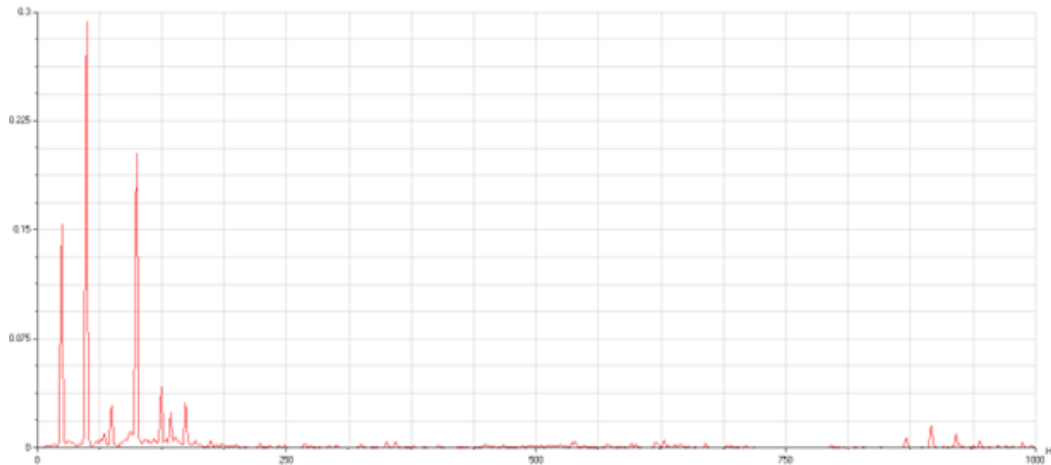
**Figure 6 Vertical vibration spectrum for pump C at Point 2**

Based on Figure 6, pump C showed multiple characteristics of fault, which suspected angular misalignment and eccentric rotor. This was due to the vibration graph showing symptoms from numerous peaks and noise. The angular misalignment can be seen on the peaks generated at 50, 100 and 150Hz. The criteria of angular misalignment, in which the vertical and horizontal recordings showed the same conditions as a referral. The problem caused by the angular misalignment may come from the manufacturer's imperfection or when the assembly process. The eccentric rotor showed from the generated peak at 90 °, called the high pass pole in FFT. The 2X line frequency was also developed at the 2X of the graph's peaks, which also confirmed the eccentric rotor defects. It may cause by the loose rotor bars in the motor. This reason was also supported by the vibration measurement, where the motor side experienced higher velocity than the pump side.

The recommendation for the pump to cope with these problems was to realignment the pump for angular misalignment and checked the rotor shaft at the motor for eccentric rotor faults.

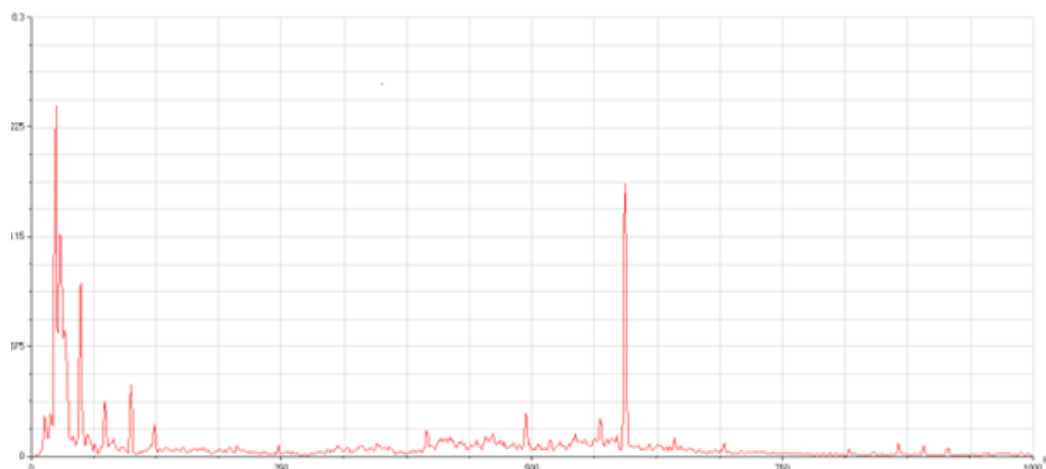
**Figure 7 Horizontal vibration spectrum for pump D at Point 2**

Based on Figure 7, pump D showed several peaks and noise on the velocity times speed of vibration. This behavior was analysed, and suspected flow turbulence, cavitation and structural looseness. The flow turbulence was detected from the random and low-frequency spectrum right before 180°. This turbulence occurred due to observing the variation of fluid velocity that entered the pump from vessel 203. It causes the presence of the air inside the pump was also the causes of the flow turbulence recorded. Since the presence of air inside the pump, the cavitation on the pump also occurred based on the noise generated at the back of the graph. The noise showed hump looking graph at the 5X to 7X rotation, indicating cavitation. Bubbles develop within a fluid during cavitation when the pressure rapidly falls below the vapor pressure. Higher pressures cause the bubbles to collapse and created shockwaves that eventually cause damage to parts of the pump. The structural looseness was spotted from the criteria of the single strong peak, in which the horizontal measurement recorded a higher amount than the vertical direction. The looseness fault was in unsatisfactory level since the vertical peak value lower than horizontal peak value based on ISO 2372 It may cause the base of the plant platform that was holding the base of the pumps loosed and need to be tightened back. It may occur from the need for more maintenance and supervision from the facility.

The recommendation for the pump to cope with these problems was installing an anti-vortex fitting at the bottom of vessel 203 before entering pump D to decrease the flow turbulence in the pump and check the bolts and nuts at the foundation to eliminate the structural looseness

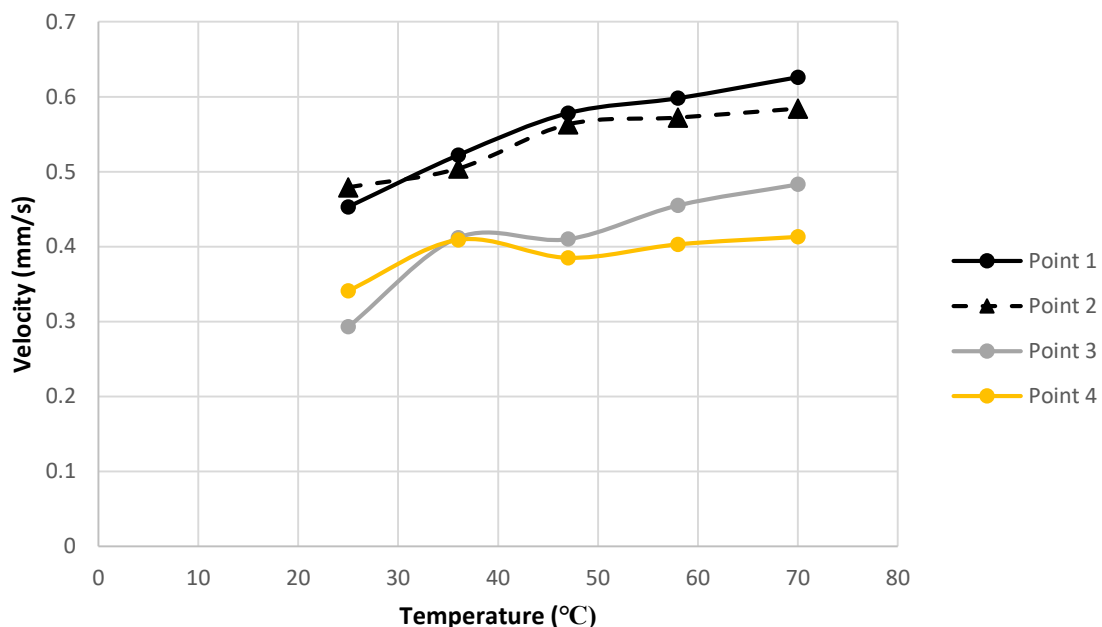
**Figure 8 Velocity measurement of average  $V_{rms}$  for pump D in different temperature**

Figure 8 shows the average velocity measurement during five (5) operating temperature tests at the 1435 rpm speed of 50 Hz. Based on the figure, the pattern of the vibration velocity increased at all points that had been measured. The motor side velocity measurement points 1 and 2 increased by 38%

and 22%, respectively. The pump side velocity measurement, points 3 and 4, increased by 64% and 21%, respectively. When temperature increases, the pump's structure will be affected by decreasing the pump's stiffness, which enhances faster vibration. The increased fluid temperature also influences the viscosity of the fluid. Since the fluid's viscosity decreases, less energy absorption may increase the vibration in the pump's structure. It is because the heated fluid stores more energy than the cooler fluid.

The vibration on point 3 and point 4, located at the pump side, showed an increased value due to the effect of temperature fluid. When the fluid temperature was 36°C, the velocity measurements for points 3 and 4 were almost the same, 0.412 mm/s and 0.409 mm/s, respectively. It was suspected the resonance occurred when the fluid was at this specific temperature. This resonance can be different for all pumps since the states of the wear and tear were not identical to all pumps. Since the first 180° shows flow turbulence, the resonance cannot be detected since the flow turbulence produces a more significant frequency than resonance., So the pump analysis using a few different parameters can be used to detect this problem. The other way was also by referring to the manufacturer's operating standard.

On the motor side, which points 1 and 2, the measured velocity was higher than the pump side. Based on the primary mechanical term, the motor will generate more energy than the pump side since the motor converts electrical energy to mechanical movement. The motor had more components and generated more vibration energy than a pump. It is a normal phenomenon where the driver device causes more vibration than the driven device.
