Structural Evaluation and Root Cause Analysis of Vehicular Box Culvert (VBC) Defects in Section 6A of ECRL Project

This research investigates concrete defects in Vehicular Box Culverts (VBCs) within Section 6A of the East Coast Rail Link (ECRL) project. A significant defect was identified at Culvert 192 (CH384+580), where cracks were found in the top slab and wing wall. The study aims to comprehensively analyze the types and causes of concrete defects in the VBCs within work zone 2 of Section 6A. The methodology involved detailed site visits and inspections of 21 VBCs, documenting defects such as shrinkage cracks, water seepage, and discoloration. The quantitative analysis, presented through bar and pie charts, revealed discoloration as the most frequent defect, with medium severity levels being the most common. Contributing factors to these defects include poor soil compaction, inadequate waterproofing, and substandard construction practices. An AutoCAD 3D model was employed to illustrate loading conditions and their impact on VBC settlement, emphasizing the effects of vehicular loads and soil pressure. The findings indicate that most defects are manageable through standard maint

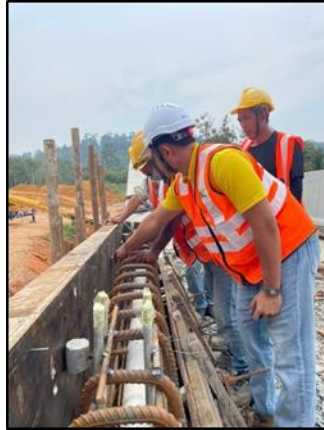
Fig. 3 Picture taken during site visit
