# Haji Muhammad Yassin Mosque Building Inspection using Unmanned Aerial Vehicle (UAV)

Muhammad Syakir Subli<sup>1</sup>, Abd Sukor Sarif<sup>1\*</sup>

<sup>1</sup> Department of Civil Engineering Technology, Faculty of Engineering Technology  
Universiti Tun Hussein Onn Malaysia Pagoh Campus, Pagoh, Muar, 84600 Johor, Malaysia

DOI: <https://doi.org/10.30880/peat.2024.05.02.059>

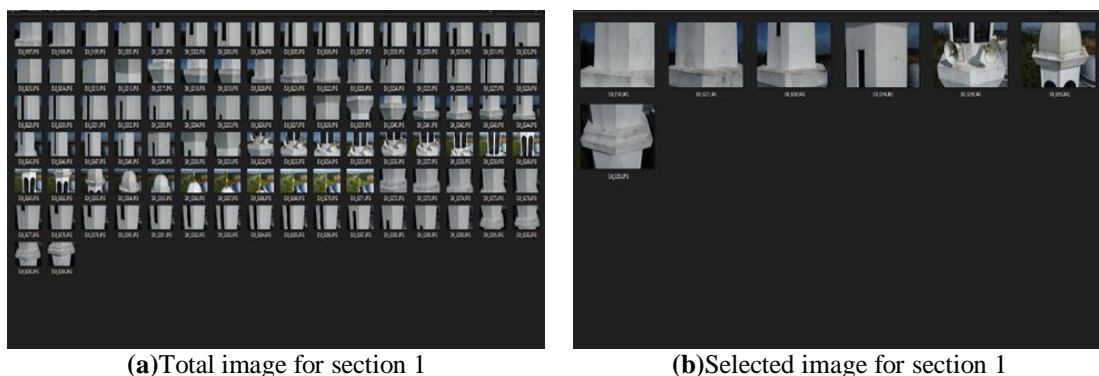
**Fig. 3** Total image and selected image for section 1 (a) First picture; (b) Second picture

The image processing is using Adobe Photoshop software to process the image. There are two main parts of image processing which is image selection and image editing. In image selection, the total image for each section is analysed one by one, so only the image that contains defect was selected. For example, Figure 3 shows the total image for section 1 and the selected image that contains defects on section 1. The total image for section 1 is 98 images. The selected image for section 1 is 7 images.

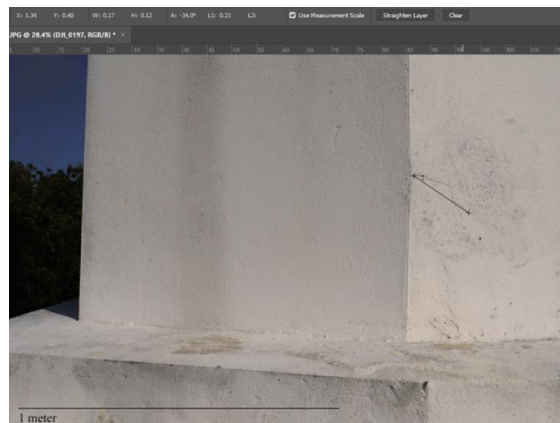
**Fig. 6** The length of the defect by using the scale made on Adobe Photoshop

The user can choose where to put the scale and the colour of the scale. For this case, the scale will be on the bottom left side of the image with black colour. To measure the defect by using this scale, the image that contains the defect needs to be inserted into the app that contains the scale. Figure 6 shows the length of the defect, hairline crack is 0.17 m. The W shows the length value at x-axis and the H value shows the length value at y-axis.

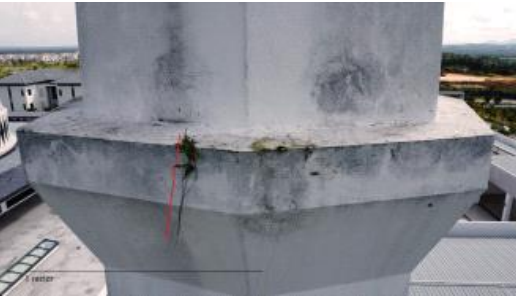
**Table 2** CSP 1 Matrix table for image number 20

<b>Image No.</b>	20		
	<b>Section</b>	4		
	<b>Element</b>	Minaret		
	<b>Type of defect</b>	Plant growth		
	<b>Defect measurement</b>	0.44 m		
	<b>CSP</b>			
	<b>Condition</b>	<b>Priority</b>	<b>Matrix Score</b>	<b>Colour</b>
	3	2	6	
	<b>Reccomendation</b>	Condition monitoring		
	<b>Building Rating</b>	Fair
