## **A Study on Causes of Abnormal Noise That Affecting Ride Quality in MRT Putrajaya Line**

**Qasrin Najiha Mizan<sup>1</sup>, Mohd Nazrul Roslan<sup>1\*</sup>, Nor Effendi Yusof<sup>2</sup>**

<sup>1</sup>Department of Transportation Engineering Technology, Faculty of Engineering Technology,  
Universiti Tun Hussein Onn Malaysia, 84600 Pagoh, Johor, MALAYSIA

<sup>2</sup>Mass Rapid Transit (MRT) Corporation Sdn. Bhd.  
Wisma MRT, 50490 Bukit Damansara, Kuala Lumpur, MALAYSIA

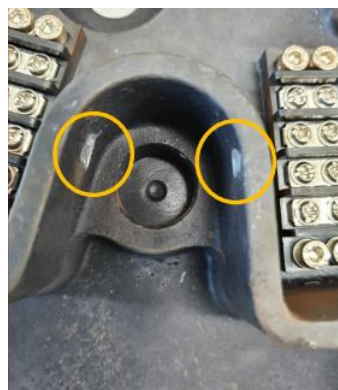
**Figure 4: Defect on junction box housing due to shaft's bolt**

- ii. Cam modification to remove plain washer to ensure there is a gap between the shaft and the junction box housing as Figure 4 and Figure 5 below.

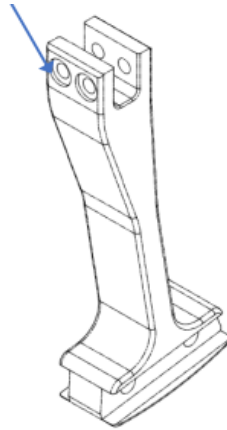
**Figure 5: Removal of washer at camshaft**

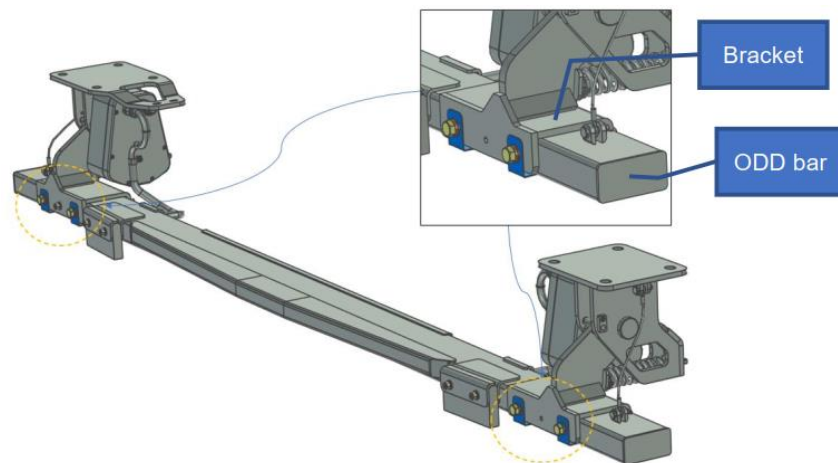
**Figure 6: Installation of holding bracket to hold ODD bar from vibrating**

- iii. Installation of additional holding bracket to control the vibration between the bracket and bar holder as shown in Figure 6 below.
