# Evaluation of Non-Compliant Road Furniture on Urban Road Safety: A Case Study of Jalan Kinta, Perak Darul Ridzuan (FT001 Section 606.85 to 607.85)

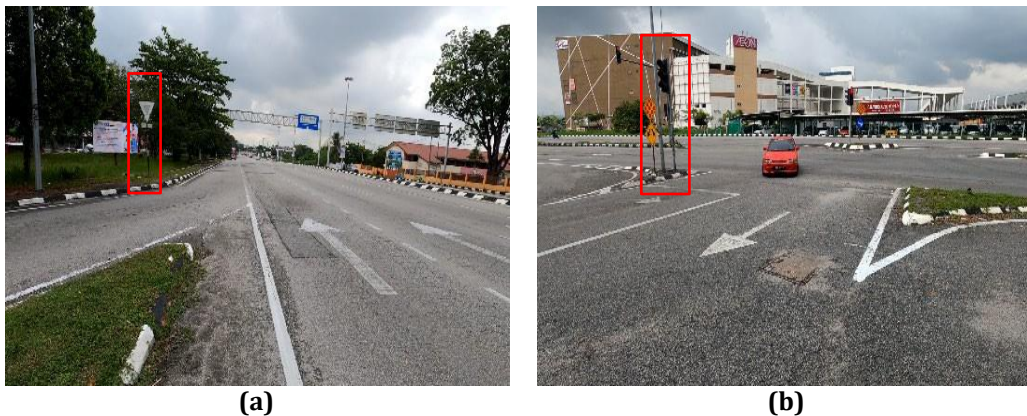
Firstly, the study identified significant issues with traffic signs, including breakage, fading, and obstruction by stall advertisements. Furthermore, the visibility of certain signs was compromised due to overgrown trees. These shortcomings pose a considerable risk to road users, as clear and visible signage is crucial for effective communication and guidance. Next, Fig. 5a exhibits non-compliance regulatory traffic signs in the study area, providing visual illustrations of the discussed road furniture conditions. In addition, non-functioning traffic signals were observed, impacting the regulated flow of traffic. The malfunction of these signals introduces an element of unpredictability and can lead to congestion, disruptions, and, most importantly, safety hazards. Addressing these issues is crucial to maintaining a smooth and organized traffic system. Fig. 5b displays instances of traffic signal non-compliance in the study area, offering visual representations of the discussed road furniture conditions.

**Fig. 5** Road Furniture Condition (a) Faded Regulatory Traffic Sign; (b) Malfunction Traffic Signal

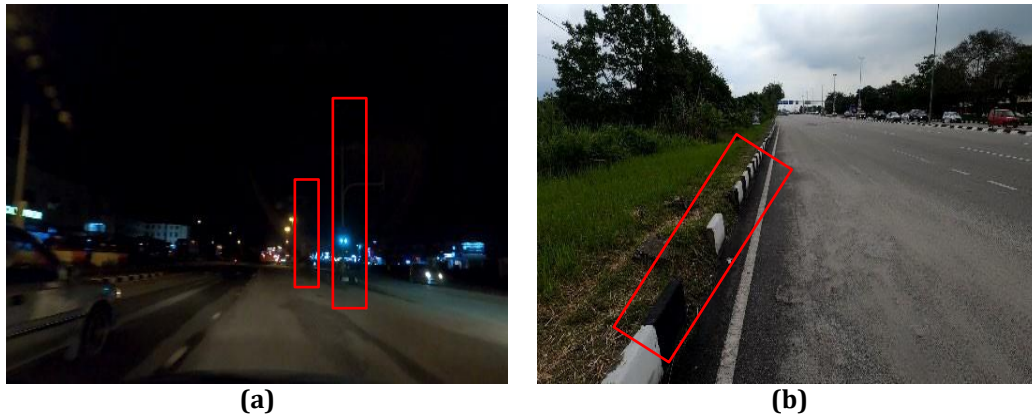
Moreover, the analysis of streetlights exposed noteworthy concerns. Several lights were found to have malfunctioned bulbs, contributing to poorly lit sections. The absence of streetlights in certain areas was even more alarming, creating potential hazards for drivers and pedestrians. Adequate street lighting is fundamental for ensuring visibility and overall safety, and the identified deficiencies must be promptly addressed. As an illustration, Fig. 6a showcases non-compliance streetlights in the study area, offering visual representations of the discussed road furniture conditions. Then, issues related to kerbs were also documented, including missing kerbs and failing to install them after construction completion. Properly installed and maintained kerbs are vital for delineating road edges and enhancing overall safety. Fig. 6b presents an illustrative example of a kerb within the study area. These visual depictions provide a tangible perspective on the condition of road furniture, featuring specific instances of kerbs that reflect the broader findings discussed in the comprehensive examination.

**Fig. 6** Road Furniture Condition (a) Malfunction Streetlight; (b) Missing Kerbs

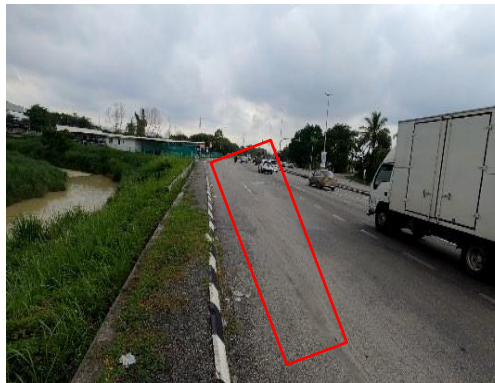
Lastly, the analysis revealed that road markings on paving surfaces diminish their clarity and effectiveness. Additionally, faded markings were identified, contributing to potential confusion among road users. Clear and well-maintained road markings are essential for guiding drivers and ensuring orderly traffic flow. For example, Fig. 7 showcases instances of road marking non-compliance in the study area, offering visual representations of the discussed conditions related to road furniture.

**Fig. 7** Faded Road Making
