# Cutting on Existing Bonded Post-Tensioned Slabs: Safety Precautions, Procedures and Execution

**Abstract:** Post-formed cut-off or cutting of the post-tensioned slabs is a common practice during post-tensioning work. However, cutting on existing post-tensioned slabs must be done carefully to avoid severe damage to the building. The measurements during the design review are critical in considerations of post-cutting conditions, variations between shop drawings and site, possible grouting failure and excessive deformation. This paper presents a successfully execution of cutting operations on bonded post-tensioned slabs without compromising the structural strength and serviceability. There are procedures and requirements that need to be considered prior to cutting at the design stage, prior to cutting at the site and at slab cutting stage. The safety precautions are necessary for unintentional scenarios that require immediate action. Cutting the slab creates potential hazards. It was found that the grouting material plays an important role not only in solidifying the concrete but also in forming a secondary anchorage mechanism. Therefore, selection of suitable grouting material sho

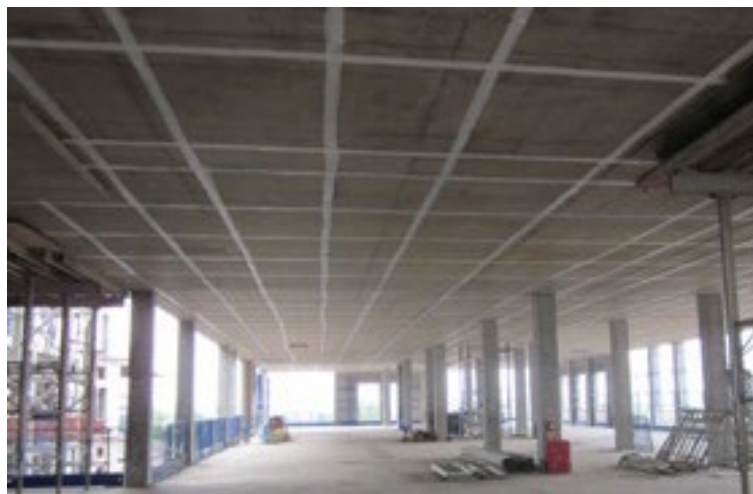
Fig. 3 - The marking of tendon locations [24]

It is a common practice to mark the installed tendon locations after the rear propping has been removed by painting them on the exterior underside of the slab for each completed slab. Fig. 3 shows the marking of tendon locations. This marking of the actual tendon locations is in many cases different from the tendon locations in shop drawings, as the site adjustment is done with plumbing pipes installed within the slab. Therefore, information about this adaptation history was also included in this study. Although the intention was to do this as a precautionary in case further plumbing and piping work required drilling through the slab, this approach proved helpful for the procedures of cutting the slab.

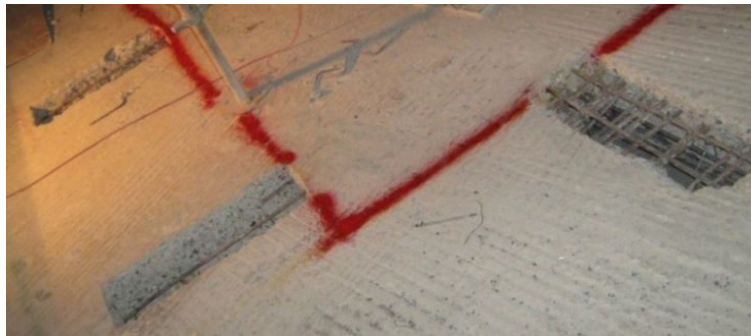
**Fig. 4 - Cutting zone and locking pockets area**

A proposed opening would normally have at least two locking pockets, and in some cases none (see Fig. 4). On the other hand, with a change in outline, the number of locking pockets that would replace the anchor or onion could normally be as little as one, or in some cases none at all. This is based on “prior to cutting at the site”. Some possible grouting failure after stressing, immediately after cutting the strands, such as: (i) strands shortening (slipping inside the ducts) and (ii) strands flying out (from the ducts), all of which are due to a loss of grout grip around the strands. In this study, there are neither strands shortening nor strands flying out during the cutting operations. It should be emphasized that in order to increase the safety factor, it is necessary to secure the tendons at the slab vicinity.

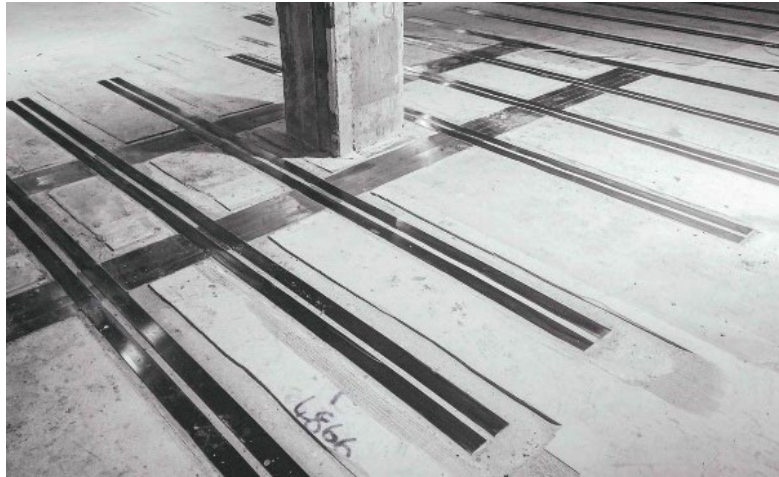
**Fig. 7 - Slab strengthening with fiber-reinforced polymer [28]**

The site was instructed to perform the cutting of the slab immediately after confirming that there was no anomaly in the grout lock. The anomaly in this case could take the form of cracks, signs of leakage or a visible rough surface that could indicate strands shortening. Slow and careful cutting operations were carried out, expecting that the cutting operations would meet not only hardened concrete but also grout filled tendon duct and strands which affects the cutting speed. The human body leaning towards the opening side must be avoided. During the cutting operations, the slab is monitored for unintentional deformations. In a particular situation where the deformations are too large, immediate implementation of the prepared scenario for slab strengthening should be initiated. Fig. 6 and Fig. 7 illustrate several approaches that can be considered for slab strengthening.
