Reinforced Concrete Beams with Opening Strengthened using CFRP Sheets

Abstract: This study explores the behavior of reinforced concrete beam with opening strengthened using CFRP sheets. The beams were deficient in bending and under-reinforced in order for the beams to fail in bending. Load-deflection behavior and strain profile were observed besides the crack pattern and modes of failure. A total of five (5) beams were casted and tested. One (1) beam was treated as control specimen, two (2) beams were reinforced concrete beams with square and circular opening respectively while the other two (2) beams were reinforced concrete beams with square and circular opening strengthened using CFRP sheets. For the strengthened beams, they were wrapped at three sides (U-wrap) of the beams with CFRP sheets. From the experimental results, it is observed that all beams fail in bending as expected. Beam with circular opening (un-strengthened) recorded the lowest ultimate load with 25.7 kN, a decreased for about 6.4% compared to control specimen. On the other hand, beams with circular opening strengthened using CFRP sheets recorded the highest ultimate load of 30.7 kN, which is an increased for ab

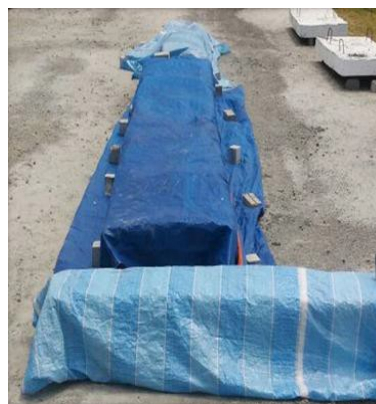
The casting process for all beams was executed in one batch. The concrete was poured in three layers so that the compaction process was executed sufficiently and not overly done. The compaction of concrete was done by using a mechanical vibrator. For curing process, all specimens were covered by plastics as soon as the casting of the specimens completed as shown in Fig 6. Curing process is important in order to make sure the concrete does not lose its moisture or otherwise it could affect the strength of the concrete. After 24 hours, wet sacks were used to replace the plastic. The wet sacks were used until the concrete achieved the age of 28 days and therefore the sacks were poured with water every day in order for the sacks maintain wetted. Fig. 7 shows the specimens after they were detached from the formwork.

Fig. 6 - Curing of the beam after casting.

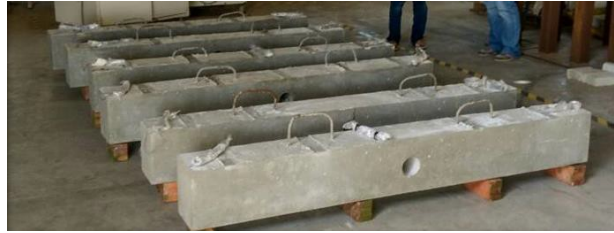
Fig. 7 - Beams after detached from formwork.
