The International Journal of Integrated Engineering

Ergonomics Evaluation for Turning Machinists in Oil and Gas Industry

Abstract: It was discovered that there were ergonomics risk factors towards machinists during manual handling of large work pieces that may affect the health of the machinists based on the initial ergonomics risk assessment conducted on the CNC turning machine shop in oil and gas manufacturing company. The study aims to determine and improve the ergonomics risk factor that the machinists may be exposed to. In this study, the data were collected and analyzed using Cornell Musculoskeletal Questionnaire, Rapid Entire Body Assessment (REBA) and torque analysis. Survey result from Cornell Musculoskeletal Questionnaire found that most of the turning machinists experienced ache, pain and discomfort on their lower back, right hand shoulder and upper back. REBA analysis indicated that body posture applied during tightening headstock jaws is categorized as very high risk with REBA score of 11 and immediate improvement action is required. The root cause was identified using 5 Why methodology where torque wrench design limitation has been identified as the main contributor

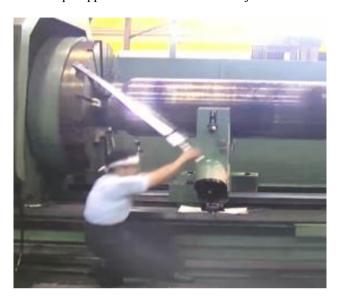
The photo of posture 12 in Fig. 4 shows the machinists' postures while tightening the headstock jaw to ensure that the wellhead housing was clamped securely on the machine chuck. It was done by applying 1200Nm torque on the pinion shaft that provides clamping force to the headstock jaws towards the wellhead housing. The same amount of torque has been applied to all 4 units of headstock jaws by using 0.95m length torque wrench. The high amount of torque was required to withstand the 3 tonne weight of the wellhead in both static and rotating mode. The main root cause of the high REBA score for posture 12 has been identified by using the 5 why analysis (Fig. 5) and it is found that the root cause was the excessive force applied during the tightening of the head stock jaws which is due to the torque wrench design limitation. By understanding that the torque required was 1200Nm by using the 0.95m length torque wrench, the

machinist was forced to apply pulling force of 128.7kgf. Since the pulling force required was too high, the machinist was forced to pull the torque wrench with additional support of their own body weight. By doing so, all the body posture experienced rapid large range change in posture which poses a very high risk to their musculoskeletal system.

Fig. 4 - Photo of Posture 12 (Very High-Risk Posture)

Since it is very critical for the clamping force to withstand the weight of the wellhead, the tightening torque of 1200Nm shall not be changed to improve the ergonomics risk towards the machinist. Therefore, the improvement action taken was to use the manual torque multiplier equipment to reduce the input torque applied by the machinist and at the same time maintaining the 1200Nm torque applied towards the headstock jaws.

There were some excessive body flexion, high force applied and rapid large range in posture observed while completing the task
 The body tends to support the pulling activity while tightening the torque
 The pulling force required to be applied by machinist was too high to meet the jaws clamping torque requirement.
 The design of the torque wrench used (with unsuitable length) require excessive pulling force to meet the required high clamping torque
 Torque wrench design limitation caused excessive force to be applied while tightening the head stock jaws

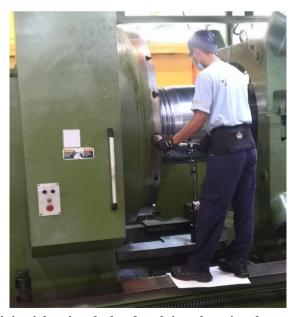
Fig. 8 - Photo of the machinist tightening the headstock jaws by using the manual torque multiplier and applying new methods

Fig. 6(a) shows the torque multiplier being used during the tightening process, while Fig. 6(b) illustrates the new equipment being used which consists of manual torque multiplier and torque wrench. The torque multiplier being used was HT-72/27 model from HT-72 Compact Series manufactured by Norbar company with part number 180212 [15]. By applying the manual torque multiplier, the input torque required showed 27 times reduction from the output torque to be applied. This means that in order to apply the output of 1200Nm torque, the input torque required was only 44.4Nm. The pulling force required to tighten the 44.4Nm by using 0.5m length torque wrench was only 9.1kgf. This is a significant improvement compared to the previous pulling force of 128.7kgf. Improvement action taken was to change the location of the tightening torque applied for the clamping and adjusting purposes as well as aligned with the direction of dial clock for run out check. The concept has been simplified in a diagram as shown in Fig. 7. Verification on the effectiveness of the improvement action has been conducted through REBA analysis by using the photo after improvement as shown in Fig. 8. The result showed that the REBA scoring has been reduced significantly from 11 (very high risk) to 3 (low risk).
