Voltage and Current Analysis of Oil Immersed Power Transformer due to Lightning Impulse with Different Insulation Conditions

Keywords: Oil immersed power transformer, lightning impulse, good and poor insulation

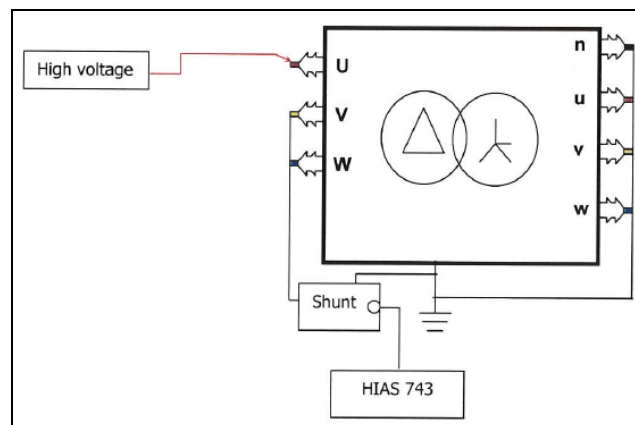
Fig. 2.3 - Connection between test transformer and test system

The connection between the test transformer and the test system is illustrated in figure 2.3. To avoid inducing excessive over voltages in the windings that are not being tested, they are shorted through shunt resistor and linked to ground. However, short circuiting affects the transformer's impedance, posing difficulties in altering the impulse generators' typical waveshape. Additionally, it lowers detection sensitivity.

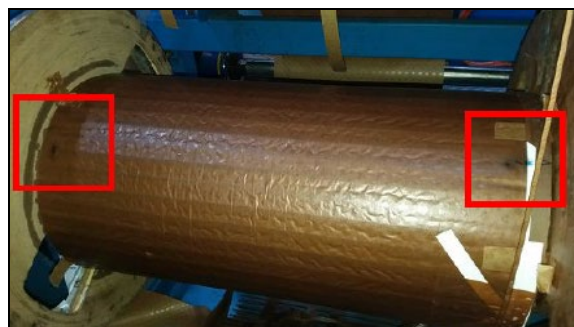
Fig. 2.7 - Points of punctures of a coil between HV and LV coil barrier sheet

Figure 2.7 shown two points of damages or punctures of a coil between HV and LV coil barrier sheet.

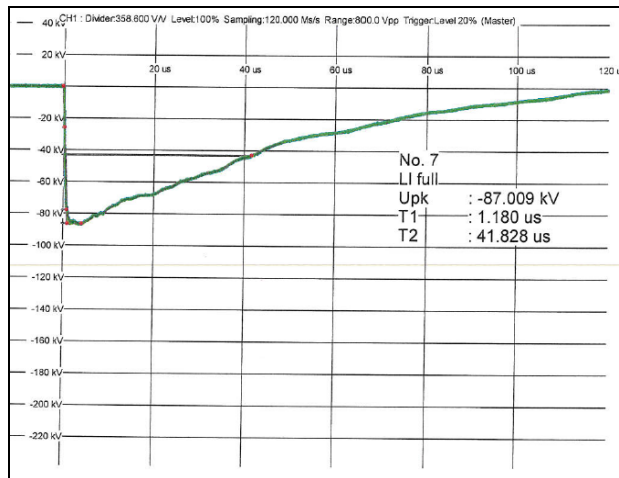
Fig. 3.1 - Reduce lightning impulse voltage waveform

Reduce lightning impulse voltage waveform is shown in Figure 3.1. The peak voltage and RMS value are 87.0 kV and 61.5 kV respectively. The front and tail time are 1.2 μs and 41.8 μs.

The output is the same for the red, yellow and blue phase, therefore just the yellow stage result is shown. The peak voltage for reduce lightning impulse voltage waveform of Figure 3.1 is equivalent to 87.0 kV. Some calculations have to be made to obtain the RMS value. The formula for converting maximum voltage to RMS:

The RMS value for phase voltage is 61.5 kV based on the conversion using formula 3.1. The front and tail time are 1.2 μs and 41.8 μs. The waveform in Figure 3.2, 3.3 and 3.4 depicts full lightning impulse voltage waveform. The test result of lightning impulse voltage for yellow phase in negative polarity is shown in Table 3.1. The peak voltages are 172.6 kV, 172.9 kV and 172.6 kV respectively, which corresponds to an RMS value of 122.0 kV, 122.3 kV and 122.0 kV respectively. The average for peak voltage and RMS value are 172.7 kV and 122.1 kV. The front and tail time are 1.2 μs and 42.0 μs for the three full lightning impulse voltage waveforms.

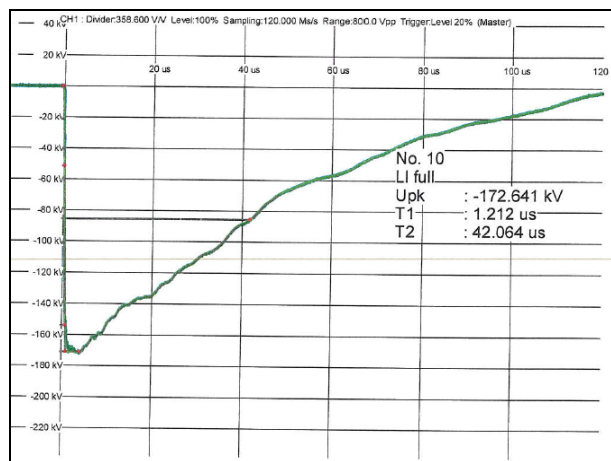
Fig. 3.4 - Full lightning impulse voltage waveform test 3

Full lightning impulse voltage waveform is depicted in Figure 3.4. The peak voltage and RMS value are 172.6 kV and 122.0 kV respectively. The front and tail time are 1.2 μs and 42.0 μs.

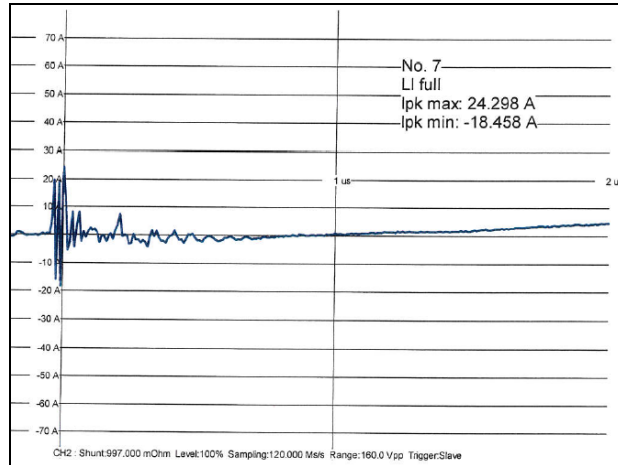
Fig. 3.5 - Reduce lightning impulse current waveform

Reduce lightning impulse current waveform is depicted in Figure 4.5. The maximum and minimum of peak current are 24.3 A and 18.5 A respectively. The RMS value for maximum and minimum of peak current are 17.2 A and 13.1 A.

The maximum and minimum of peak current for reduce lightning impulse current waveform of Figure 3.5 is equivalent to 24.3 A and 18.5 A. Some calculations have to be made to obtain the RMS value. The formula for converting maximum and minimum current to RMS:

The RMS value for maximum and minimum of peak current are 17.2 A and 13.1 A based on the conversion using formula 4.2. The waveform in Figure 3.6, 3.7 and 3.8 depicts full lightning impulse current waveform. The test result of lightning impulse current for yellow phase in negative polarity is shown in Table 4.2. The maximum of peak current is 43.4 A, 50.5 A and 30.5 A and the minimum of peak current is 24.0 A, 16.9 A and 29.5 A. It corresponds to RMS value for maximum of peak current of 30.7 A, 35.7 A and 21.6 A and RMS value for minimum of peak current of 17.0 A, 12.0 A and 20.9 A. The average for maximum and minimum of peak current are 41.5 A and 23.5 A respectively and the average for RMS value for maximum and minimum of peak current are 29.3 A and 16.6 A respectively.

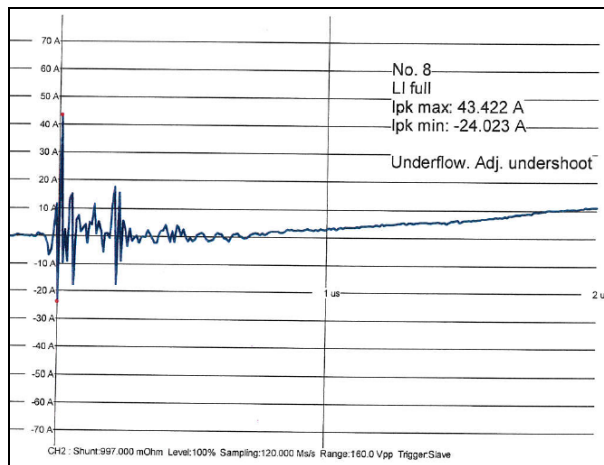
Fig. 3.6 - Full lightning impulse current waveform test 1

Full lightning impulse current waveform is depicted in Figure 3.6. The maximum and minimum of peak current are 43.4 A and 24.0 A respectively. The RMS value for maximum and minimum of peak current are 30.7 A and 17.0 A.

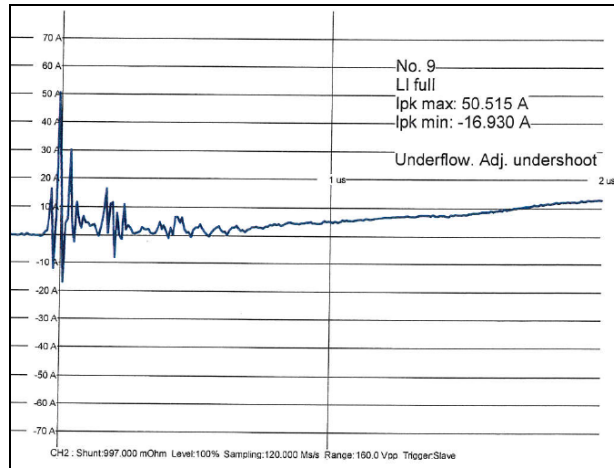
Fig. 3.7 - Full lightning impulse current waveform test 2

Full lightning impulse current waveform is depicted in Figure 3.7. The maximum and minimum of peak current are 50.5 A and 16.9 A respectively. The RMS value for maximum and minimum of peak current are 35.7 A and 12.0 A.

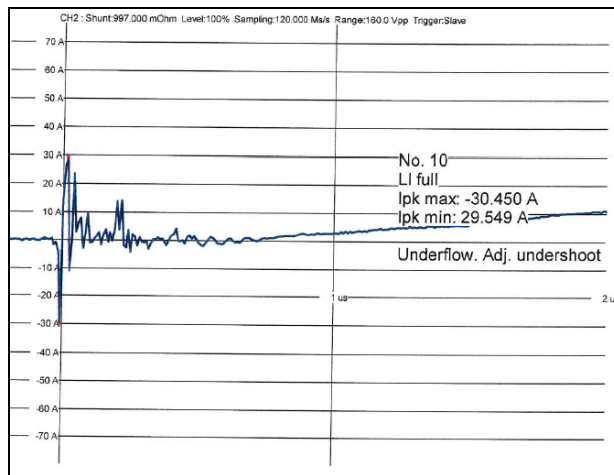
Fig. 3.8 - Full lightning impulse current waveform test 3

Full lightning impulse current waveform is depicted in figure 3.8. The maximum and minimum of peak current are 30.5 A and 29.5 A respectively. The RMS value for maximum and minimum of peak current are 21.6 A and 20.9 A.
