Concrete Repair Using Fiber from Surgical Mask

Muhamad Arif Shafiq Mazlan¹, Sallehuddin Shah Ayop²

¹Faculty of Civil Engineering and Built Environment,
 Universiti Tun Hussein Onn Malaysia, Batu Pahat, 86400, MALAYSIA

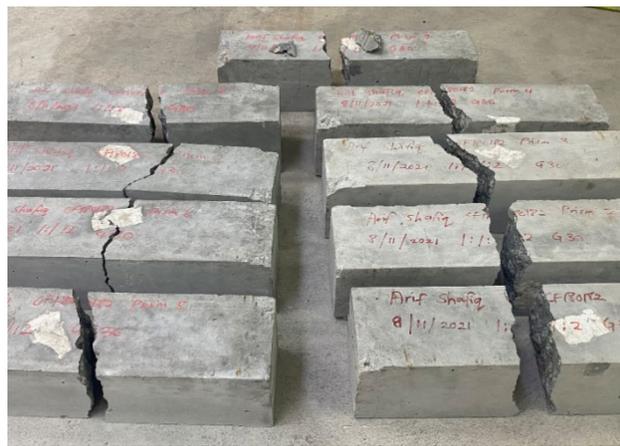
Fig. 5 - Concrete failure before repaired

Before repaired, the concrete prism was a sudden failure after achieve maximum force and the concrete prisms were split into two parts. This is because the concrete was lack in bending stress and it cannot have made an initial crack during testing. Figure 5 showed the condition of concrete failure before repaired.

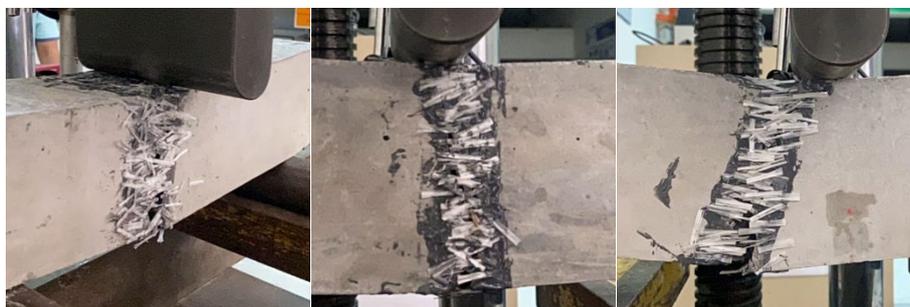
Fig. 6 - Failure after repaired (1st Method)

Fig. 6 shows the polypropylene fiber controlled the crack happened during the testing. The polypropylene fiber still tied the concrete failure from splitting.

While after repaired, the failure of the concrete prism was showed the crack pattern of concrete. From the crack pattern, it showed that cracking happened slowly because of the fiber still tied the cracking. Each three methods, shown the same result for the crack pattern, therefore using fiber or surgical mask can support the concrete in increasing the bending stress to make the concrete was not sudden failure. By using polypropylene fiber and surgical mask also will give an early warning before concrete fail in real live condition.

Based on the all three method of concrete repaired, failure happened on the same location and condition with the concrete prism before repaired. That was meant that repaired concrete failed due to the previous crack line that been repaired. This result conclude that the failure occurs on the repaired materials and the repaired materials were not enough to bond the deteriorated concrete prism. Also, based on the failure condition of the repaired concrete prism, it showed that failure happened on the adhesive epoxy layer first and the fiber still joined and tied the bonding of the concrete prism. This result concludes that adding fiber on the adhesive epoxy was functional in increasing the strength of the bonding on concrete repaired.
