Enhancement of Structural Integrity on Apron and Soil Settlement Behavior at Kompleks Penghulu Ayer Hitam, Muar Structures

Concrete apron failure, often linked to soil settlement, presents significant challenges in civil engineering and infrastructure development. This study investigates the mechanisms contributing to apron deterioration, including cracking, spalling, and structural instability, focusing on soil settlement behavior. Field studies and laboratory tests such as Atterberg limit, grain size analysis, compaction test, and consolidation tests were conducted. Results show the soil has a moderate plasticity index (9.9%), is well-graded gravel ($C_u=3.75$, $C_c=1.5$), with an optimum moisture content of 14.5% and a rapid consolidation coefficient ($12.74 \text{ m}^2/\text{year}$). These findings inform recommendations for improved apron designs. Geogrids are proposed as an effective solution to enhance stability and durability, addressing the complex interaction between soil and concrete structures.

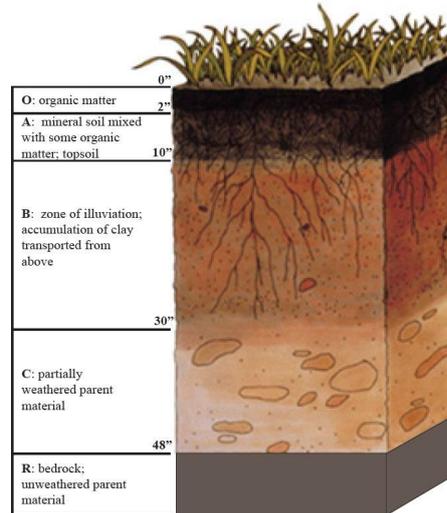
Soil also reduces urban runoff through infiltration and nutrient attenuation [2]. In construction, soil significantly impacts structure design, stability, and performance. Prior to construction, site investigations are crucial to determine soil conditions and create a soil profile diagram, which identifies distinct soil layers (horizons) and their characteristics. Fig. 1 shows the soil profile diagram.

Fig. 1 Soil profile diagram [2]

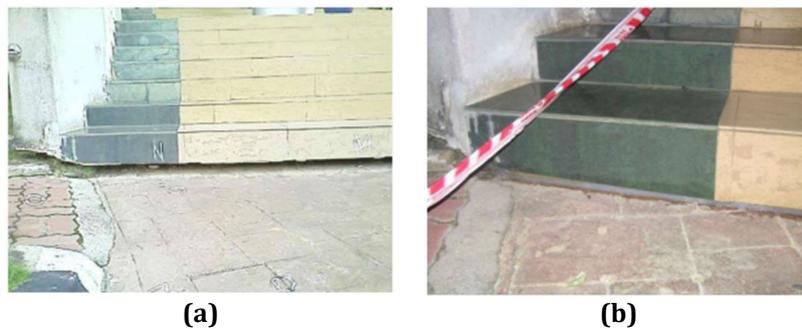
Soil settlement, the process of soil consolidation beneath structures, causes sinking and can lead to cracks in foundations, slabs, masonry veneer, ceilings, and walls [3]. Settlement is often due to building on void-filled or poorly compacted soil. Heavy rain infiltrates soft soil, reducing its strength and causing subsidence as groundwater levels drop [4]. In Malaysia's wetland areas, soil settlement critically affects infrastructure like building aprons and retaining walls [5]. A special resin is injected to improve soil properties, as shown in figures depicting visible cracks and post-treatment results. Fig. 2 shows the result of before and after treatment.

Fig. 2 Result of before and after treatment (a) Before treatment; (b) After treatment [3]

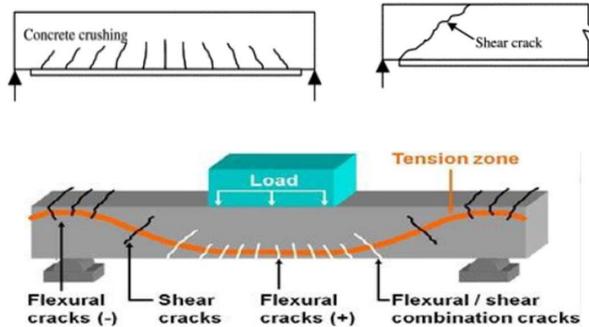
Structural cracks, resulting from excessive loading, poor construction, and poor design, can pose serious safety hazards. These cracks may occur in beams, columns, slabs, and foundations and can appear as diagonal, vertical, or horizontal fissures. Structural fractures categorized into three types: slab cracks, column cracks, and beam cracks [9]. Table 1 shows the structural cracks forms on beam, column and slab. Fig. 3 shows the cracks on beam.

**Fig. 3** Cracks on beam [9]

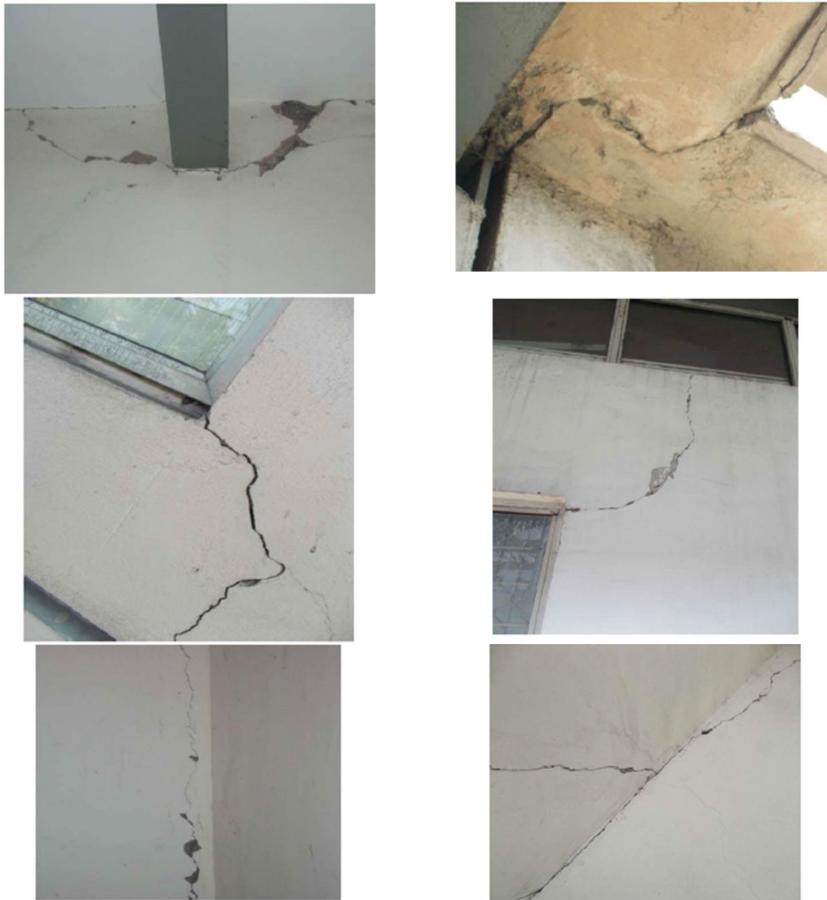
A foundation crack that is not threatening a building's structural integrity is known as a non-structural foundation crack. They are mostly caused by shrinking concrete during the curing process. Non-structural cracks are most found in finishes, partitions, or non-load-bearing elements. Fig. 4 shows the cracks in the building.

**Fig. 4** Cracks in the building

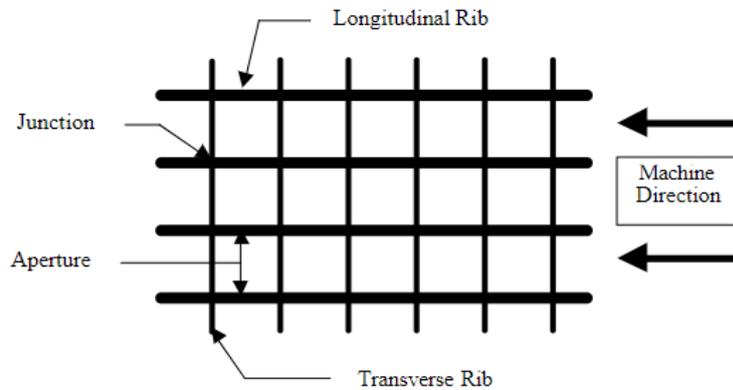
Geogrids, geosynthetic materials used for reinforcement in construction, have become essential for reinforcing soil in both paved and unpaved roads with poor soil conditions [10]. Known for their high elasticity, geogrids effectively disperse loads across large surface areas. A junction in a geogrid is where longitudinal and transverse ribs meet, created through methods like knitting or weaving [10]. Fig. 5 illustrates the plan view of a geogrid section and labels its various components.

Fig. 5 Geogrid component nomenclature

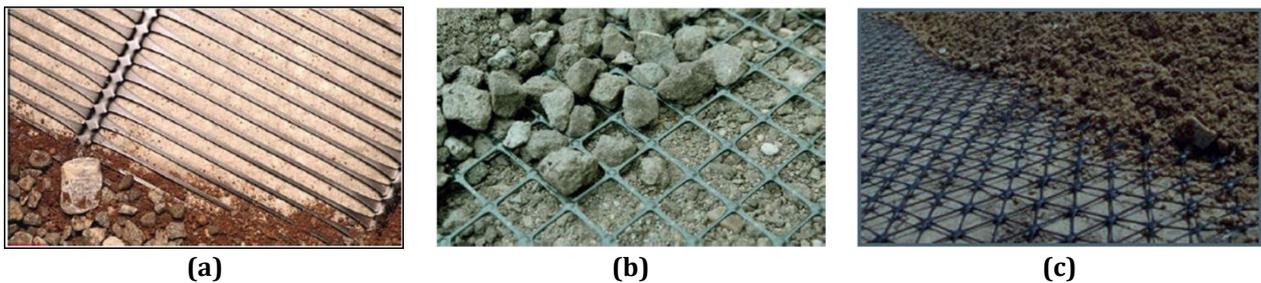
Geotextiles prevent overlay cracking and serve as waterproof barriers, reducing vertical water flow into pavement structures [11]. Geogrids are classified into three types based on aperture: uniaxial, biaxial, and triaxial. Uniaxial geogrids, with tensile strength in one direction, are used to reinforce slopes, retaining walls, and embankments. Biaxial geogrids provide tensile strength in two directions and are used for pavements, railroads, and flexible pavements but lose strength under multi-directional stress [12]. Triaxial geogrids, with triangular apertures and three rib orientations, offer uniform tensile strength in all directions and improved soil particle-rib interaction [12]. Fig. 6 shows the three types of geogrids.

Fig. 6 Types of geogrids (a) Uniaxial geogrids; (b) Biaxial geogrids; (c) Triaxial geogrids

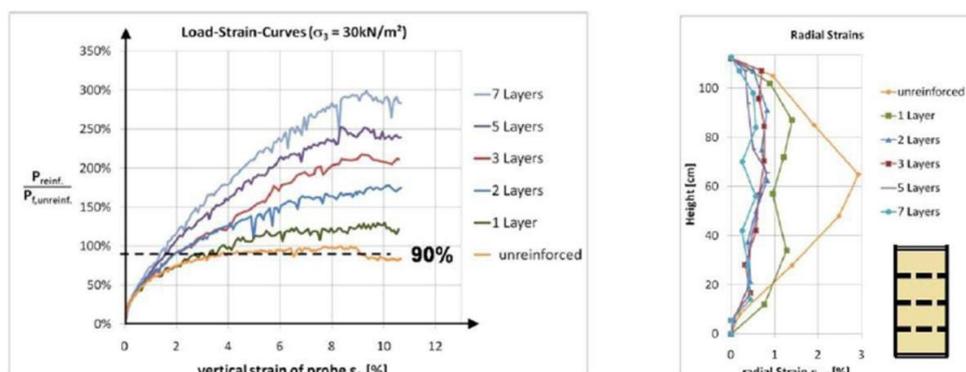
From a test, the ultimate load increases with each geogrid layer, reaching about 2.5 times that of the unreinforced sample with 5 layers of grid [13]. The more reinforcing layers there are, the less lateral bulging and vertical compression there is. Fig. 7 indicates the effect of geogrid layers in triaxial test.

Fig. 7 Effect of geogrid layers in a triaxial test

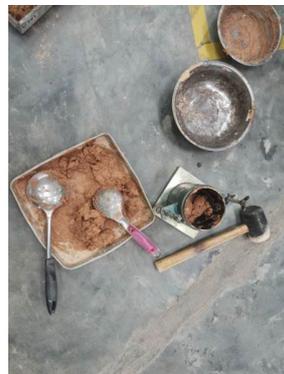
A compaction test is a common geotechnical procedure used to determine the optimal moisture content and maximum dry density of soil, essential for assessing its suitability for construction. Compaction increases soil dry density, reducing potential settlement under load and decreasing permeability [15]. This process involves applying stress to expel air from soil particles, enhancing the soil's engineering properties. It is a cost-effective and widely used soil improvement technique [16]. The Standard Proctor Compaction Test, following ASTM D698 guidelines, is the most frequently used method for evaluating compaction characteristics. Fig. 10 shows the equipment for compaction test.

Fig. 10 Compaction test equipment

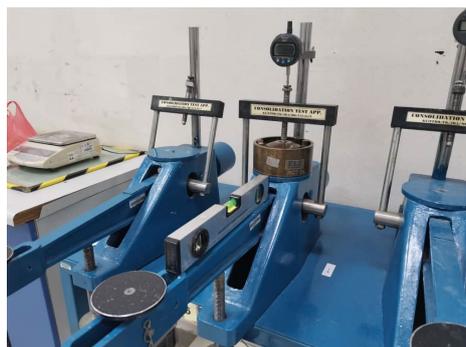
A consolidation test is a geotechnical laboratory procedure that evaluates the compression and settlement behavior of soil under applied loads, providing critical data on soil response to stress changes and long-term settlement predictions. This test determines the compressibility and consolidation properties of soil. When a saturated, compressible clay layer is subjected to increased stress, the resulting pore water pressure gradually decreases over time [17]. The test follows ASTM D2435: Standard Test Methods for One-Dimensional Consolidation Properties of Soils Using Incremental Loading. Fig. 11 shows the apparatus for consolidation test.

Fig. 11 Consolidation test apparatus

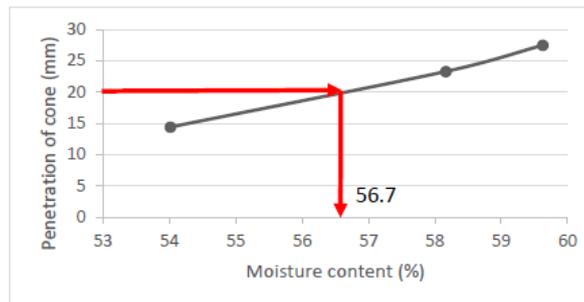
The Atterberg limit test measures soil's liquid limit (LL) and plastic limit (PL), providing information on the plasticity, compressibility, and behavior of fine-grained soils. Table 2 shows the result of water content and penetration from Atterberg limit tests, while Fig. 12 illustrates the LL of soils.

Table 2 highlights the relationship between water content and penetration depth, demonstrating that higher moisture content leads to softer, less compact soil. Sample 1, with 54.02% water content and 14.4 mm penetration depth, indicates compact soil. Sample 2 (58.17% water content, 23.3 mm depth) and Sample 3 (59.63% water content, 27.8 mm depth) show increased softness and decreased compaction. Figure 12 indicates the LL of soil at 56.7%, the critical moisture content where soil transitions from a plastic to a liquid state under shear forces. This indicates moderate plasticity, important for geotechnical engineering.

Fig. 12 Liquid limit of soil

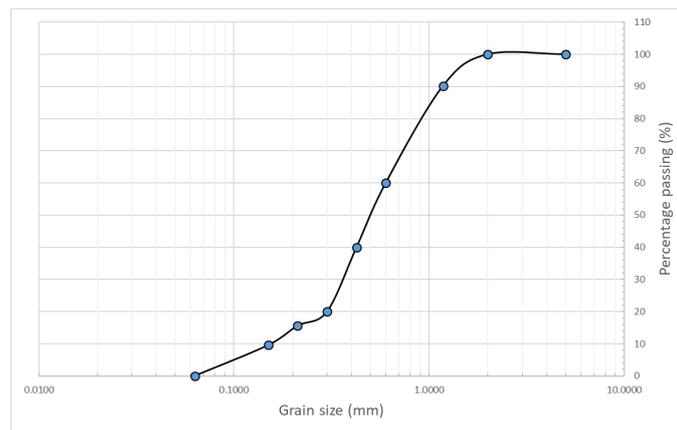
Cu is determined as the ratio of particle diameter D_{60} to D_{10} , yielding a value of 3.75, indicating a wide range of particle sizes in the soil sample. The coefficient of gradation, Cc, results in a value of 1.5. The particle size distribution curve, shown in Fig. 13, illustrates these properties graphically, with percentage passing on the y-axis and grain size on the x-axis. The curve starts with 100% passage at the largest sieve size (5.0 mm) and gradually drops with decreasing particle size, reflecting the soil's gradation. Fig. 14 shows the Unified Soil Classification System (USCS) classification based on the test results, with the soil having a Cu of 3.75 and a Cc of 1.5.

Fig. 13 Particle size distribution curve

The analysis highlights several crucial soil properties relevant to geotechnical engineering. A plasticity index (PI) of 9.9% indicates moderate plasticity, critical for assessing load behavior and suitability for construction projects. The uniformity coefficient (C_u) of 3.75 and coefficient of gradation (C_c) of 1.5 suggest well-graded soil with diverse particle sizes, offering robust strength, permeability, and compaction properties. The optimal moisture content (OMC) of 14.5% is the moisture level at which soil achieves maximum compaction density, guiding appropriate compaction techniques during construction. A coefficient of consolidation (C_v) of $12.74 \text{ m}^2/\text{year}$ indicates rapid soil consolidation under stress, essential for predicting settlement and deformation of structures.

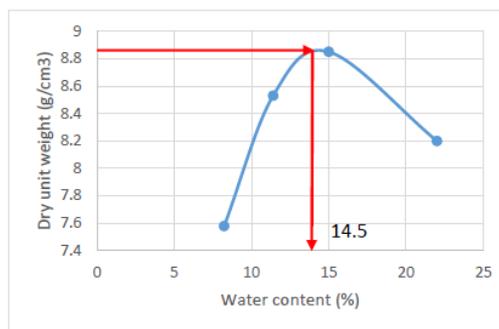
Fig. 15 shows the compaction curve, indicating the optimum moisture content (OMC) of soil at 14.5%. This OMC represents the moisture level at which the soil achieves its maximum density during compaction. At 14.5% moisture, soil particles rearrange effectively, yielding the highest possible density under compaction. However, for well-graded gravel, an OMC of 14.5% is considered high, resulting in lower density and increased softness, leading to potential settlement. Coarse-grained soils like gravel and sands typically have lower OMC values than fine-grained soils because they retain less water [5].

Fig. 15 *Compaction curve*

Despite generally suitable characteristics, the rapid consolidation ($C_v = 12.74 \text{ m}^2/\text{year}$) poses a significant challenge for apron design, leading to uneven settlement and potential cracking. Geogrid reinforcement is recommended to enhance bearing capacity, reduce differential settling, and improve load distribution, ensuring a more resilient and stable apron. Further site-specific investigations and engineering analyses are necessary to confirm soil suitability and address potential risks. A major contributing factor to the apron failure is the high rate of soil consolidation ($C_v = 12.74 \text{ m}^2/\text{year}$), resulting in unequal settlement when under load. Even with the soil's moderate flexibility (PI = 9.9%) and well-graded character ($C_u = 3.75, C_c = 1.5$), uneven settling would have been worse by inadequate compaction or moisture fluctuations. Structural instability and fracture caused by this uneven settling. Geogrid reinforcement is advised to improve load distribution, lower differential settlement, and increase bearing capacity in order to lessen these problems. The long-term durability of the apron depends on proper compaction at the ideal moisture content (OMC = 14.5%) and additional site research.

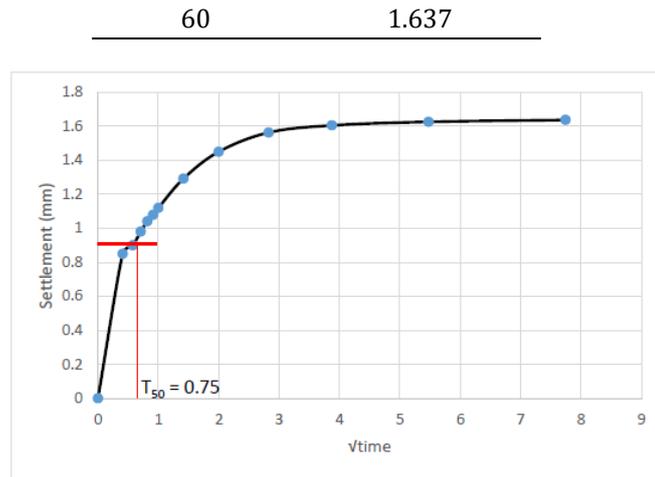
The consolidation test measures the volume loss of a laterally constrained soil specimen under vertical pressure. The resulting data allows for the calculation of the soil's compression index, recompression index, pre-consolidation pressure, and consolidation and secondary compression coefficients. Table 6 summarizes settlement observations at various time intervals. Initial settlement rates are high, indicating rapid deformation. Over time, the settlement rate stabilizes, with changes becoming less pronounced, indicating increasing material stability. Settlement continues due to secondary consolidation over extended periods [18]. Settlement values range from 0.85 mm to 1.637 mm, reflecting the degree of deformation. Table 6 shows the consolidation test data. Fig. 16 illustrates a T_{50} value of 0.75 minutes, indicating that the soil achieves 50% primary consolidation quickly, demonstrating strong permeability and effective water drainage. This rapid consolidation is crucial for geotechnical engineering and construction.

Fig. 16 Consolidation curve

$$C_v = \frac{T_v H^2}{t} = \frac{0.197 \times (19.28/2)^2}{0.75} = 12.74 \text{ m}^2/\text{year} \tag{1}$$

The coefficient of consolidation (C_v) of $12.74 \text{ m}^2/\text{year}$ shows that soil consolidates quickly under load conditions. In geotechnical engineering, this value is vital since it provides information about how the soil settles. Understanding C_v helps to build foundations and structures that can endure expected settlement, assuring long-term stability and safety.
