Cracking Assessment of Reinforced Concrete Slab Using Impact Hammer Test

Nuramieza Mohd Yazid¹, Nor Hayati Abd Ghafar^{1*}

¹ Faculty of Civil Engineering and Built Environment,
Universiti Tun Hussein Onn Malaysia, Batu Pahat, 86400, MALAYSIA

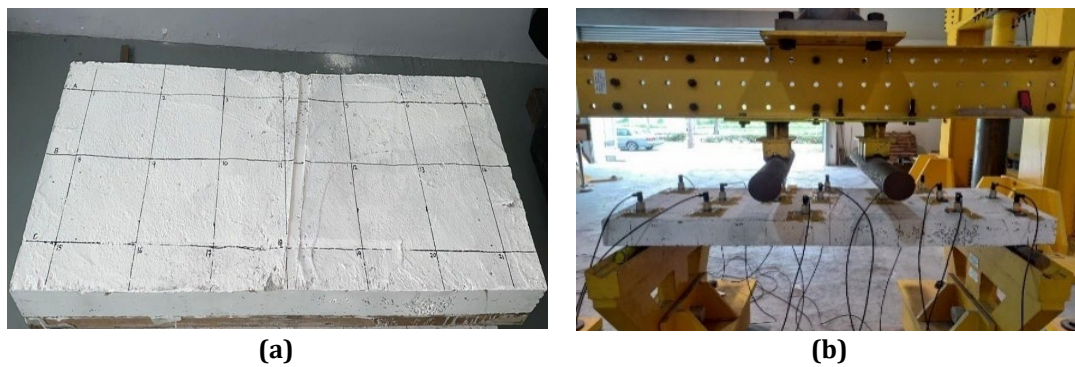
Fig. 2 Sample of slab (a) Gridlines on the slab; (b) Location of the accelerometer

After 28 days, when the concrete reached a compressive strength of 25 MPa, the gridlines were plotted on the slab along the length and the width of the slab as shown in Figure 2 (a). The function of drawing the grid line was to create a point where the accelerometers were placed as shown in Figure 2 (b) and Figure 3 shows the schematic diagram of the location of accelerometers.

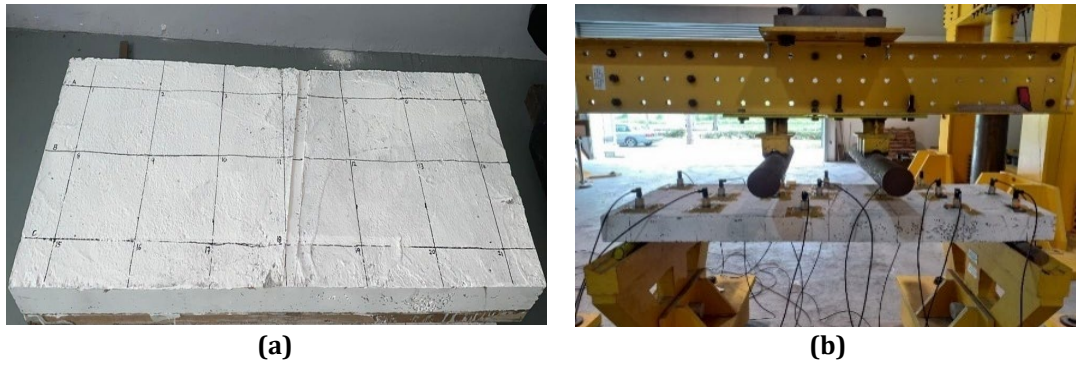
Fig. 4 Laboratory testing (a) Impact hammer test equipment; (b) Four-point bending test

The accelerometers were represented by the green dot while the black dot represents a location where the hammer was impacted. An impact hammer was used as a vibration excitor while accelerometers were used to record and measure the vibration wave. Each of the accelerometers was connected to the data logger using cables. The connection of the accelerometers to the data logger was according to the number of channels as shown in Figure 4 (a). Then, the data logger was connected to the computer so that the vibration wave could be recorded. Figure 4 (b) shows the hammer that was used in the impact hammer test.

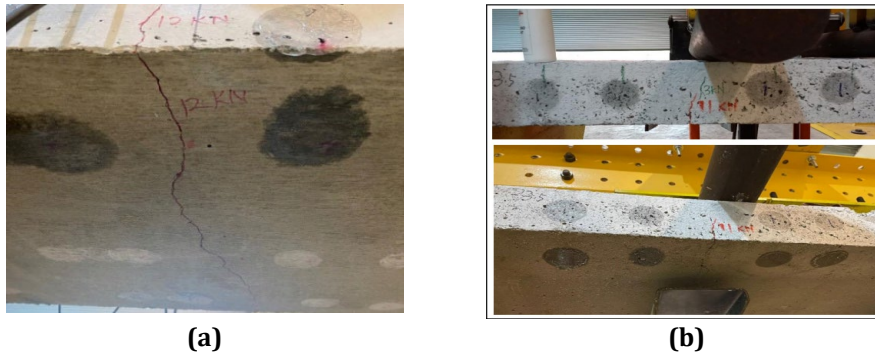
The pattern and location of the cracking for both Slab 1 and Slab 2 were almost the same as shown in Figure 9 and Figure 10. The slab was loaded for 3 kN and 6 kN, 12 kN and 15 kN. However, there was no result for the 3 kN and 6 kN loads because the load was automatically set up to 12 kN from the machine during the four-point bending test, and the machine only stopped when the load reached 12 kN. Meanwhile, for Slab 2, the four-point bending test was performed by gradually increasing the load from 3 kN to 6 kN, 12 kN, and 15 kN. However, no cracking was observed during the 3 kN and 6 kN loading. Only after applying 12 kN and 15 kN loads did the flexural crack

appear at the middle of the slab. The bending of the slab created a tensile stress that exceeded the tensile strength of the concrete, which resulted in a flexural crack.

Fig. 5 Crack mapping (a) slab 1; (b) slab 2

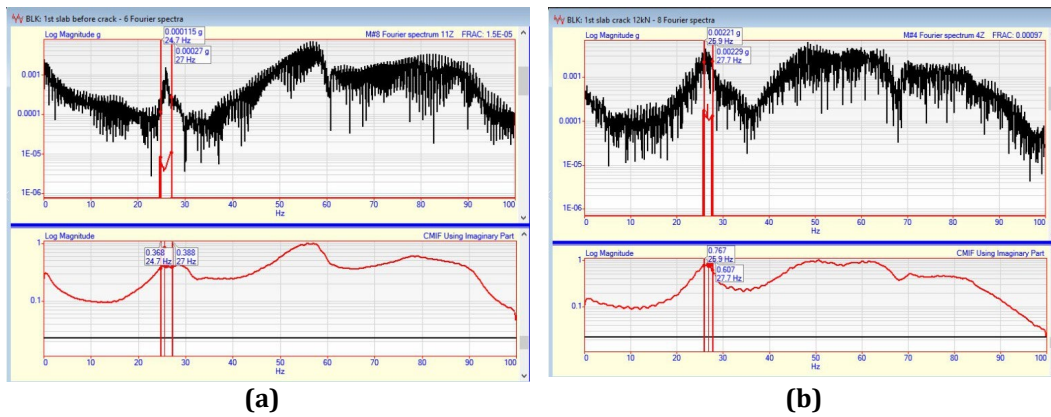
Fig. 5 Fourier transform of slab 1 (a) Before crack; (b) 12 kN load

The data collected during the impact hammer test was then analysed in the Me'Scope software package. The raw data was transformed into the Fast Fourier Transform (FFT) function as illustrated in Figures 5 (a) and (b), and Figure 6 to display the natural frequency of the vibration waves. The natural frequency of the slabs before and after crack is shown in Table 1.

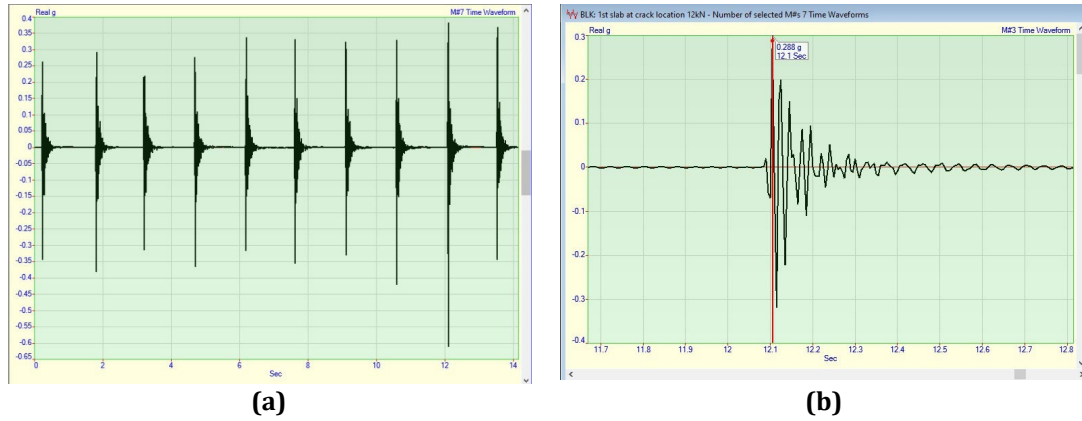
Fig. 7 Analysis result of (a) Vibration wave of slab 1 at 12 kN; (b) Peak acceleration of vibration wave

The acceleration along the crack was compared to understand the crack width of the slab. Figure 13 show the graph of acceleration against time in second for the impact hammer test. Ten vibration waves indicate that the hammer was hit ten times on the slab. The acceleration is represented by the y-axis of the graph. Figure 14 shows the peak acceleration of the vibration waves.

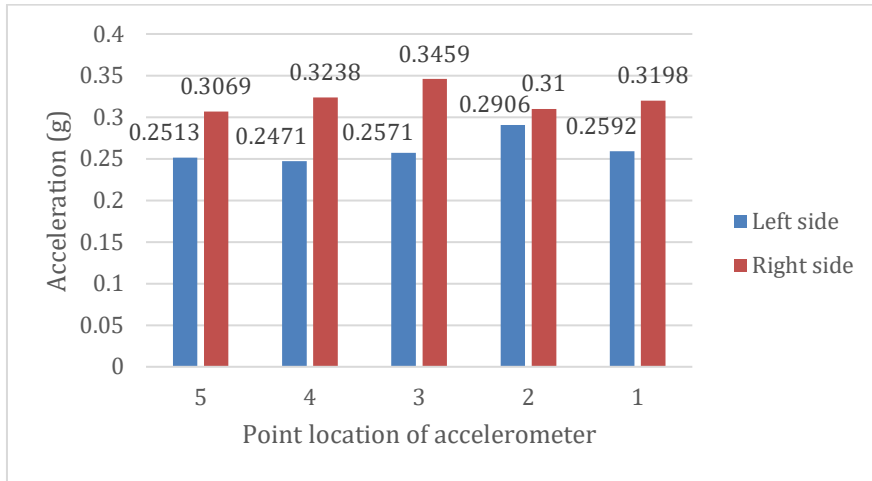
Fig. 11 Acceleration of the wave on slab 2 from left to right after propagating through the crack area

The wave acceleration increased from the left to the right side, as shown in Table 4 and Figure 18. The highest percentage difference was at point 3 while the lowest percentage difference was at point 2.
