Motor Vibration and Temperature Detector by Using IoT

Amirah Syafiqah Arman Sabri¹, Roziah Aziz^{1*}

¹ Department of Electrical Engineering, Faculty of Electrical and Electronic Engineering,
Universiti Tun Hussein Onn Malaysia, 86400 Parit Raja, Johor, MALAYSIA

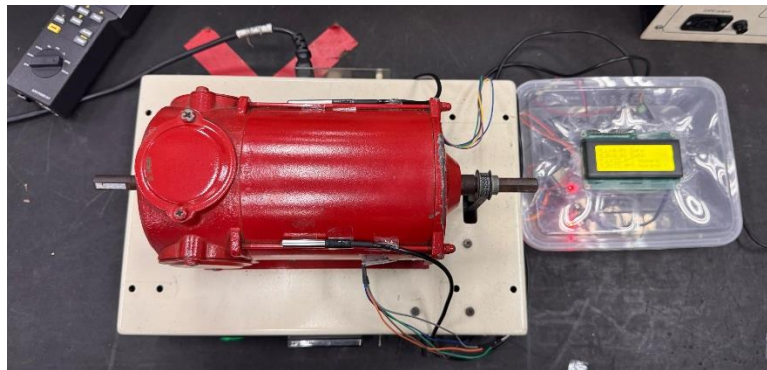
Fig. 1 *Prototype of project design*

This real connection of Fig. 1 that demonstrated in this sketch explains how a 3-phase motor is connected with monitoring sensors and microcontroller system. In order to measure operating temperatures, the DS18B20 temperature sensors are positioned at key locations of the motor which on its body and will give signal to the buzzer if the temperature of the motor is reaching the limit. These sensors are wired to the ESP32 microcontroller that analyses this data acquired by the sensor. The ADXL335 vibration sensor is placed on body of the motor as a way monitoring high levels of vibrations which may signal mechanical problems such as imbalance or wear. The whole system is housed in an enclosure protective box with the ESP32 microcontroller and an LCD screen inside. The LCD is employed to give actual time feeds on the set temperatures and vibrations where it will give a warning such as 'Hazard' if the level exceeds the allowable limit and "Safe" when the sensors is within limit. Meanwhile, the ESP32 will send a signal to the Blynk Application as it can also display the status of motor condition towards its vibration and temperature. This configuration guarantees dependable motor monitoring, facilitating prompt reactions to potentially hazardous situations to safeguarding the motor and adjacent equipment.

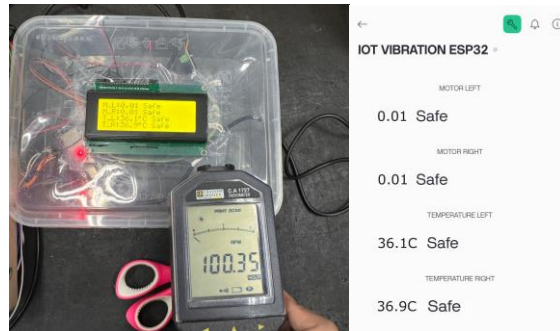
Fig. 4 Result of 100.35 RPM

In Fig. 4., temperature and vibration data remained low and well below the threshold values at a low motor speed of 100.35 RPM. This state was categorised as "Safe," meaning that there were no indications of high heat or mechanical stress and the system was stable.

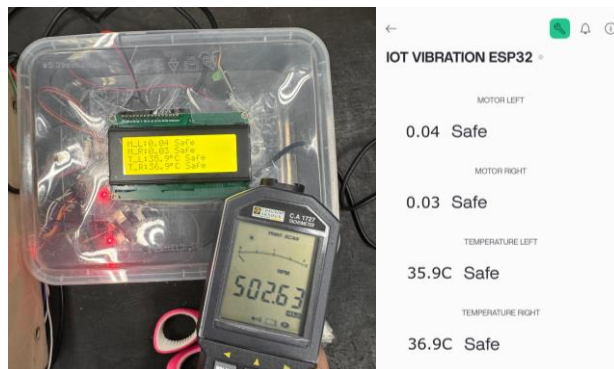
Fig. 5 Result of 502.63 RPM

Based on Fig. 5, temperature and vibration levels increased slightly yet remained within an acceptable range as the motor speed increased to 502.63 RPM. The system maintained its "Safe" rating, confirming reliable motor operation at moderate load.

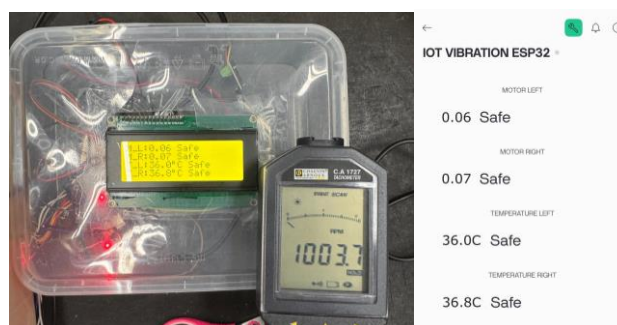
Fig. 6 Result of 1003.7 RPM

The system detected slight increases in both sensor readings at 1003.7 RPM as shown in Fig. 6 but these values remained within the predetermined ranges. The "Safe" status confirmed the motor was operating efficiently without risk of failure at this speed.

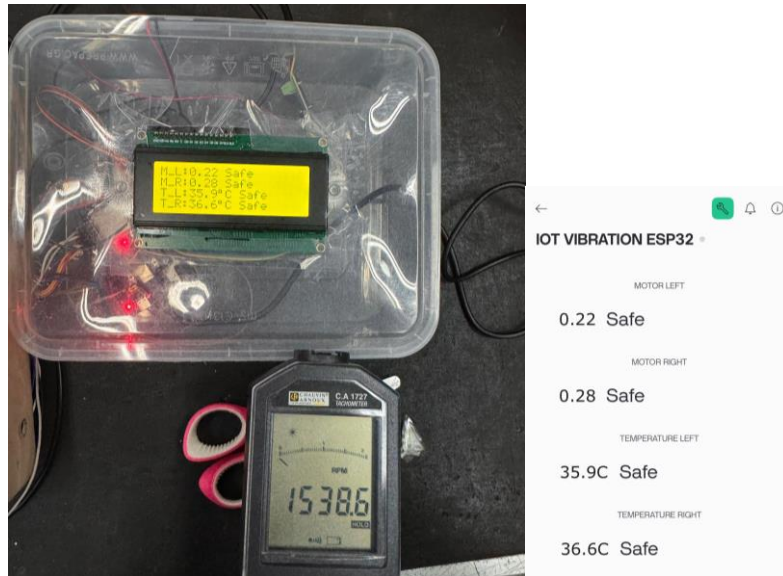
Fig. 7 Result of 1538.6 RPM

Vibration readings reached the top limit but stayed below 0.5G when the motor was operating at 1538.6 RPM in Fig. 7. The status remained "Safe" despite being near the threshold, demonstrating the system's capacity to withstand faster speeds without losing stability.

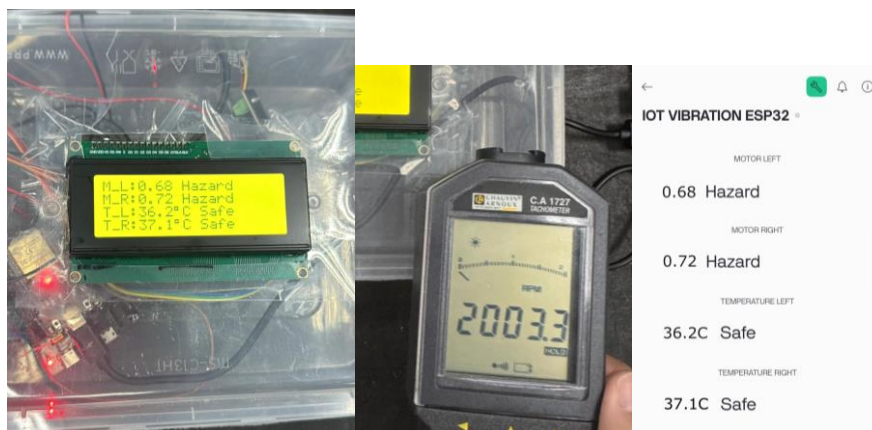
Fig. 8 Result of 2003.3 RPM

As shown in Fig. 8, a "Hazard" alert was triggered when the vibration levels surpassed 0.5G at 2003.3 RPM. This was a crucial moment where maintenance care might be needed because it signalled the beginning of potentially harmful mechanical conditions. However, the temperature is not yet triggering the "Hazard" signal since it is still below the set temperature which in this experiment is 38.0°C.

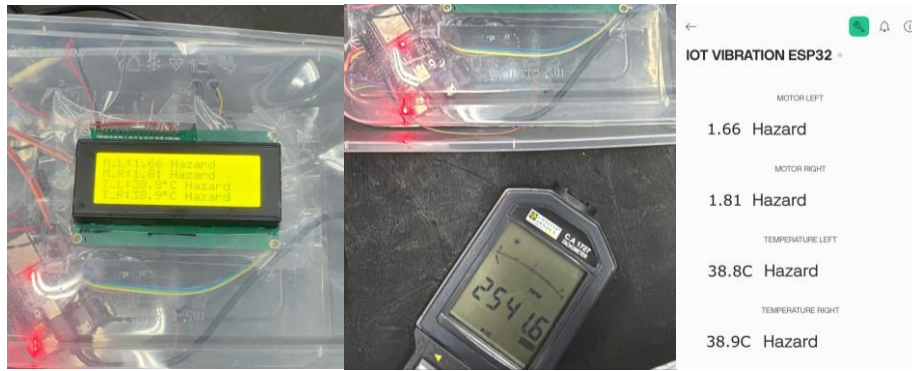
Fig. 9 Result of 2541.6 RPM

Result of RPM value for both vibration and temperature readings above the danger criteria in these data that illustrate in Fig. 9 which correspond to the maximum tested speed of 2541.6 RPM. The system flagged a "Hazard" condition, demonstrating its effectiveness in detecting high-risk states and the need for immediate action to prevent motor damage.

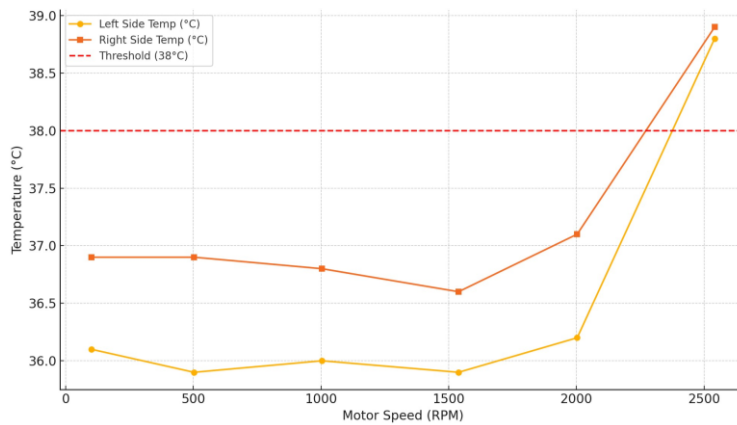
Fig. 10 Temperature vs. RPM (Left and Right Side)

This graph illustrates in Fig. 10 shows the relationship between motor speed (RPM) and temperature recorded on both the left and right sides of the motor. Particularly at higher speeds, the temperature progressively rises in line with the RPM. To show the highest safe temperature, a threshold line is placed at 38°C. According to the graph, both temperature measurements stay below the limit at lower RPM but surpass 38°C at the maximum speed of 2541.6 RPM, resulting in a "Hazard" status. This illustrates how the system may identify overheating when working at high rates.

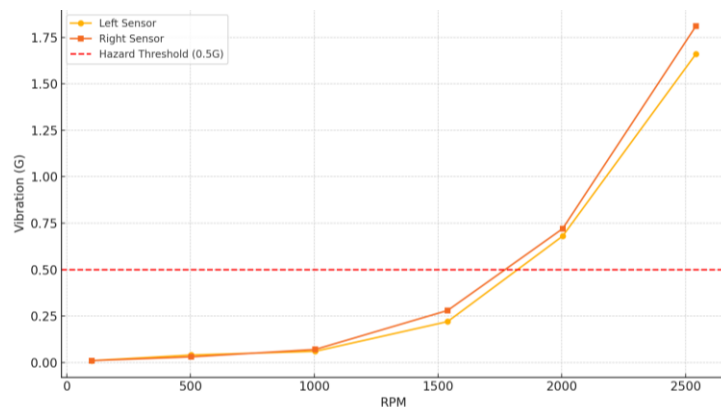
Fig. 11 Vibration vs. RPM (Left and Right Side)

Fig. 11 shows the vibration levels measured by the left and right sensors on a motor at different RPM speeds. Both sensors show a steady increase in vibration levels as the RPM rises. Safe motor operation is indicated by vibration readings that stay below the 0.5G hazard level at low speeds which at 100.35 to 1538.6 RPM. Both sensors, however, pick up vibrations that surpass the threshold when the motor hits higher speeds at 2003.3 RPM and above which could indicate a mechanical problem. This demonstrates the significance of real-time monitoring for early warning and maintenance by confirming that greater motor speeds can result in dangerous vibration levels.
