A Study of Air System Performance On EMU KTM Class 83

Keywords: Air System, Failure Analysis, EMU Train

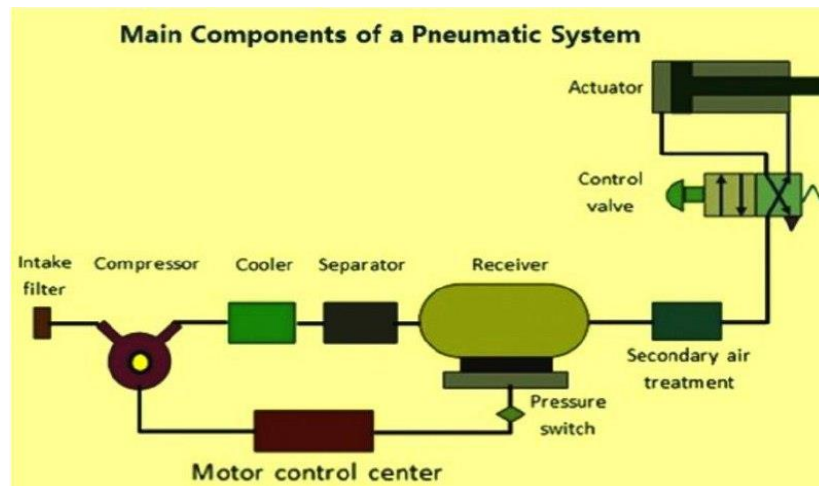
Figure 2: Component of pneumatic system

Pneumatic system of EMU train is a system that utilize compressed air to power. It refers to the use of compressed air to operate various functions within the train. Figure 2 displays a typical pneumatic system arrangement, which shares important elements with a hydraulic system [3]. The main difference between the two is the method of energy transfer is hydraulic systems utilise pumps to supply mechanical energy to oil, whereas pneumatic systems use compressors to provide mechanical energy to air. Furthermore, a hydraulic system frequently operates at extremely high pressures in order to transmit huge amounts of force and power, whereas a pneumatic system normally operates at low pressures of 5 - 7 bar for industrial applications.

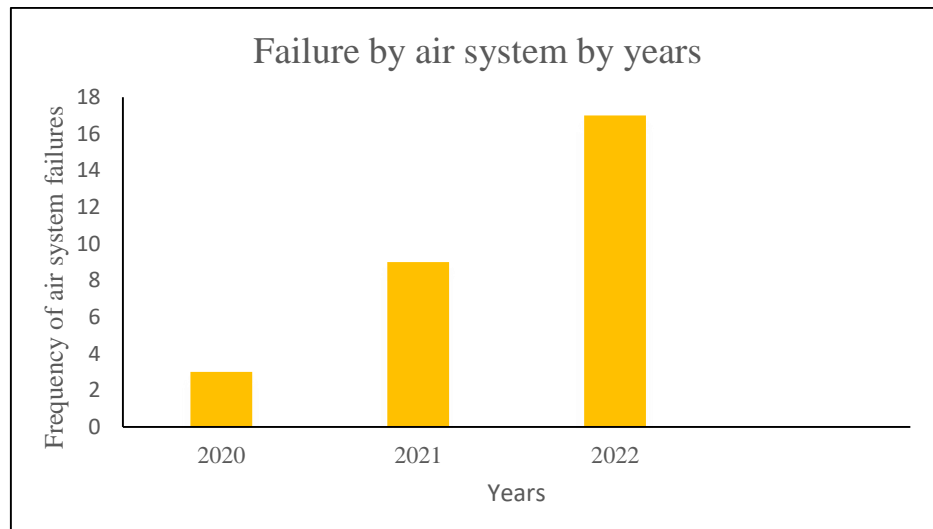
Figure 9: The failure in air system in year 2020, 2021 and 2022

In Figure 9, the focus was on air system failures that were recorded from 2020 to 2022. During this time, 29 failures in total were documented. Interestingly, the year 2020 saw the fewest failures, which was due to the Movement Control Order (MCO) issued by the Malaysian government, which required people to stay at home.

The number of failure in the air system was recorded as 3 in year 2020, while it increased to 9 failures in 2021 and further escalated to 17 failures by 2022. This represents as percentage increase of failure rates by 20.69% from 2020 to 2022. The number of failures has shown a consistent increase from 2021 to 2022 ranging from 9 in 2021 to 17 in 2022, reflecting a considerable rise of around 27.59%. This higher trend in failures can be attributed to the fact that more train sets are now operational in 2022 compared to the previous year.

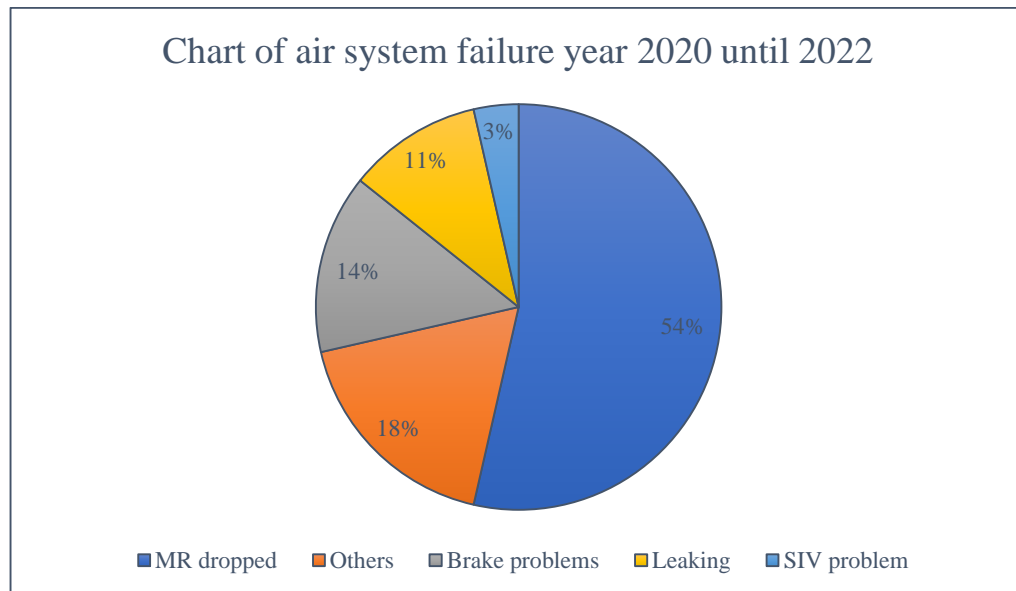
Figure 10: Percentage of air system failure year 2020 until 2022

The air system can be split into five distinct systems based on the data supplied in Figure 10: main reservoir dropped, braking difficulties, leakage issues, SIV problems, and others (which include external heating, valve isolating cock problem, and motor problems damages). The analysis of these systems finds that the main reservoir drop has the highest failure rate, with an average percentage of 54%, necessitating additional maintenance.

As shown in Figure 10, main reservoir dropped was the primary cause of air system failures, with potential causes including damage to the induction motor, leaks in the main reservoir pipe and piston valve, detachment of the pipe between coaches, as well as loose electrical connections at the main compressor. Main reservoir dropped occurs when pressure falls below 7 bars, causing a train to malfunction. Normal reading should be 8-10 bar. The driver will then report the failure and the train is taken to the maintenance team for repair.

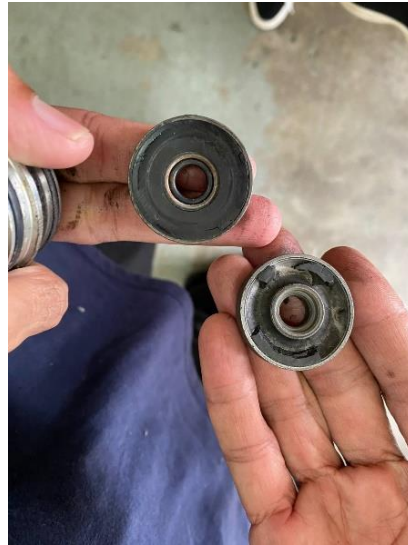
Figure 11: Defect valve kit (right), normal valve kit (left)

components in an EMU train's pneumatic system, ensuring reliable performance and efficiency in various operations. Failure in piston valve will affect the main reservoir dropped. The valve kit of piston valve often experiences failure as shown in Figure 11 due to wear and tear, deteriorating seals and gaskets from usage, temperature changes, and exposure to contaminants. This can cause gaps or cracks, causing air leakage then cause to main reservoir dropped. Regular maintenance practices are crucial to address these concerns. In such cases, the maintenance team replaces damaged items with new service kits, as shown in Figure 12.

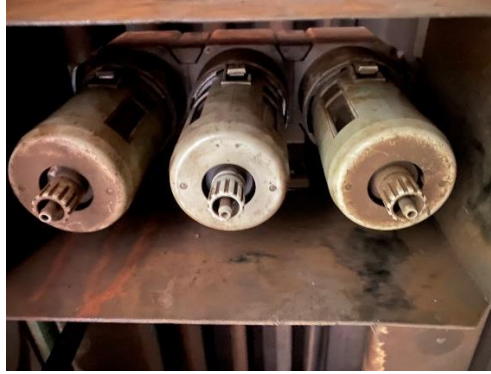
Figure 13: Air filter

Therefore, to improve the reliability and efficiency of the pneumatic system, one option is to consider upgrading or modifying the system. This can involve replacing outdated components with more advanced and dependable ones or implementing technologies that minimise main reservoir pressure drops. In order to enhance the air quality at the main reservoir in EMU trains, proactive measures were taken by installing an additional air separator with three filters beside the existing air dryer component as shown in Figure 13. Originally, only air dryer and oil separator mechanism was used for filtering purposes. The new air separator serves a similar purpose as these previous components by ensuring that only clean filtered air enters into the main reservoir. The air separator improves efficiency and reduces man power for maintenance work by effectively filtering high-quality air. In cases where the air quality is poor and cannot be efficiently filtered, water may remain in the filtered air and can affect the air system in train.

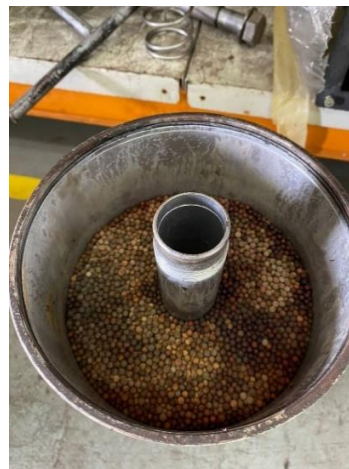
Figure 14: Desiccant gel that has been used 2 years inside the air dryer

As part of routine visual inspections, thoroughly inspect the air dryer for the presence of damage, leaks, or loose connections. In addition, the air dryer housing must be inspected for condensation or water accumulation. During this process, the intake and output ports, filtration elements, and drying mechanism should all be thoroughly inspected. The desiccant gel, which is housed within the air dryer tower, also needs to be replaced on a regular basis. Because the aim of the air dryer is to eliminate moisture by using a desiccant gel, it is critical to constantly monitor and change the desiccant as needed. Because of its short lifespan, the desiccant gel's ability to absorb moisture reduces over time. A total of 4.5kg of desiccant gel is used within the tower, which typically requires refilling after two years. By properly maintaining the air dryer system, one can increase the overall dependability and lifetime of pneumatic systems on trains. Figure 14 and 15 shows the desiccant gel which has been used in the air dryer for two years. Figure 15 depicts the difference between the two-year desiccant gel and the new gel desiccant. The different in terms of their colors demonstrates that the desiccant gel in the air dryer effectively absorbs the moisture.
