A Study on the Propagation of Cracks in A Reinforced Concrete Beam Incorporating Spent Garnet Subjected to Repeated Impact Loads

Maizatul Najihah Basirun¹, Shahrul Niza Mokhtar^{2*}

¹ Faculty of Civil Engineering and Built Environment,
Universiti Tun Hussein Onn Malaysia, Batu Pahat, Johor, 86400, MALAYSIA

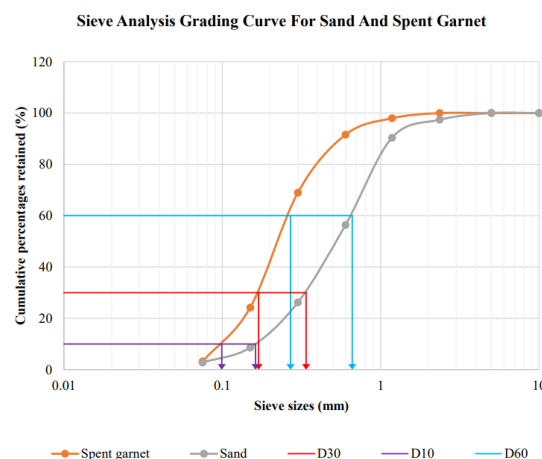
Fig. 1 Sieve analysis grading curve for sand and spent garnet
(Phang et al., 2022)

Phang et al. (2022) conducted a sieve analysis on spent garnet and sand, revealing well-graded patterns in both materials, as depicted in Figure 1. The grading coefficients for sand and spent garnet were 1.09 and 1.07, respectively, both exceeding 1.0, which is considered theoretically well-graded. This implies that the particle grading of spent garnet meets the standards for fine aggregates used in concrete production.

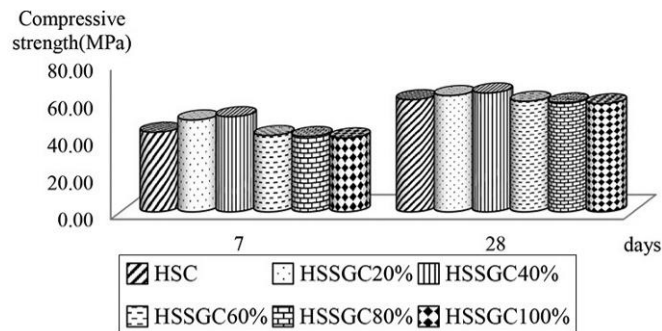
Fig. 2 Compressive strength for high-strength spent garnet concrete (HSSG) for all specimens at 7 and 28 days
(Kadir et al., 2019b)

In a study conducted by Kadir et al. (2019), the replacement of river sand with spent garnet in concrete demonstrated increased strength at 7 and 28 days, with the strength reaching up to 40% as indicated in Figure 2. At 28 days, the strengths for high-strength spent garnet concrete (HSSGC) at 20% and HSSGC at 40% increased by 3.77% and 6.02%, respectively. The enhanced strength for HSSGC at 40% was attributed to the fine particles of spent garnet filling voids, reinforcing the concrete. However, exceeding 40% resulted in reduced strength as spent garnet, classified as a poorly graded aggregate, caused degradation in bonding with cement. Consequently, the study identified 40% spent garnet as the optimal proportion for maximizing concrete strength.

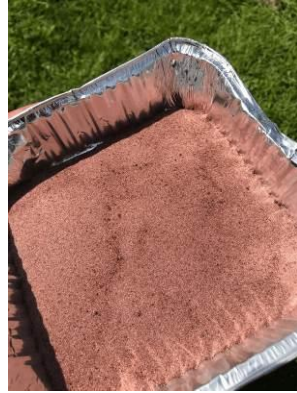
Fig. 3 Spent garnet at Advanced Materials Engineering Laboratory UTHM

In southern Malaysia, the MMHE company supplied spent garnet, utilized as a partial replacement for fine aggregates. The spent garnet underwent sieving using a 4.75 mm sieve before being added to the concrete mixture. The material was weighed based on the quantity specified by the Department of Environment (DOE), with various percentages used in this study, including 0%, 10%, 20%, 30%, and 40%. The spent garnet material, obtained from Boustead Naval Shipyard Sdn. Bhd, Lumut, Perak, is depicted in Figure 3 in the laboratory setting. This sustainable approach to waste material utilization contributes to the study's environmental considerations and potential for concrete mix optimization.

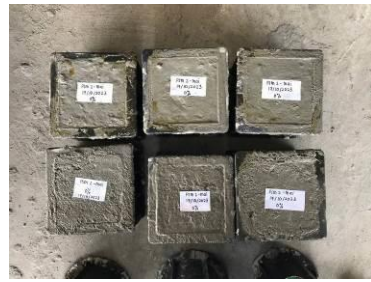
Fig. 5 Concrete cube for (a) 0% of spent garnet; (b) 10% of spent garnet

minimizing voids or air pockets. All cube samples maintained consistent dimensions, measuring 100 mm in length, width, and height. Likewise, the 15 beam specimens shared uniform measurements of 800 mm in length, 120 mm in width, and 150 mm in height.

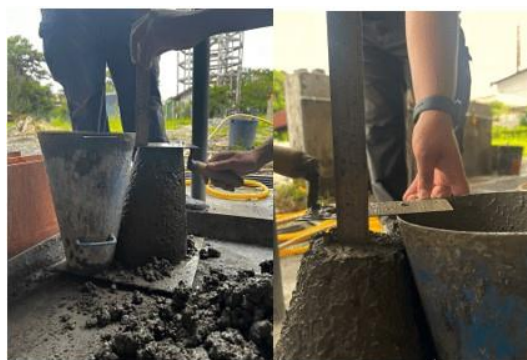
Fig. 7 Slump test for 30% of spent garnet at Advanced Material Laboratory UTHM

A slump test was conducted to gain insights into the consistency of the freshly mixed concrete and its ability to be effectively placed and compacted during construction. The cone used for the test had a height of 300 mm, an upper diameter of 100 mm, and a lower diameter of 200 mm. The concrete slump test, following the guidelines of BS 1881 - Part 102:1983, involves several steps. To perform a slump test on fresh concrete, first, clean the inside cone and place it on a flat surface. Fill the cone with concrete in three layers, tamping each layer 25 times. After rodding the top layer, level the concrete with a trowel or tamping rod. Measure the slump by determining the difference in height between the mould and the highest point of the specimen. In this example as shown in Figure 7, the slump test resulted in a slump of 35mm for a 30% spent garnet mix in fresh concrete.

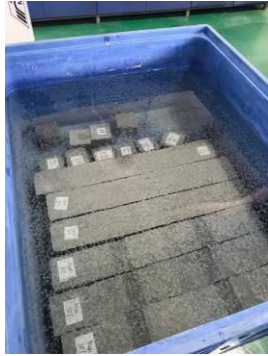
Fig. 8 Curing tank at Advanced Materials Engineering Laboratory UTHM

All specimens were removed from the moulds and underwent a curing process 24 hours after being cast. The 7-day curing period was crucial for evaluating initial strength development, while the 28-day curing period assessed long-term strength and durability. The curing process involved placing concrete cubes inside water-filled barrels. Figure 8 shows the curing process of concrete cubes at the Advanced Materials Engineering Laboratory UTHM. It depicts the placement of the concrete cube inside a water-filled barrel.

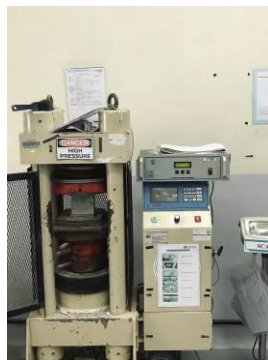
Fig. 9 Compressive machine test at Materials Engineering Laboratory UTHM (FKAAB)

In this study, all cube specimens were extracted after 7 and 28 days of curing. The compressive strength testing, following BS EN 12390-3-2009 guidelines, involved several steps. The specimen was removed from the curing tank and weighed before undergoing compressive testing. The testing surface was flat, and the specimen position was centred between the compression plates. The load was gradually increased until the maximum load achieved during the test was recorded. Samples were placed in a compression machine with surface contacting plates, as shown in Figure 9.

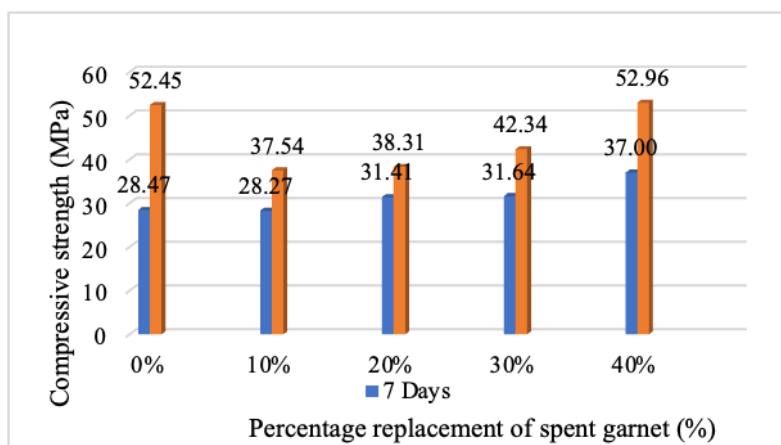
Fig. 12 Comparison of compressive strength at aging day (7 and 28 days)

In Figure 12, demonstrated in the graph, the comparison of compressive strength values at 7 and 28 days reveals significant improvements in the control group (0% replacement) from 28.47 MPa at 7 days to 52.45 MPa at 28 days. With spent garnet replacement, there is a minor decrease at 10% but a consistent increase at 20%, 30%, and 40% replacements, reaching a peak at 40% with 52.96 MPa at 28 days.

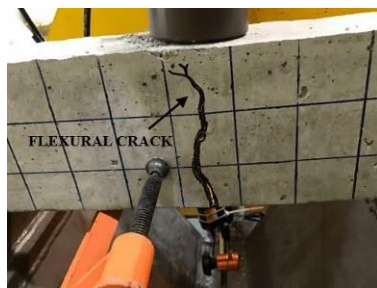
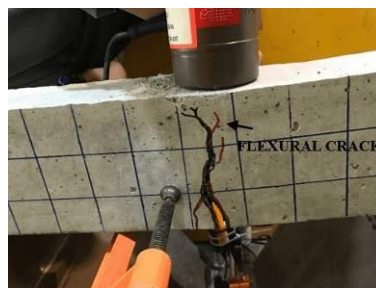
Fig. 17 Crack patterns after first, second and third impacts on RC beam with 20% spent garnet replacing sand

Flexural cracks appeared at the midspan of a reinforced concrete (RC) beam with 20% spent garnet replacing sand when subjected to a 100 kg load, as shown in Figure 16. These cracks worsened with repeated impacts, eventually leading to beam failure, as depicted in Figure 17(c). Interestingly, at 20% replacement, flexural cracks continue to be the predominant feature in the crack pattern. This suggests that the beam's behaviour aligns with conventional concrete mixes, even with a higher percentage of spent

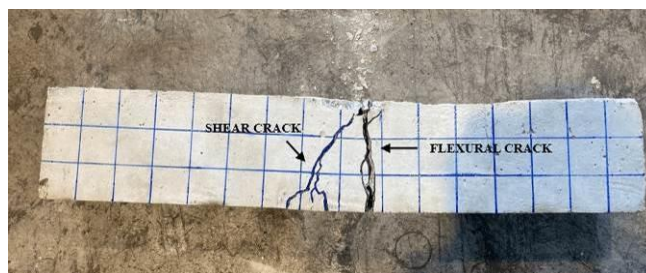
In Figure 18 shows the crack patterns indicating the beam's response to a 30% spent garnet replacement under impact load. Upon reaching a 30% replacement, there is a noticeable shift in crack patterns. Initially, flexural cracks occur during the first and second impacts, reflecting the influence of bending moments on the beam, as shown in Figure 19(a)(b). However, by the third impact in Figure 19(c), flexural-shear cracks emerge, indicating potential changes in the mix's mechanical properties. This shift may affect both flexural and shear resistance mechanisms within the beam.

Fig. 18 Final crack patterns with 30% spent garnet replacing sand

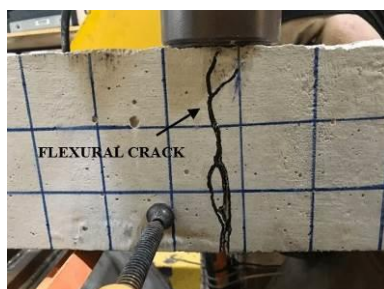
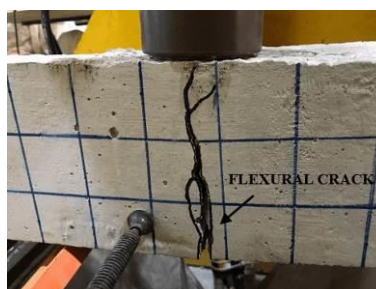
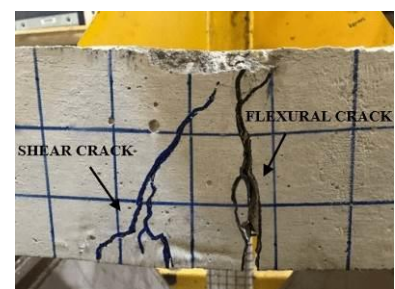
Fig. 19 Crack patterns after first, second and third impacts on RC beam with 30% spent garnet replacing sand
