Structural Evaluation and Root Cause Analysis of Vehicular Box Culvert (VBC) Defects in Section 6A of ECRL Project

This research investigates concrete defects in Vehicular Box Culverts (VBCs) within Section 6A of the East Coast Rail Link (ECRL) project. A significant defect was identified at Culvert 192 (CH384+580), where cracks were found in the top slab and wing wall. The study aims to comprehensively analyze the types and causes of concrete defects in the VBCs within work zone 2 of Section 6A. The methodology involved detailed site visits and inspections of 21 VBCs, documenting defects such as shrinkage cracks, water seepage, and discoloration. The quantitative analysis, presented through bar and pie charts, revealed discoloration as the most frequent defect, with medium severity levels being the most common. Contributing factors to these defects include poor soil compaction, inadequate waterproofing, and substandard construction practices. An AutoCAD 3D model was employed to illustrate loading conditions and their impact on VBC settlement, emphasizing the effects of vehicular loads and soil pressure. The findings indicate that most defects are manageable through standard maint

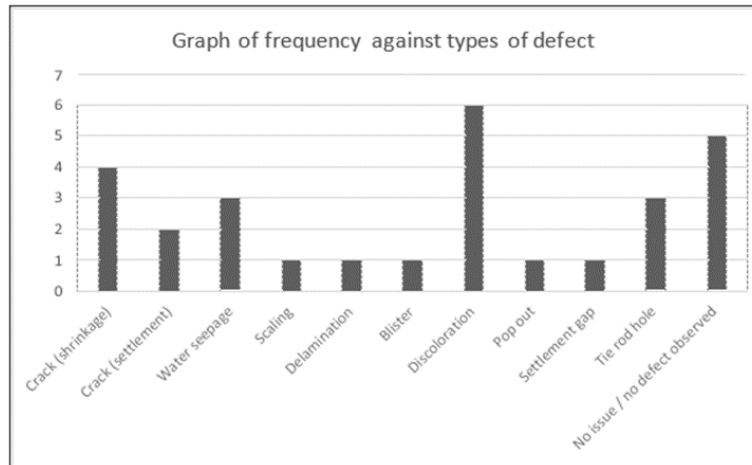
Fig. 5 Bar chart of frequency against types of defect

Fig. 5 shows the bar chart that illustrates the frequency of various types of concrete defects observed in VBC within work zone 2 of section 6A of the ECRL project. The x-axis represents different types of concrete defects, while the y-axis shows the frequency of these defects, measured in numbers (Nos). From the bar chart, several key observations can be made. The most frequently observed defect is discoloration, with a count of six instances. The category of "no concrete defect observed" is the second most common, with a frequency of five. Shrinkage cracks

were noted four times, while both tie rod holes and water seepage were recorded three times each. Settlement cracks occurred twice, and scaling, delamination, blistering, pop out, and settlement gaps were each observed once. These observations highlight the variety of defects that can occur in concrete structures, even within a single project section. The trends observed in the bar chart suggest that certain defects, such as discoloration, are more prevalent in the VBCs of section 6A. This could be due to several factors, including the use of calcium chloride as an admixture, intended to accelerate the setting time of concrete, often leads to uneven color distribution according to article from Portland Cement Association (2001).

In the context of the ECRL project, varying amounts of calcium chloride across different batches of concrete might have caused significant discoloration issues, particularly if the admixtures were not properly mixed. Additionally, variations in the alkali content of the cement used can react with other components in the concrete mix, leading to surface discoloration. High alkali content, common in large-scale projects where materials are sourced from different suppliers, could contribute to this defect. Proper curing practices are essential to maintain uniform moisture levels in concrete, yet inadequate or inappropriate curing methods, such as insufficient water curing or premature drying, can lead to surface discoloration. Furthermore, the presence of a wet substrate or base on which the concrete is poured can lead to uneven moisture distribution, impacting the hydration process of the concrete at different rates across the surface. This issue is particularly relevant in large-scale projects like the ECRL, where site conditions can vary significantly. Inconsistent water-cement ratios during mixing or at different stages of the pour also contribute to color variations. This inconsistency can be exacerbated by the sheer scale of the project, where multiple teams and equipment are involved in concrete mixing. On the other hand, more serious structural defects like settlement cracks and delamination are less frequent but still present and significant.

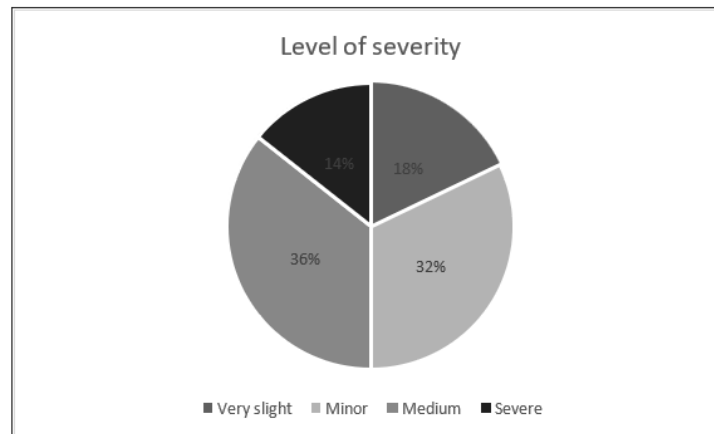
Fig. 6 Pie chart of severity level

The percentages of severity level are illustrated into pie chart as shown in Fig. 6. The categories shown in the pie chart are the severity levels which are very slight, minor, medium, and severe. The units of measurement are percentages based on the frequency of each severity level occurrence. The pie chart reveals several key insights into the severity levels of the observed defects. The severity level with the highest percentage is medium, accounting for 35.71% of the defects. This is followed by minor severity at 32.14%, very slight at 17.86%, and severe at 14.29%. These observations indicate that the majority of defects fall within the medium and minor severity levels, with severe defects being the least common. The proportions observed in the pie chart likely exist because each VBC exhibits different types and extents of defects, leading to varying severity levels. Medium and minor severity levels are more common, whereas severe defects, although present, are less frequent. The majority of the defects in the VBCs of work zone 2 of section 6A of the ECRL project fall within the medium severity level, which accounts for 35.71% of the observed defects. Several factors contribute to this predominance.

Firstly, medium severity defects such as shrinkage cracks, water seepage, and tie rod holes are relatively common in concrete structures due to typical construction processes and environmental conditions. Shrinkage cracks, for instance, occur as concrete dries and hardens, a natural phenomenon influenced by the total water content and environmental conditions like temperature and humidity. Similarly, water seepage can result from poor waterproofing practices or wear and tear over time, leading to water penetrating through small cracks or gaps. Tie rod holes are another frequent issue, as they result from the removal of formwork rods, leaving holes that can develop into defects if not properly filled and maintained. These types of defects, while impactful, do not critically compromise the structural integrity of the VBCs, categorizing them as medium severity. They are more serious than minor defects, which are typically aesthetic, but they do not pose immediate health or safety risks like severe defects. The prevalence of medium severity defects suggests that while there are notable issues, they are primarily manageable through standard maintenance and repair practices. This implies that the construction quality is generally acceptable, but there are areas needing improvement to prevent these medium-level issues from escalating. Understanding which severity levels are most and least frequent helps in assessing the overall condition of the VBCs in work zone 2 of section 6A of the ECRL project. The predominance of medium and minor severity defects suggests that while there are issues to address, the majority are not critically severe. This can guide maintenance and repair efforts, prioritizing areas that require more immediate attention due to severe defects.

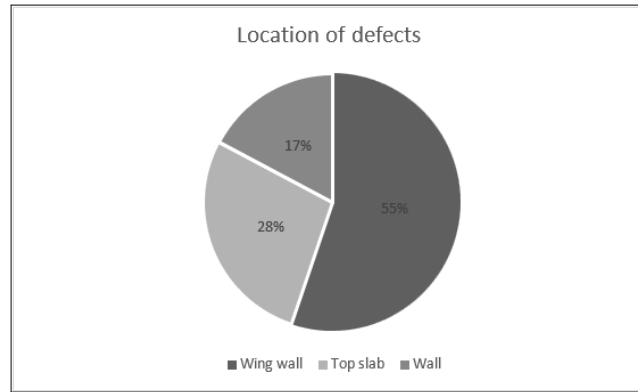
Fig. 7 Pie chart of defects location

Fig. 7 shows the percentages for location of defects, separated into three locations or components of VBC which are wing wall, top slab and wall. The units of measurement are percentages based on the frequency of defects occurring in each location. The pie chart reveals several key insights into the locations of the observed defects. The component with the highest percentage of defects is the wing wall, accounting for 55.17% of the total observed defects. This is followed by the top slab with 27.59%, and the wall with 17.24%. These observations indicate that defects are more commonly found in the wing wall compared to the top slab and wall. The proportions observed in the pie chart likely exist due to the specific structural and environmental conditions each component is exposed to. The wing wall, having the highest percentage of defects, might be more prone to issues due to several key factors. Firstly, the wing wall is more exposed to environmental conditions compared to the top slab and wall. Being positioned externally, the wing wall faces direct exposure to weather elements such as rain, wind, and temperature fluctuations. This constant exposure can lead to increased wear and tear, making the wing wall more susceptible to defects like discoloration, scaling, and cracking due to thermal expansion and contraction. Additionally, the design of the wing wall structure for the VBCs in the ECRL project does not incorporate reinforcement bars. The absence of reinforcement can reduce the structural resilience of the wing wall, making it more prone to cracking and other forms of damage under load-bearing conditions. Reinforcement bars are crucial for distributing stress and enhancing the tensile strength of concrete, and their absence can lead to a higher incidence of defects. Moreover, the wing wall often bears significant load-bearing responsibilities, supporting not only the weight of the soil and infrastructure above but also any lateral forces exerted by the surrounding environment [18]. This additional stress can exacerbate defects, particularly in the absence of reinforcement.

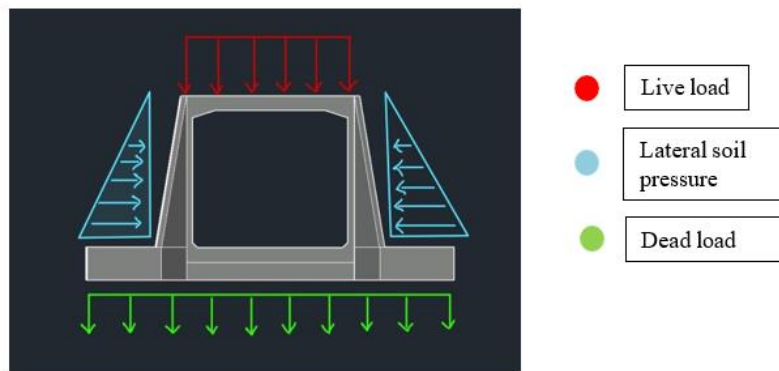
Fig. 8 Illustration of different types of loading on VBC using AutoCAD

Settlement gaps, found in VBC G, occur due to the settlement of the formation under the VBC, similar to settlement cracks, caused by poor compaction and the soil's geotechnical properties, resulting in shifts in VBC components and creating gaps between them. The settlement of the VBC in work zone 2 of section 6A of the ECRL project can be attributed to various types of loading applied to the structure, including dead load, live load, soil pressure on the side walls, surcharge due to live load, and uniform lateral load on the side walls as shown in Fig. 8. The dead load consists of the self-weight of the VBC structure, including the embankment and deck slab, exerting continuous pressure on the foundation. This can lead to gradual settlement over time, especially if the underlying soil is inadequately compacted or has poor load-bearing capacity. The weight of the embankment, deck slab, and track load are considered as uniformly distributed loads on the top slab, with the uniform soil reaction on the

bottom slab further adding to this load. Inadequate support or variations in soil reaction can cause uneven settlement [18].

Live load, as calculated according to IRC 21-2000, considers the contact area of vehicle wheels or tracks and their dispersion along the traffic direction. If load dispersion overlaps due to miscalculations, it can cause concentrated loads, leading to localized settlement if the soil cannot uniformly support these pressures. The self-weight of the side walls acts as a concentrated load, producing a uniform soil reaction on the bottom slab. Variations in soil properties or poor compaction beneath the side walls can lead to differential pressure distribution, resulting in uneven settlement [18]. Earth pressure on the vertical side walls, calculated using Coulomb's theory, is based on the coefficient of active earth pressure, soil density, and the height of the culvert. This earth pressure can exert significant lateral forces on the side walls, and any changes in soil properties or the presence of voids or weak layers can lead to differential settlement. Uniform lateral pressure on the vertical side walls, resulting from embankment loading and live load surcharge, can also contribute to differential settlement if the pressure is not uniformly distributed or if the soil beneath lacks adequate bearing capacity [18].
