# Haji Muhammad Yassin Mosque Building Inspection using Unmanned Aerial Vehicle (UAV)

Muhammad Syakir Subli<sup>1</sup>, Abd Sukor Sarif<sup>1\*</sup>

<sup>1</sup> Department of Civil Engineering Technology, Faculty of Engineering Technology  
Universiti Tun Hussein Onn Malaysia Pagoh Campus, Pagoh, Muar, 84600 Johor, Malaysia

DOI: <https://doi.org/10.30880/peat.2024.05.02.059>

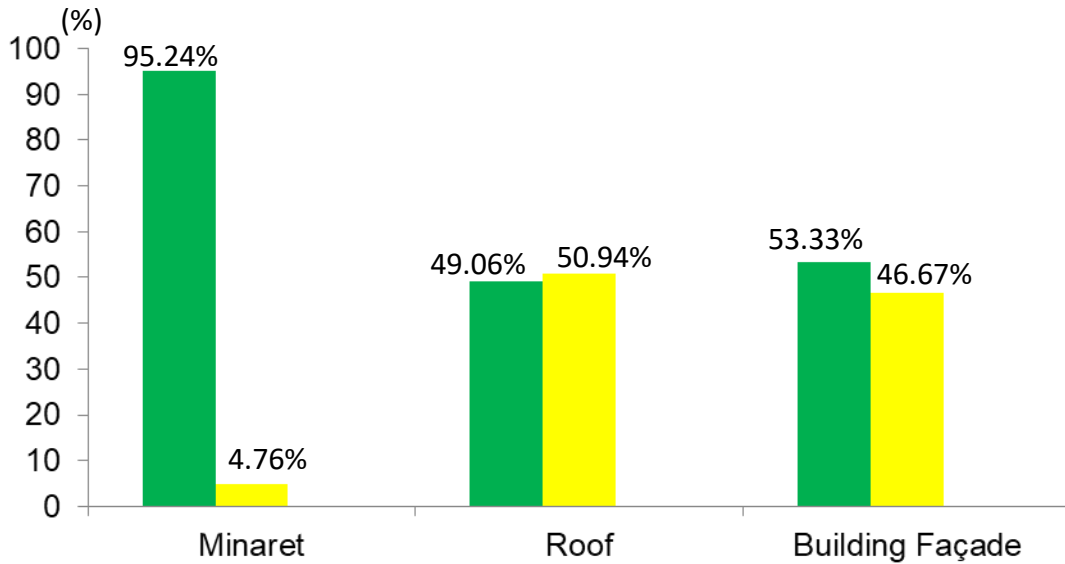
**Bar graph 1** Summary of CSP 1 Matrix result.

The result from the CSP 1 Matrix will shows the overall building health condition of Haji Muhammad Yassin Mosque. Out of 89 data analyzed, 54 of the data colored in green while the other 35 data colored in yellow. There is no red colored for this inspection. The green colored is 60.67% while the yellow colored is 39.33%. The green colored shows more than half of the total image. The total score for this building is 4.303. This shows that the overall building condition of Haji Muhammad Yassin Mosque is in a good condition. But there is a few defect that on the high yellow alert, such as in image number 60. Fast action need to be made before that defect will become much worst. Bar graph 1 shows the summary of CSP 1 Matrix result for each part of the mosque. Based on the bar graph, at the minaret 1/21 (4.76%) is yellow and 20/21 (95.24%) is green. The overall condition for the minaret is good because majority of the building defect is green. Next for the roof, 27/53 (50.94%) is yellow and 26/53 (49.06%) is green. This shows the roof needs condition monitoring because half of the building defect is yellow. So the roof need a serious attention. Finally is the building façade, 7/15 (46.67%) is yellow and 8/15 (53.33%) is green. The overall building condition for the building façade is good because the green is more than half the percentage. But it's still need a condition monitoring.
