# Modal Analysis of Corrugated Plate by Finite Element Analysis

Sakhiah Abdul Kudus<sup>1\*</sup> Kunitomo Sugiura<sup>2</sup>

**Abstract:** The use of corrugated steel plates as part of a bridge structure has received worldwide acceptance. Corrugated steel plates are widely utilized as web members of bridge girders for pre-stressed concrete bridges. In the lifetime of such a structure, performance and stability will degrade due to the effects of many factors. This process is usually accompanied by the development of corrosion and loss of thickness in the affected region. This paper aimed to study the vibration characteristics of corrugated web and flanges of bridge girder undergoing corrosion and loss of section problem. The finite element analysis utilizing ABAQUS CAE software has been adapted to model and solve this problem. First, the baseline model of undamaged and healthy corrugated plate was modelled to determine its natural frequency and mode shape. The baseline model results were further used to compare with the damage model. The size of the damage area was fixed, while the position, orientation, and depth of loss of thickness varied for different damage cases. A signifi

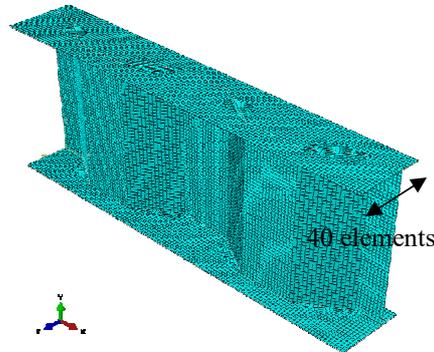
The material properties of steel considered in this study are: density = 7850 kg/m<sup>3</sup>; Poisson's ration = 0.3; and Young's modulus, E = 210 GPa. The flanges and corrugated web are meshed using S4R elements, four node conventional shell elements with reduce integration. The uniform size of elements with 0.01m was set for the whole model, which means 1 element in the thickness direction. Fig. 4 show details meshing of intact model. The boundary condition was set as the simple support of all edges of a corrugated web bridge girder. Translations in the x, y and z directions were restrained.

Fig. 4 - Meshing of bridge girder corrugated web

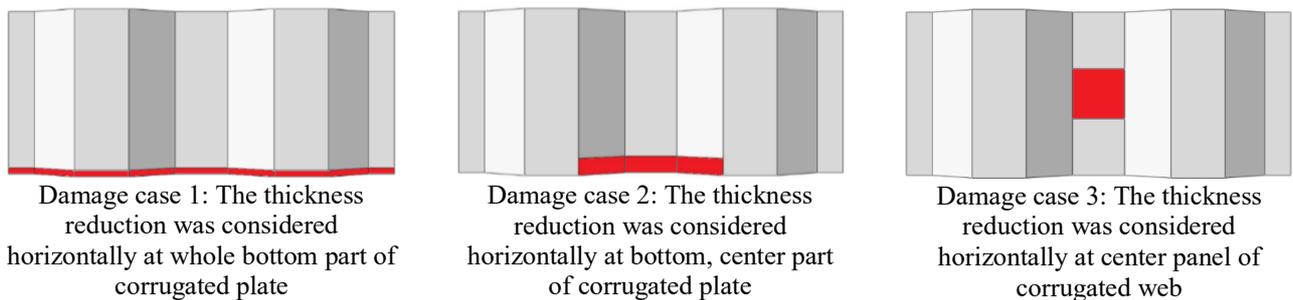
In this study, six damage cases were numerically simulated in web members. Damage was varied in terms of both orientation and position. There are three scenarios of horizontal damage orientation and another three scenarios of vertical damage orientation with three different level of cut depth. The damaged area was modelled by decreasing its flexural stiffness. Reduction of flexural stiffness was achieved by reducing the thickness of elements in damaged region. The damage area, which is 3.85% of the corrugated web area, was set constant for all 10 damage cases. Detailed descriptions of damage cases scenarios and specified regions are shown in Fig. 5 and Fig. 6.

Fig. 5 - Distribution of thickness reduction of corrugated web plate in horizontal orientation

The horizontal damage orientation in this study is to indicate corrosion problem of this structure. Normally, the bottom part of a structure suffers more due corrosion because this part is highly contaminated with chloride, air-borne salt and salinity which cumulated on structure surface and been wash away especially during rainfall and at the end, its stuck in this lower section region cause significant deterioration in this part. On the other hand, vertical or longitudinal damage orientation was simulated to indicate poor connections between the two adjacent sides of plate panel in the corrugation section.

The thickness of corrugated web, which is 10mm for the baseline model, was reduced to 7.5mm to indicate 25% thickness reduction in the specified damaged region, with 5.0mm for 50% thickness reduction and 2.5mm for 75% thickness reduction. Variation in thickness reduction was used to represent the level of severity of damage, where higher thickness reduction shows that the affected area is severely damaged.

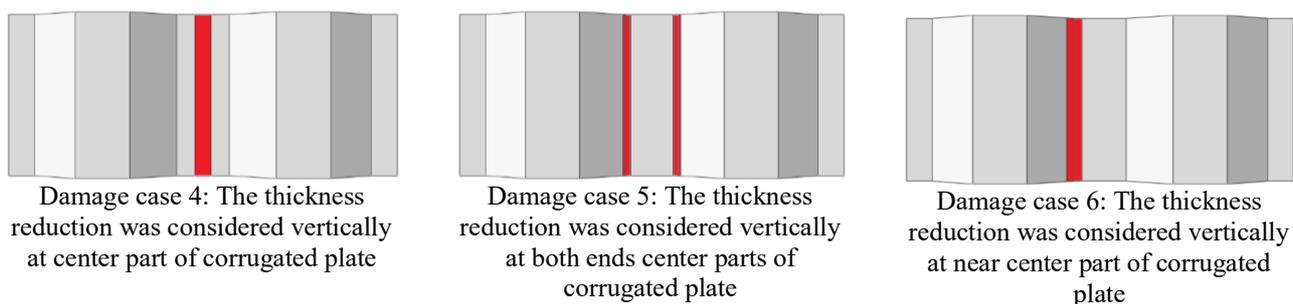
Fig. 6 - Distribution of thickness reduction of corrugated web plate in vertical orientation

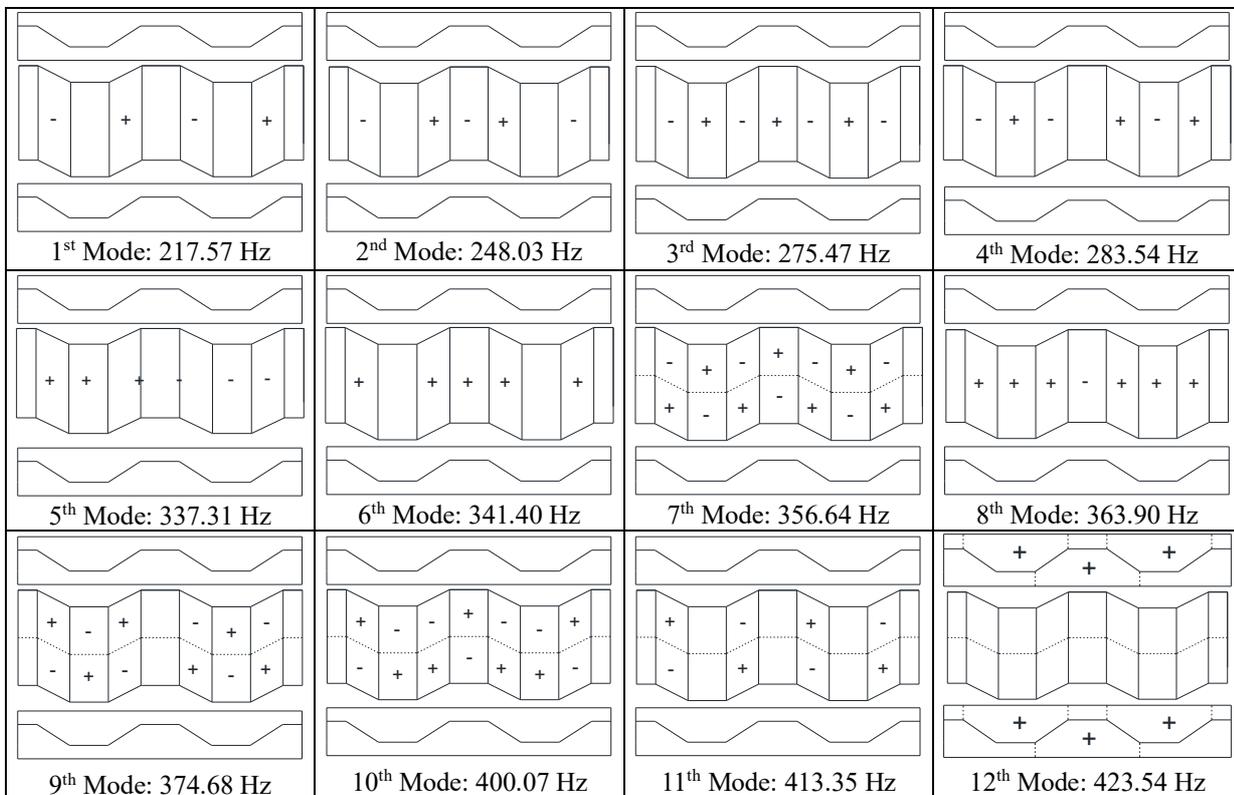
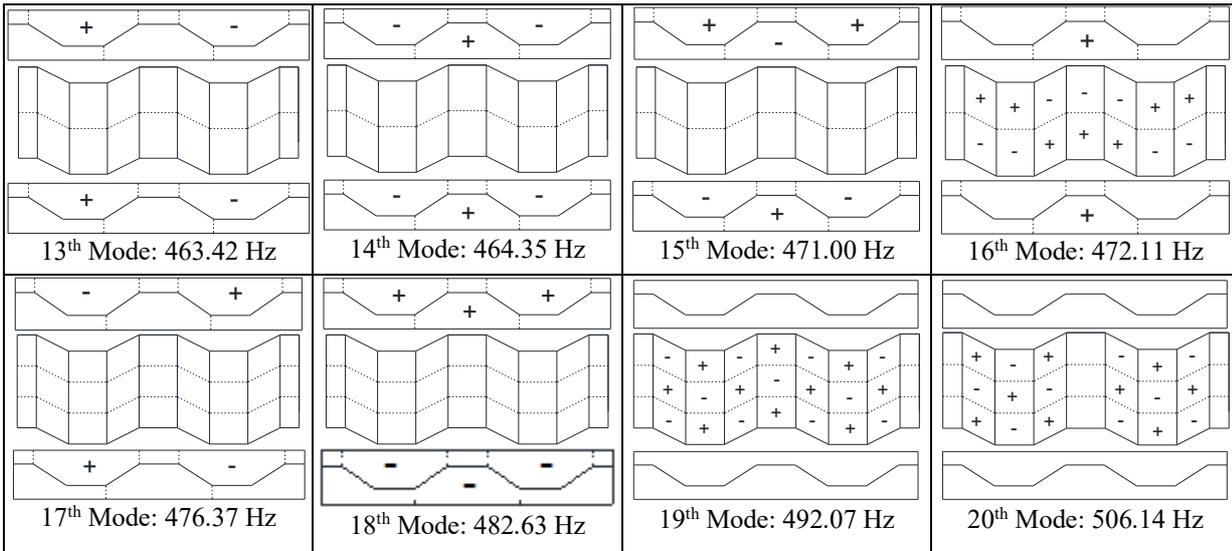
In the first mode, the vibration occurs in four alternate plate panels and no vibration occurs in another three-plate panel together with end section of corrugated plate. The vibration caused this alternate plate to move up and down independently, separated by nodal lines for each plate panel. In the second mode shape, there is an additional panel vibrated as compared to the 1st mode, where the additional vibration was observed in the middle of corrugated web with just a small amplitude of vibration. In the third mode, all the plate panel of corrugated web vibrate independently up and down in out of plane deformation with almost the same amplitude. The nodal line can be clearly observed in the 3rd mode, where a nodal line acts as a boundary to distinguish the vibration of each plate panel. On the other hand, the vibration of mode 4 is dominant at both ends and near the center region of the corrugated web. There is no vibration observed in middle panel of corrugated web plate. In mode 5th, the vibration pattern switches a little bit, where the maximum amplitude points from the center plate panel changes to its boundary line. In this mode, the highest amplitude of vibration is located in the second plate panel from both ends.

**Fig. 7 - Mode shape and natural frequency of intact model**

Whereas in sixth mode, the maximum amplitude point was located at the center of corrugated web section and there is also small amplitude of vibration in another four adjacent panels. In the 7th mode, the corrugated web was divided into 14 distinct part and each of this part vibrate independently with three plate panel in middle region vibrate with higher amplitude. The vibration pattern almost the same until mode 11. In contrary, in mode 12, the vibration starts to become dominant in both flanges, with no vibration observed in web section. The flanges move up and down in the marked region. The same vibration pattern was observed from mode 12 to mode 18, where the vibration dominant in flanges part and the amplitude of vibration in web is almost zero except for mode 16. In that mode there is higher amplitude of vibration in the center of web. In mode 19 and 20, no vibration take place in flange part and the vibration is dominant only in web region. The nodal line divided corrugated web into 21 distinct regions, in which each plate panel has three independent vibration patterns. The vibration mode shape provide user understanding of right position to placed exciter and receiver for monitoring purpose. User should avoid location where there is no occurrence of vibration and as in this case, the flange region should be avoided since there is no vibration observe in flanges part. Mostly, the vibration dominant in the corrugated web. The presence of damage in the structure will cause alteration in the mode shape, causing deflected mode shape curvature in the damage region.

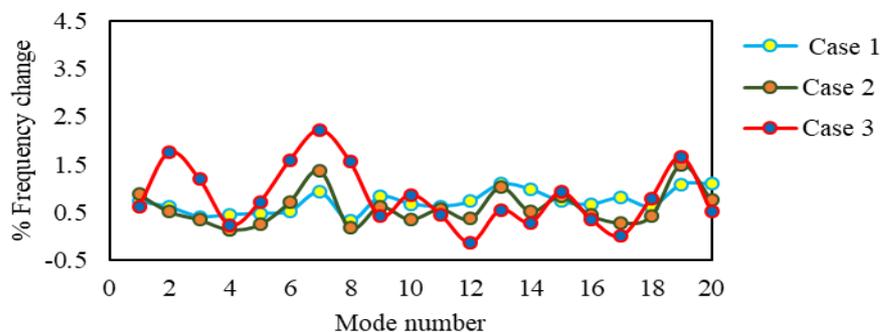
Fig. 8 shows graph of percentage of natural frequency reduction due to 25% of thickness reduction in damaged region. In the first fundamental mode, the frequency change does deviate a great deal between each case and there is less than 0.9% frequency deviation observed in this first mode. The following mode does not show any drastic frequency change. The introduction of 25% of thickness reduction does not give much deviation of natural frequency from baseline model. A clearer observation of frequency change was expected in more severe and large damage cases, indicating a higher percentage of thickness loss.

**Fig. 8 - Reduction of natural frequency for first 20 modes due to 25% thickness reduction in horizontal damaged cases**

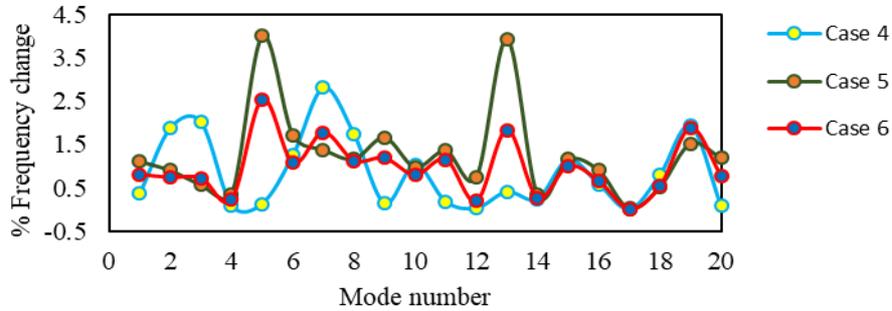
The switch of natural frequency due to cut-off of 25% thickness in vertical damaged orientation is discussed in Fig. 9. From the results obtained, damage case 5 shows the highest frequency change, mainly in mode 5 and mode 13 with values of 4.01% and 3.95%, respectively. The location of damage case 5, which is located at both ends of the

center plate panel, was the main factor causing the higher frequency change since this location is dominant vibration spot in corrugated web based on deflected mode shape for damage case 5.

**Fig. 9 - Reduction of natural frequency for first 20 modes due to 25% thickness reduction in vertical damaged cases**

Above all, the vertical damage orientation has a higher impact on the corrugated web for 25% of thickness reduction although the affected region area is same for vertical and horizontal damage orientation. This shows that the position of damage and its orientation do contribute to alteration of natural frequency.

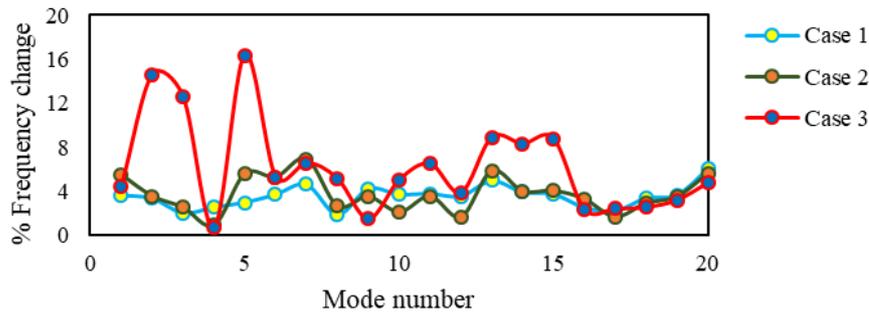
The greatest deviation of mode shape was expected to occur around the damage region and this information is valuable information for user to locate the location of damage in structure [10]. Fig. 10 graphically depicts the deviation of natural frequencies for 75% thickness reduction. In this case, damage case 2 contributes to dominant case of natural frequency change, with the highest mode deviation is observed in the mode 7. Mode 14 does not show significant alteration in frequency for damage case 3, since the location of damage in this mode was located in a passive region where no vibration is observed.

**Fig. 10 - Reduction of natural frequency for first 20 modes due to 75% thickness reduction in horizontal damaged cases**

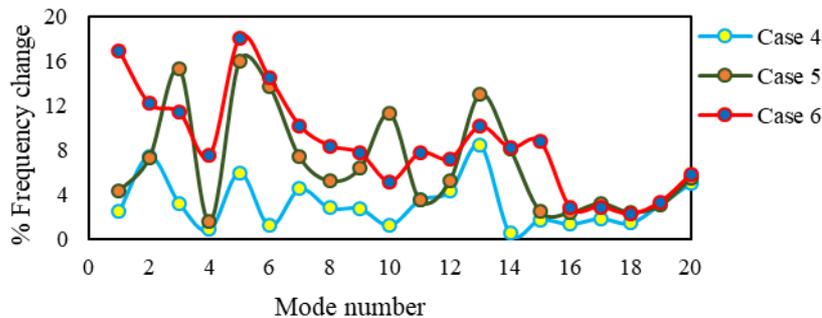
Fig. 11 indicate the graph reduction of natural frequency for first 20 modes for 75% thickness reduction in designated vertical damaged cases. From the observation, the existence of damage case 4 does not give significant effect on the integrity of a corrugated web, even for cases of higher severity at 75% thickness loss. This was related to position of damage case 4 which located in passive region where there is less and almost zero shape of vibration. Thus, the presence of this damage does not cause significant changes in either natural frequency and mode shape of the corrugated web.

**Fig. 11 - Reduction of natural frequency for first 20 modes due to 75% thickness reduction in vertical damaged cases**
