Roof Inspection Using Drone at Melaka Islamic Museum

Khairi Supar^{1*}, Sheikh Mohamad Naqib Sheikh Ismail¹, Muhammad Azammudin Azmi¹, Ariff Izzudin Jafri¹, Mohamad Azim Mohammad Azmi¹, Hairuddin Mohammad¹, Siti Khalijah Yaman²

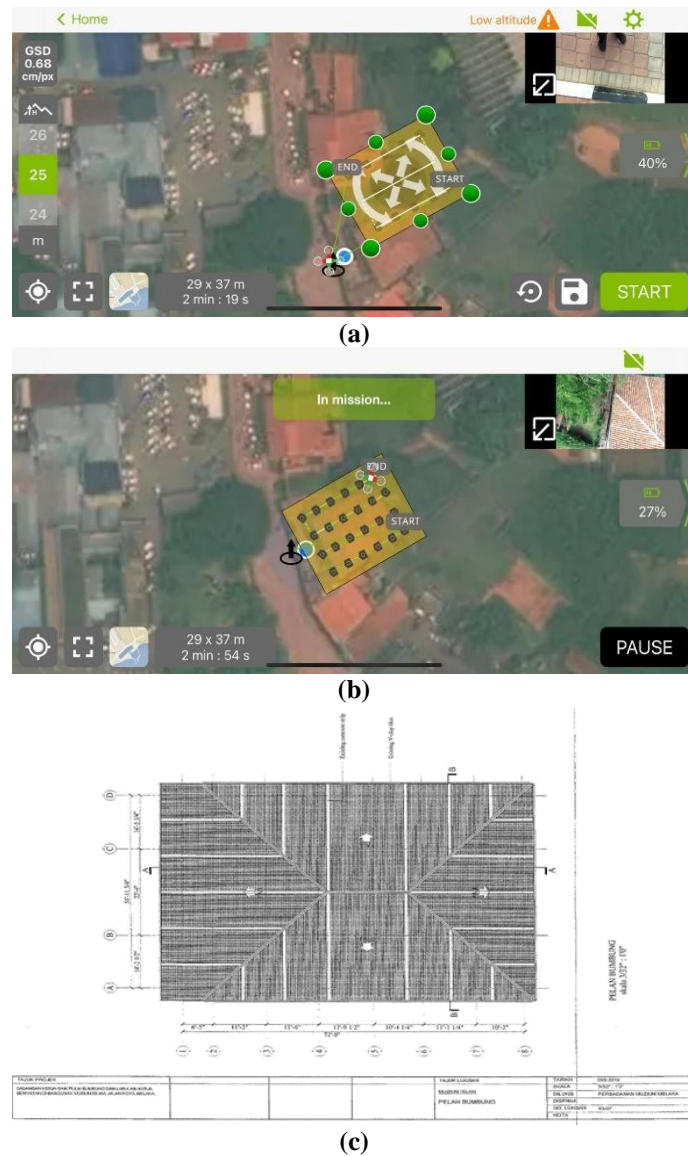
Fig. 1 (a) Area taken from the roof (b) Drone's route on the roof (c) Roof plan

DJI Phantom 4 Pro was being calibrated using the DJI Go software to make sure it was stable and accurate before launch. Then link the UAV with Pix4DCapture and state the area that needs to be inspected, which is the roof of the Melaka Islamic Museum as shown in Fig. 1. The images that have been captured from the drone are combined into full images of a roof and converted into a drawing using AutoCAD software. Every image was processed and analyzed using sections divided into grids as shown in Fig. 1(b). To gain a clearer image of any damage occurring, a more extensive study is undertaken at any defective or defective spot.

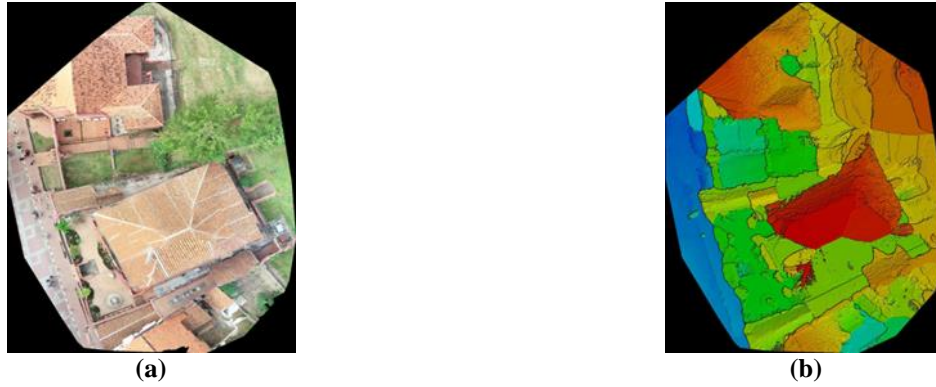
Fig. 2 (a) Orthomosaic and (b) the corresponding sparse Digital Surface Model (DSM) before the densification

The site shot must be converted into an image version through a further step to effectively portray the roof construction fault. The first step in this procedure is to upload the photos as a single image to Pix4DMapper, where it can be viewed for defect identification. The image needed to be zoomed in to show the defect, and the brightness and contrast were adjusted to improve the image's outcome. The time to fly the UAV at Islamic Museum Melaka is 3 minutes while the altitude to fly the UAV for the museum is 30 meters. Fig. 2 shows the result of the roof image processing using the Pix4DMapper application of Orthomosaic and the corresponding sparse Digital Surface Model (DSM) before densification.
