The Improvement on the Visual Painting Inspection Process Flow of Train for Kuala Lumpur Additional Vehicle (KLAV) 27 Project

Abstract: The project is based on an ongoing Bombardier-Hartasuma Consortium Project, which is Kuala Lumpur Additional Vehicle (KLAV) 27. The problem that occurred in the project is the delay in train delivery to the client that is due to the multiple detail inspection stages and the facility could not provide enough lighting. This project is using DMAIC methodology. This project is applicable to exterior of the train area when performing visual and functional inspectional inspection by using 400 ±20% lux needed. The project aims to prevent project delay and extended work by improving the inspection process flow for train production by analyzing standard acceptance criteria and providing guidelines for visual, safety, and functional inspectional will help shorten the process and reduce time-consuming inspection. Implementing the Rig Platform also will shorten the inspection flow, ensuring no delays and extended work due to multiple stages. At the end of this project, there will be no delay and extended work due to the multiple stages of inspection process.

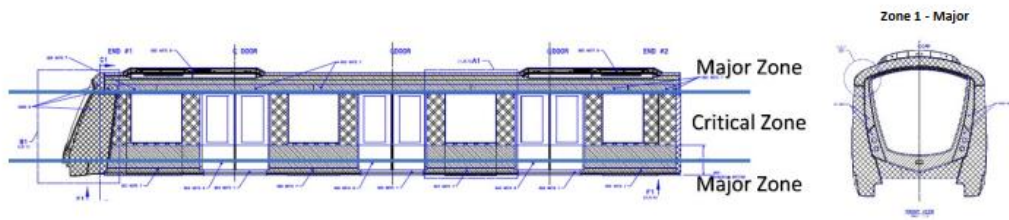
Figure 1: Zone definition [4]

Zone	Description
1	Critical	Visible from a passenger standpoint within one meter
2	Major	Visible from a passenger standpoint below 60cm and above 2.5m (from top of rail)
3	Minor	All non-visible surfaces (including undercar & car)

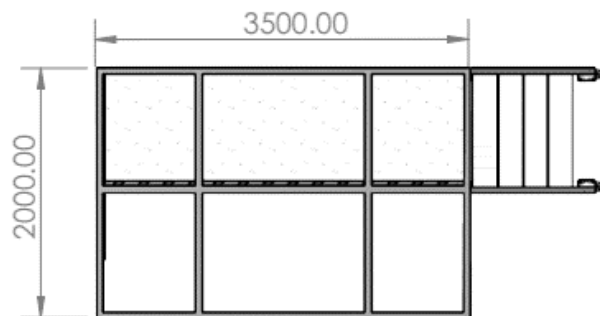
Figure 2: The Rig Platform in top view.

Rig Platform is the platform that is used during the inspection process of exterior surface. This platform is used to make sure the lux needed is enough to support according to the guidance of Quality Product Specification (QPS).

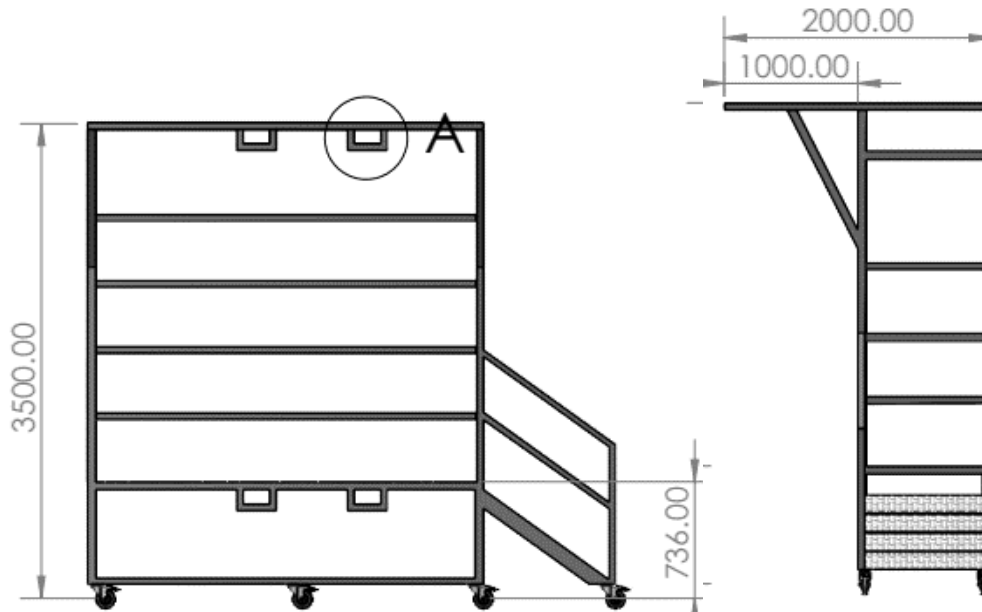
Figure 3: The Rig Platform in front views

Figure 4: The Rig Platform in side views

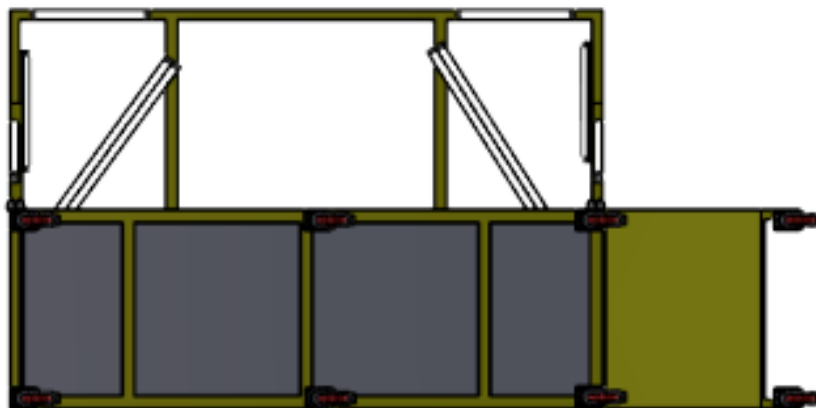
Figure 5: The Rig Platform covered by curtains in top views

The final design of Rig Platform is covered by curtains to prevent over lighting from the outside. Figure 5,6 and 7 below shows the Rig Platform covered by curtains.

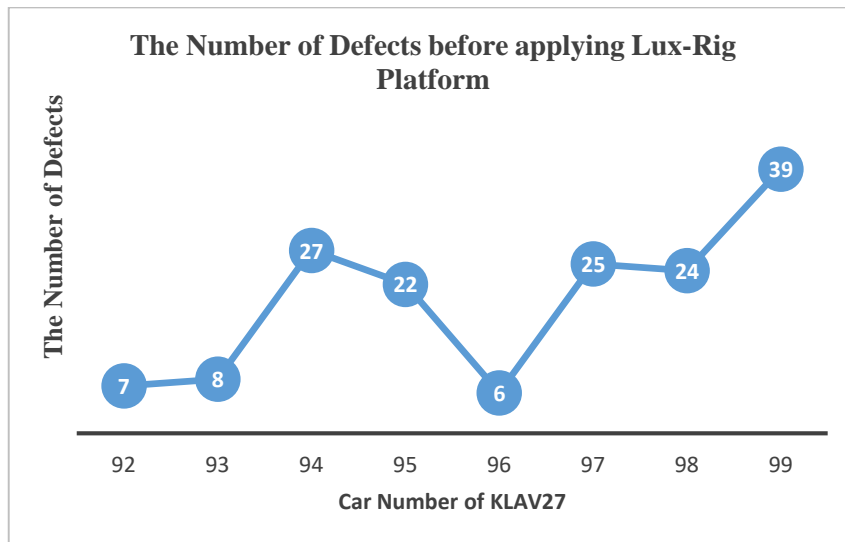
Figure 9: The number of defects before implementing Rig Platform

Figure 9 above shows the data on KLAV27 train for car 92 to 99. The data in Figure 9 shows that the minimum number of defects is 6 while the maximum number of defects is 39. The average number of defects before implementing the Rig Platform is 20. Figure 10 above shows the data on KLAV27 train for car 27 to 35. The data in Figure 10 shows that the minimum number of defects is 2 while the maximum number of defects is 8. The average number of defects after implementing the Rig Platform is 5.

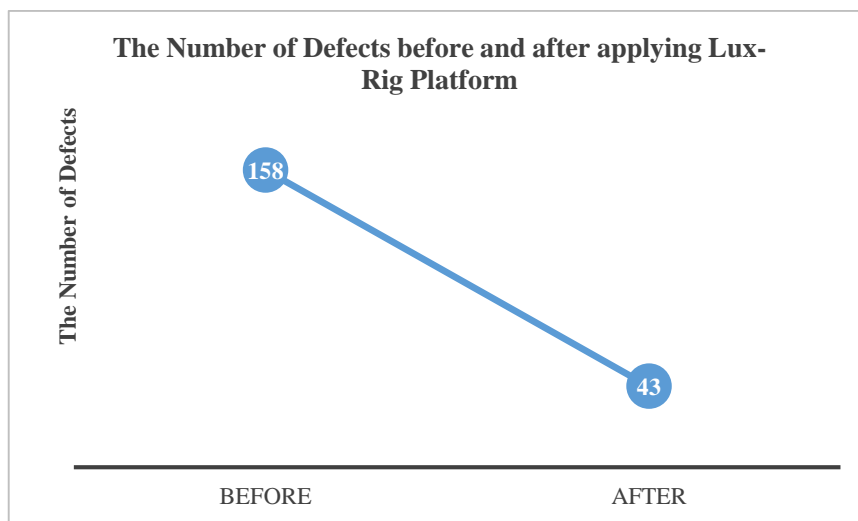
Figure 11: Comparison before and after implementing the Rig Platform

From Figure 11 above, there are many differences between before and after implementing the Rig Platform. The total number of defects before is 158 compared to after implementing the Rig Platform only 43. The Lux-Rig Platform significantly impacts the inspection process by making it smoother and more efficient. The implementation of the platform reduces delays and provides lux that the company cannot provide. It also helps staff adhere to Quality Product Specifications (QPS), preventing errors and higher costs for repairs. The platform's appearance and implementation significantly impact the inspection process, reducing the number of defects and ensuring a more accurate and efficient inspection process.

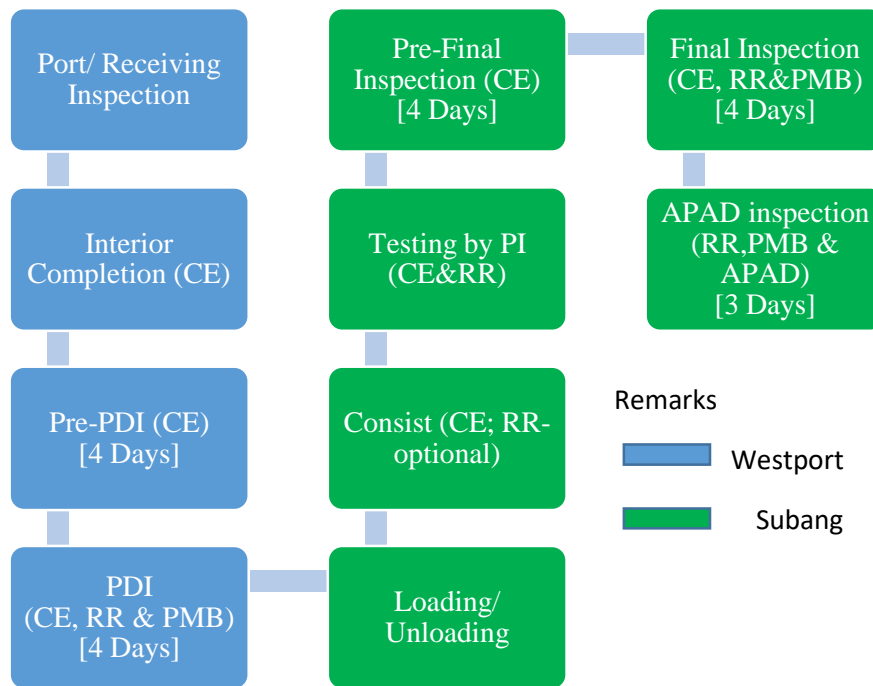
Figure 12: Current inspection process flow [4]

The current inspection process flow has few challenges, which mismatch of inspection alignment between Alstom (Bombardier) and employer. In examples, the paint issue, cosmetics, etc. the multiple detail inspection stages, which not benefit and not value add that cause of 19 days of inspection process taken from start until the handover. This is taking a longer time, which can cause delays.

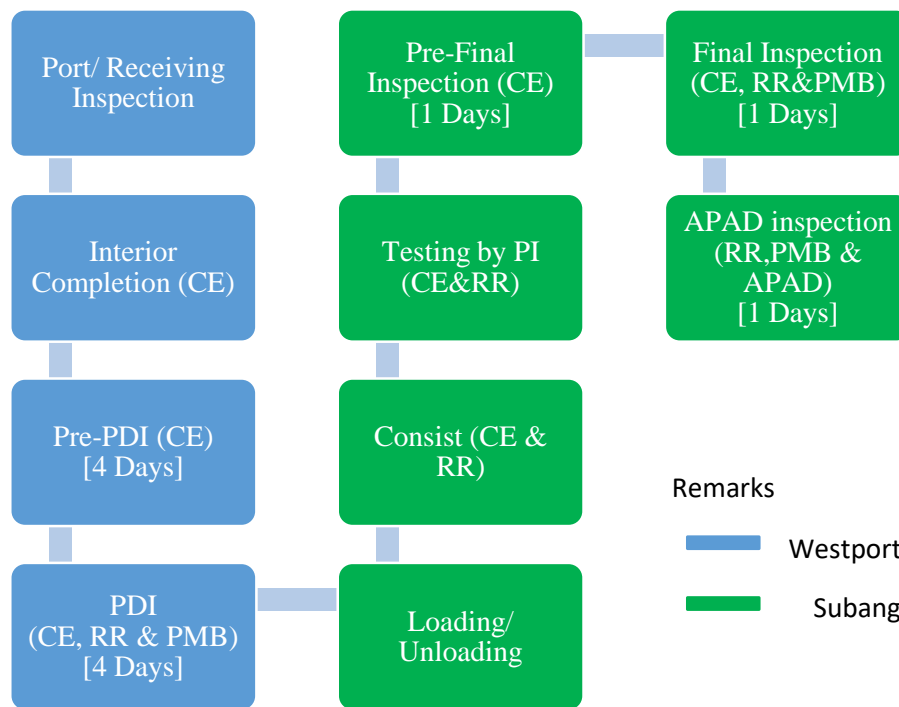
Figure 13: New inspection process flow

The advantages of this new KLAV27 inspection process flow is that the examination will be more thorough at Westport and that an overview inspection will be conducted at the depot before the area being demolished, which is more efficient. If any discovery at Westport required material from AME, Alstom had enough time to seek the material and resolve any issues as soon as possible before handover. So, the overall inspection day will be taken only eleven days till the handover.
