Corrosion Under Insulation (CUI) Monitoring: Prediction of CUI Using Electromagnetic Wave

Clement Yong Vun Kiat¹, Azzura Ismail^{1*}

¹Faculty of Mechanical and Manufacturing Engineering,
Universiti Tun Hussein Onn Malaysia (UTHM), Parit Raja, Batu Pahat, Johor,
86400, MALAYSIA

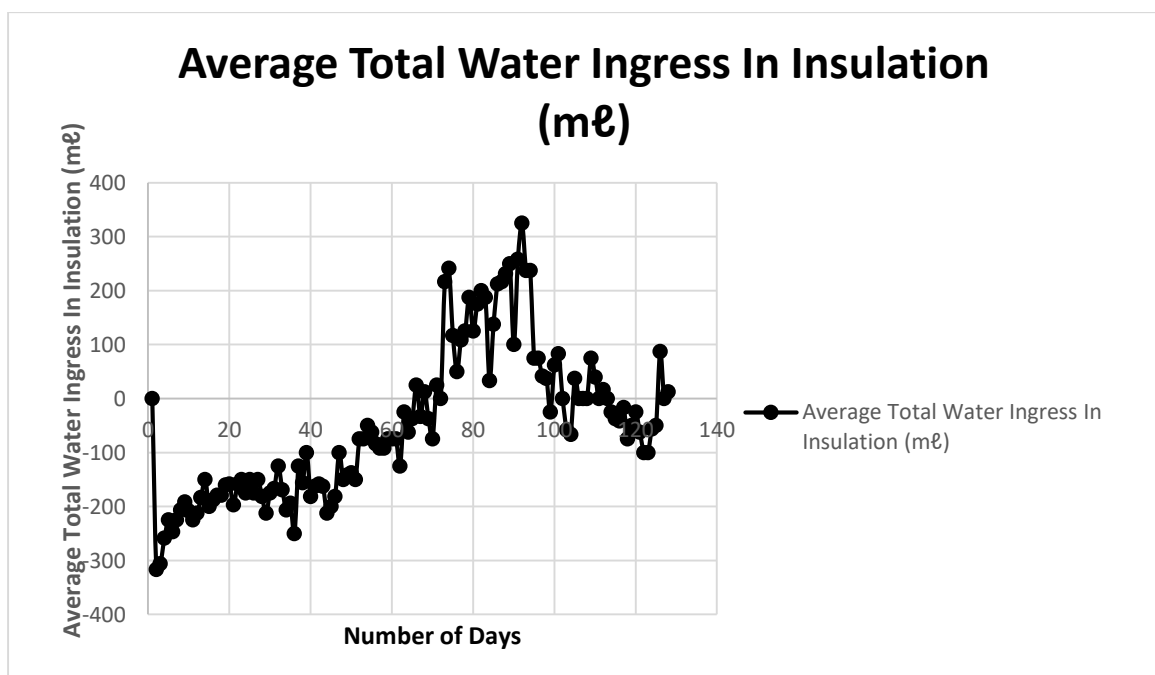
Figure 3 showed the graph of the amount of water ingress in insulation through 128 days observation, while Table 1 showed the data of relative humidity, temperature, CUI rate, and maximum total estimated wall loss. The explanation and analysis of data will be explained in subtopic 3.2.

Figure 3: Average total water content in insulation (mℓ) for 128 days observation

Based on Figure 3, the average total water ingress in insulation slowly shifted from negative towards positive, with an average value of -50.25 ml. The slow increase of reading was due to the rainy season, as more water molecule sipped into the insulation layer. Next, the reading from the three humidity sensors were higher than the average humidity based on [9], which was between 74% to 86%. The reason was because moisture was trapped in the insulation layer and not able to escape to the environment. Also, there were relationship between water content in insulation and humidity level. Redox process took place between water and carbon steel, in the presence of humidity. The CUI rate showed the reading of 0.36mm/year and was calculated based on [10]. This reading may be taken as future reference for offline insulated pipe. For the reading of maximum total estimated wall loss, the study has recorded a wall thickness reduction of 0.47mm over 128 days observation. This reading was then verified by conducting ultrasonic test.

The main findings of the study were concluded where the average amount of water ingress in insulation for an offline insulated pipe was -50.25 ml. The study also discovered that for an offline pipe, it has a CUI rate of 0.36mm/year and maximum total estimated wall loss of 0.47mm through 128 days observation. The presence of humidity also allowed uniform corrosion to occur. The pipe setup may be done in a lab, where temperature, humidity, and the addition of some heat source flow may be done to simulate the industrial environment and process in future work.
