Defect Size Comparison Using Infrared Thermography Method and Actual Measurement On Glass Fiber Reinforced Polymer

Abstract: Three types of specimens have been inspected using Infrared thermography, one of the specimens is perfectly patched without any defect in the specimen, and the remaining two specimens have defects during patching. The active infrared thermography approach is used by using a heat gun on the surface of the specimen at a temperature of 200°C. The thermal image for specimen B1 shows no defect occurring while specimens B2 and B3 show defects in the specimen. The defect dimension in the thermal image is measured using ImageJ software after being analyzed in FLIR Tools software. The surface of the specimens have been ground to reveal the defect and actual dimension have been measured for comparison. The result of the comparison dimension defects were being analyzed and explained in this study.

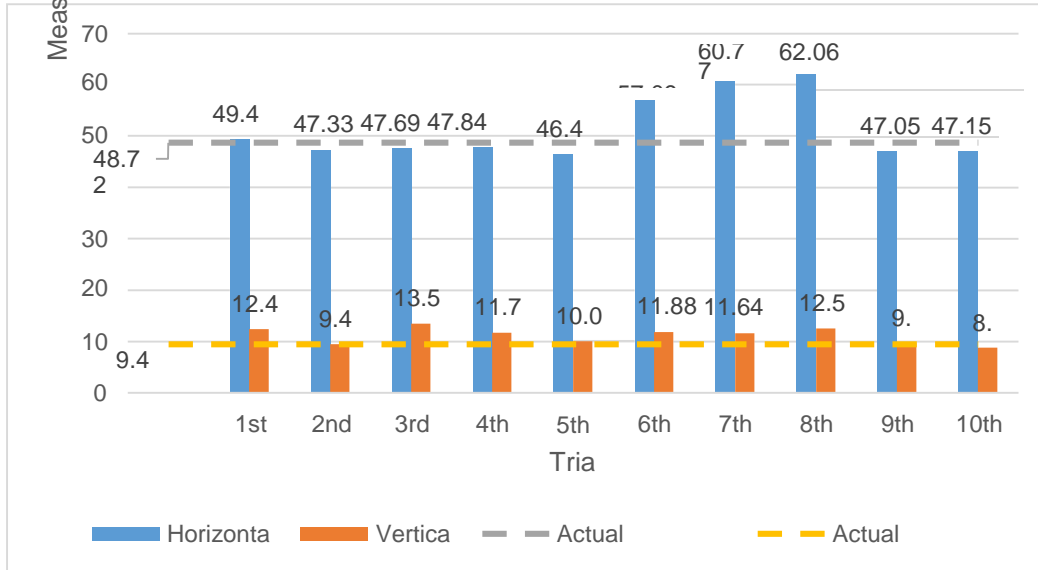
The graph in Figure 3 analyses defects X in the B2 specimen result between actual measurement and trial. Trial 6th, 7th, and 8th have longer measurement compared to the actual which is 57.09 mm, 60.77 mm and 62.06 mm. for the vertical measurement most of the trial is bigger than the actual measurement.

Figure 3 Analysis defect X in B2 specimen result between actual measurement and trial

The second objective has been achieved by comparing the actual measurement of defect and measurement from the thermal image. The defect X in specimen B2 with an average of 51.28 mm for horizontal measurement and 11.18 mm for vertical measurement while the actual measurement for horizontal and vertical is 49.62 mm and 9.06 mm. Defect Y in the B2 specimen has average measurement for horizontal and vertical is 15.02 mm and 8.19 mm while the actual measurement is 8.00 mm and 6.22 mm. For defect Z in the B2 specimen average measurement of horizontal and vertical is 10.24 mm and 4.40 mm while the actual measurement is 19.34 mm and 6.80 mm. for the last defect in specimen B3, the average measurement of horizontal and vertical is 56.43mm and 6.80 mm while the actual is 200 mm and 6.70 mm. Based on the data comparison, it can be concluded that the measurement from the thermal image that has been measured using ImageJ software has an uncertainty which is ± 9.1 mm.

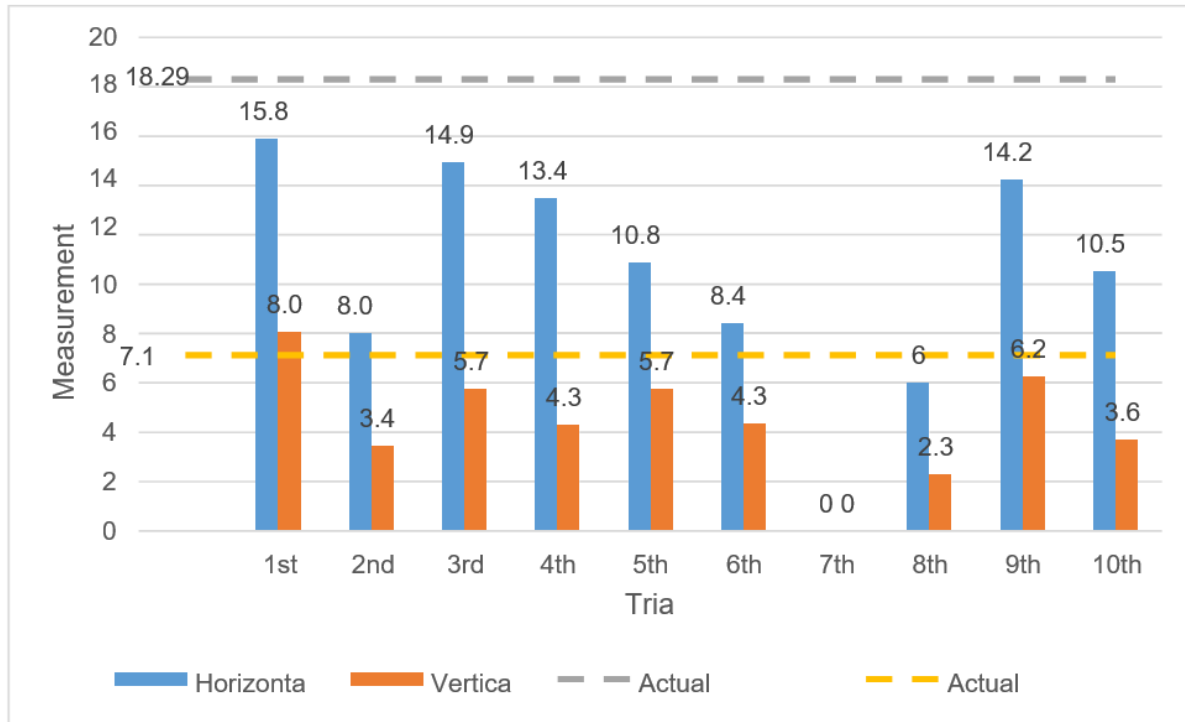
Figure 5 shows the analysis defect Z in the B2 specimen between the actual measurement and trial.

Most of the horizontal measurement has longer measurement than the actual measurement while most of the vertical measurement has lower measurement compare to the actual measurement which is 7.12 mm. The 7th trial has no value because, in the thermal image, the defect did not occur and cannot be differentiated from the temperature with temperature around the area defect.

Figure 5 analysis defect Z in B2 specimen result between actual measurement and trial
